Florida Department of Transportation Research Simulation of Prepackaged Grout Bleed under Field Conditions BDK75-977-59

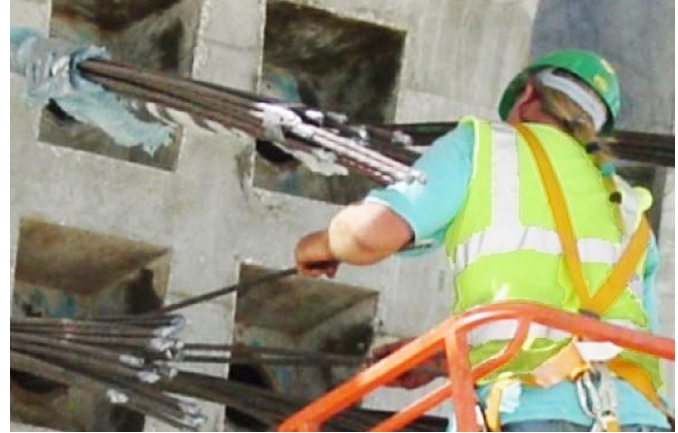
A worker places post tensioning strands in the ducts cast into this bridge component.
