# Pervious Pavements - Installation, Operations and Strength Part 3: Permeable Paver Systems

Work Performed for the Florida Department of Transportation

**Stormwater Management Academy  
University of Central Florida  
Orlando, FL 32816**

**August 2011**

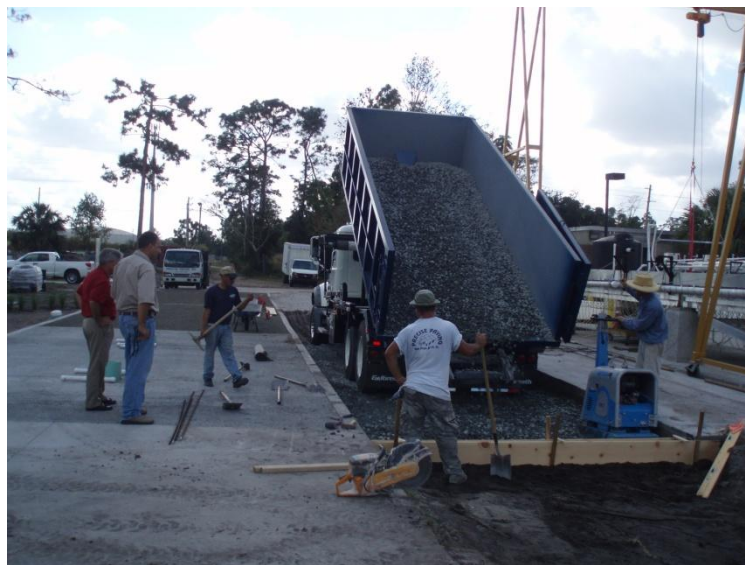
Embedded ring infiltrometers are placed two per section that are set flush with the surface of the bricks and extend down 14 inches, the bottom ending in the #4 stone. The inside of the embedded rings are constructed with the same layers and thicknesses as the rest of the section.

**Figure 5: Site and Formwork Layout**

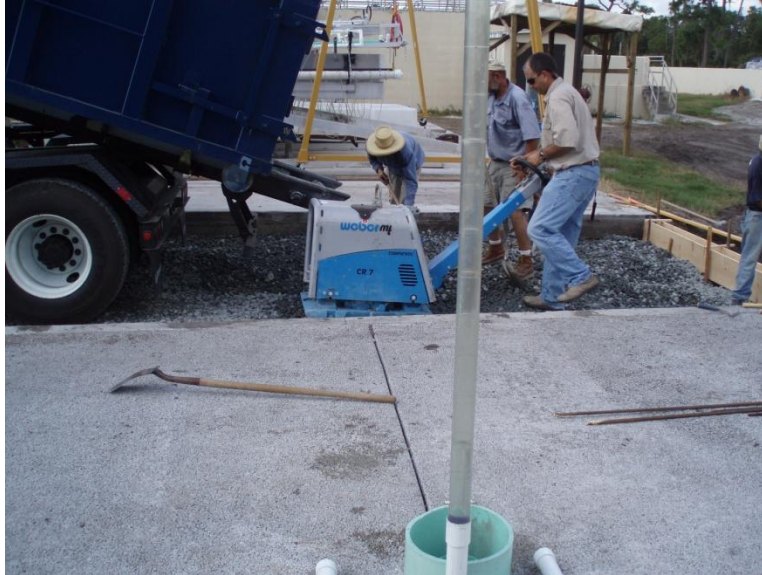
**Figure 6: Aggregates placed, leveled, then compacted**

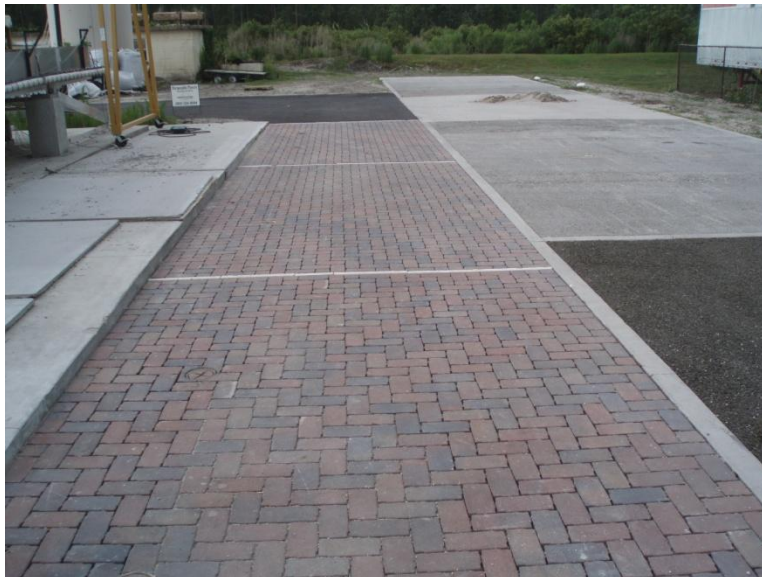
These steps were all done according to the manufacturer's specifications. Figure 7 depicts the final pavement system with the three sections delineated by the curbing.

**Figure 7: Final Layout of Pervious Pavement Sections with ERIKs**

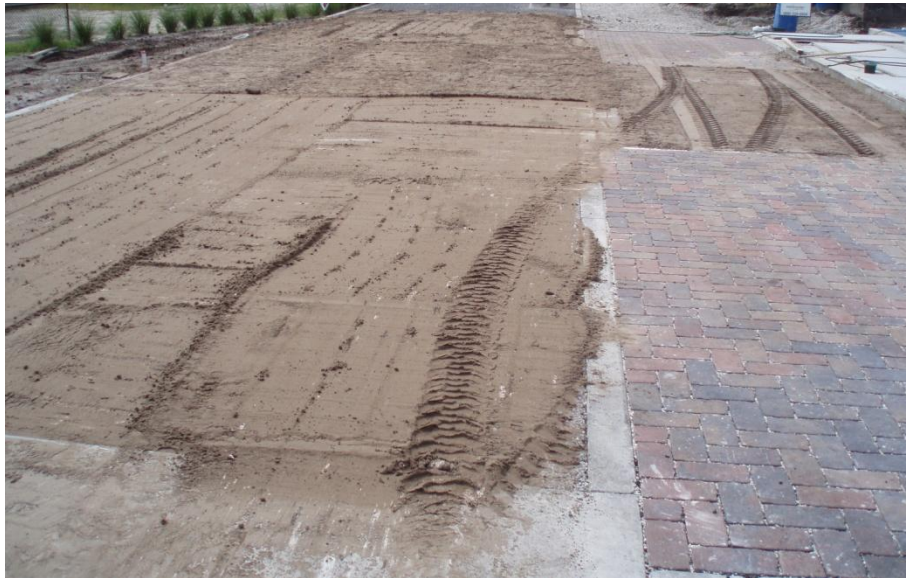
Infiltration and rejuvenation studies began by measuring initial infiltration rates soon after installation and curing was completed. After about a month and a half of measurements, the sections were then intentionally loaded with a layer of A-3 soils, approximately 2 inches thick, spread evenly across the surface with the skid steer loader to simulate long term sediment accumulation conditions (see Figure 8 below). The sediments were then washed into the pores using a garden hose (see Figure 9 below) to simulate accelerated rain events that would eventually wash this sediment into the surface pores by transport processes. The skid steer loader then was driven over the sediments back and forth until the sediments were sufficiently compacted into the pores simulating traffic loading.

**Figure 8: Spreading of A-3 sediments evenly over entire Rejuvenation section**

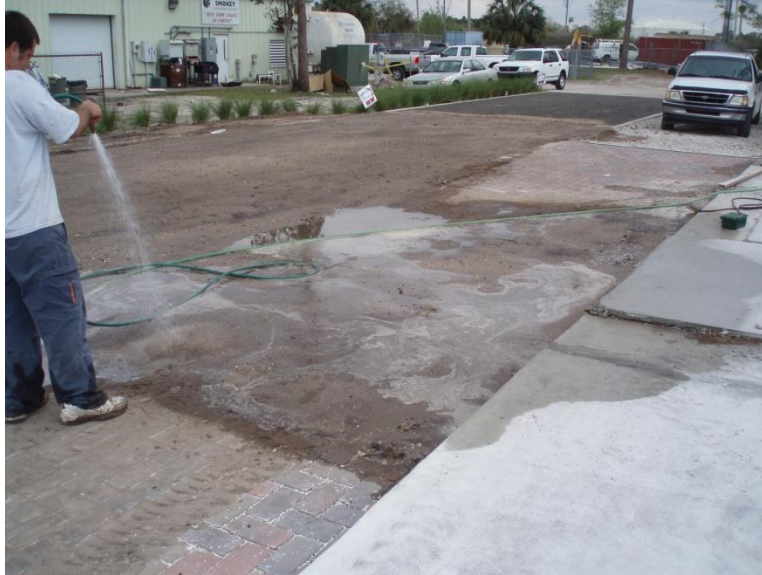
**Figure 9: Washing in A-2-4 soils with garden hose**

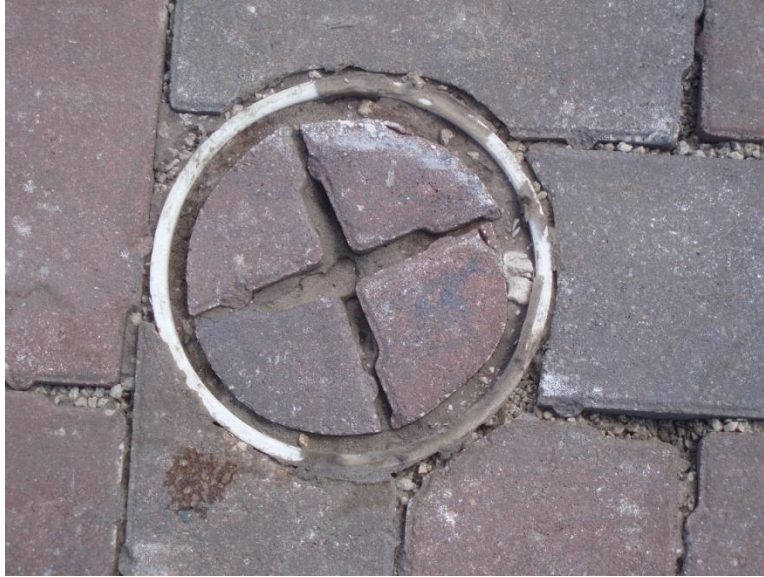
It was noticed that the vacuum force was unsatisfactory at detaching and removing the soils in a dry and hardened state (see Figure 10). At this time, water was added to saturate the pavements surface. This was done by spraying a garden hose onto the pavement surface until water ponded on the pavement surface and the sediment was sufficiently soft. Once water was introduced, the fine grained sediments reached their liquid limit, became plastic and mobile, and the vacuum force was able to remove the sediment from the surface. The vacuum force was enough to remove even the filler stones in the joints of the bricks shown in Figure 11. Once the surfaces were vacuumed, post-rejuvenation ERIK measurements were continued on the paver systems.

**Figure 10: Unsuccessful vacuuming of A-3 soils when dry and hardened**

These observations lead to the recommendation of coordinating the maintenance using a vacuum truck either during or immediately after large rain events or if ponding is noticed on the pavement surfaces. The draft statewide stormwater rule recommends nuisance flooding as an additional indicator of a clogged pavement from the ERIK device, and this study verifies that

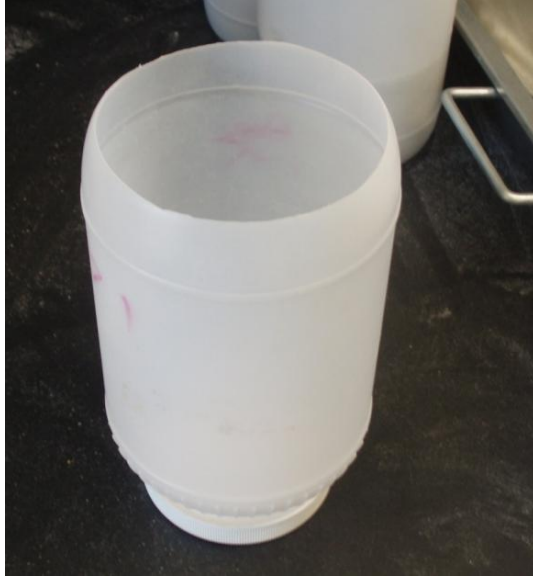
Due to the nature of the testing, a setup that allowed for repeatability of tests was required to measure the reduction of sustainable storage after clogging, and the rejuvenation of that storage after performing vacuuming on the sample surfaces. To achieve this, small half gallon plastic containers with screw on lids were chosen for the bench scale testing shown in Figures 12 and 13.

**Figure 12: Half Gallon Jar picture for component testing**

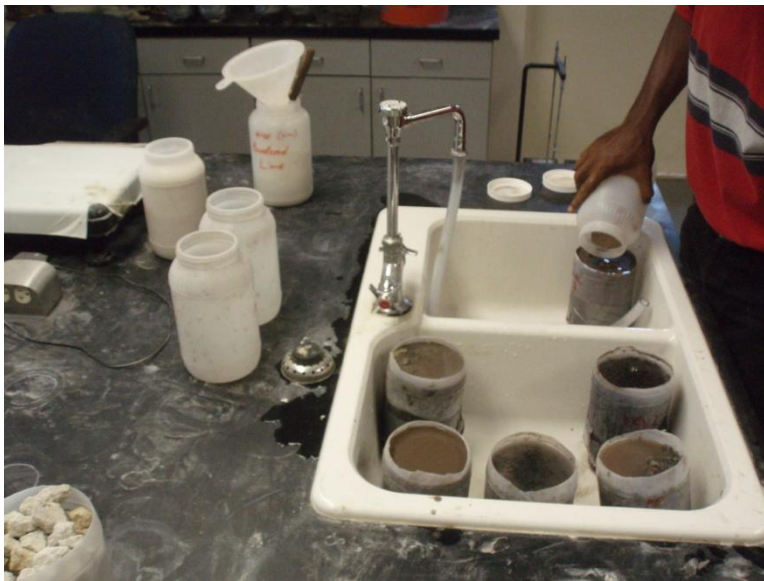
**Figure 13: Half Gallon containers being loaded with sediments**

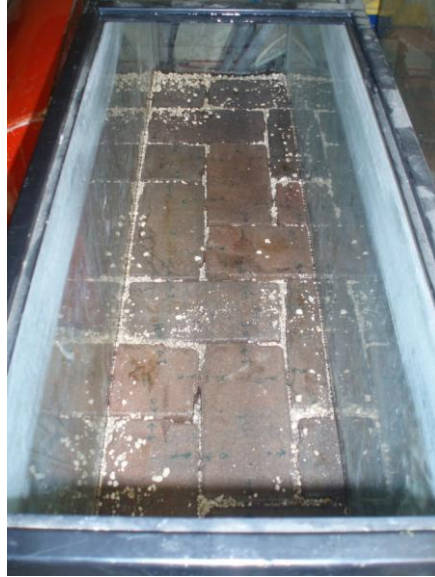
A larger (12"x19"x47") glass aquarium container (see Figure 14 below) was needed to test the storage within the bricks with joints filled.

**Figure 14: Brick paver (surface layer component) tested in large glass aquarium (12" x 19" x 47")**

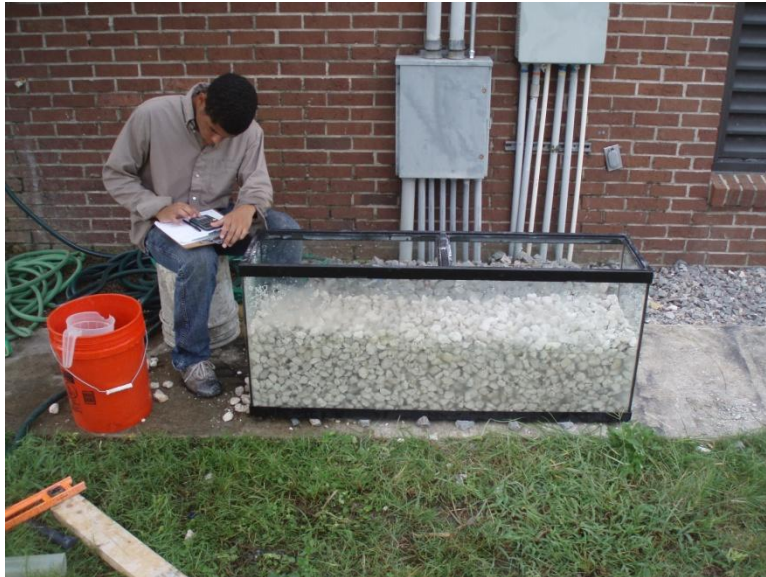
Since some of the larger aggregates had noticeably larger gaps near the side walls of the ½ gallon containers, the porosities of the #4 sized aggregates were also tested in the large aquarium see Figure 15 below.

**Figure 15: Number 4 Aggregates tested in large glass aquarium (12" x 19" x 47")**

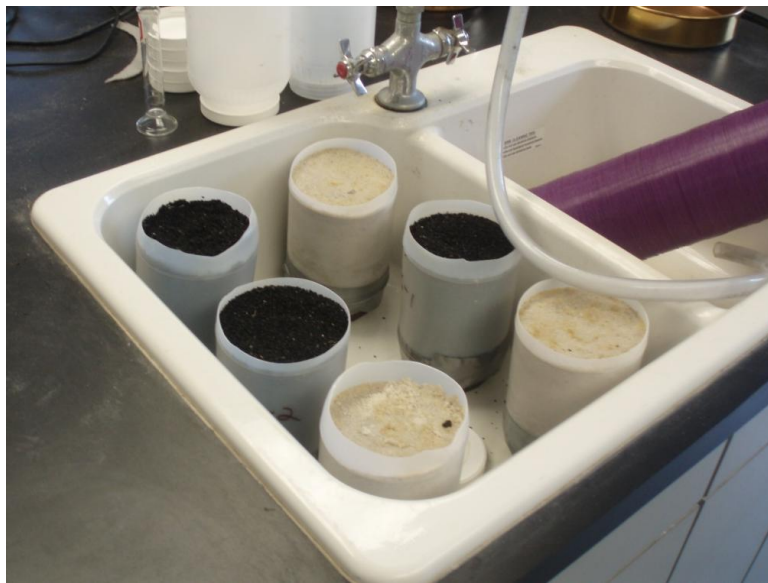
**Figure 17: Half Gallon Jars draining by gravity**

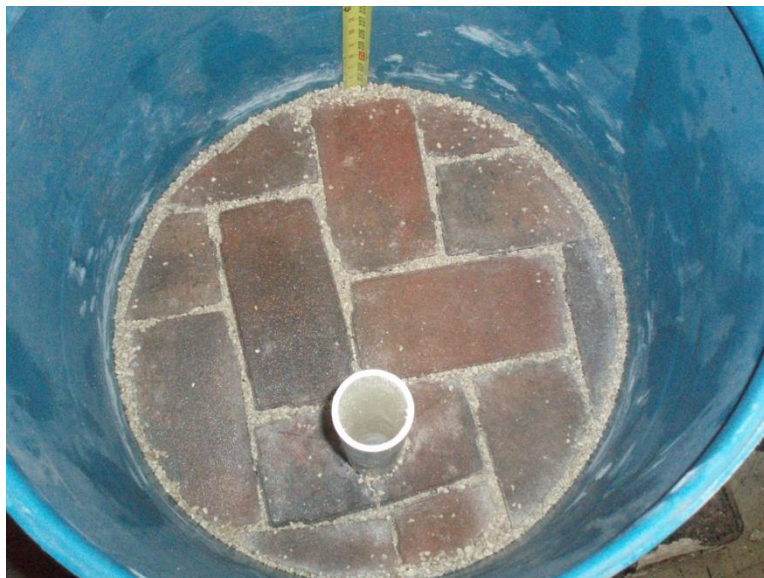
**Figure 19: System testing in 55 gallon barrel**

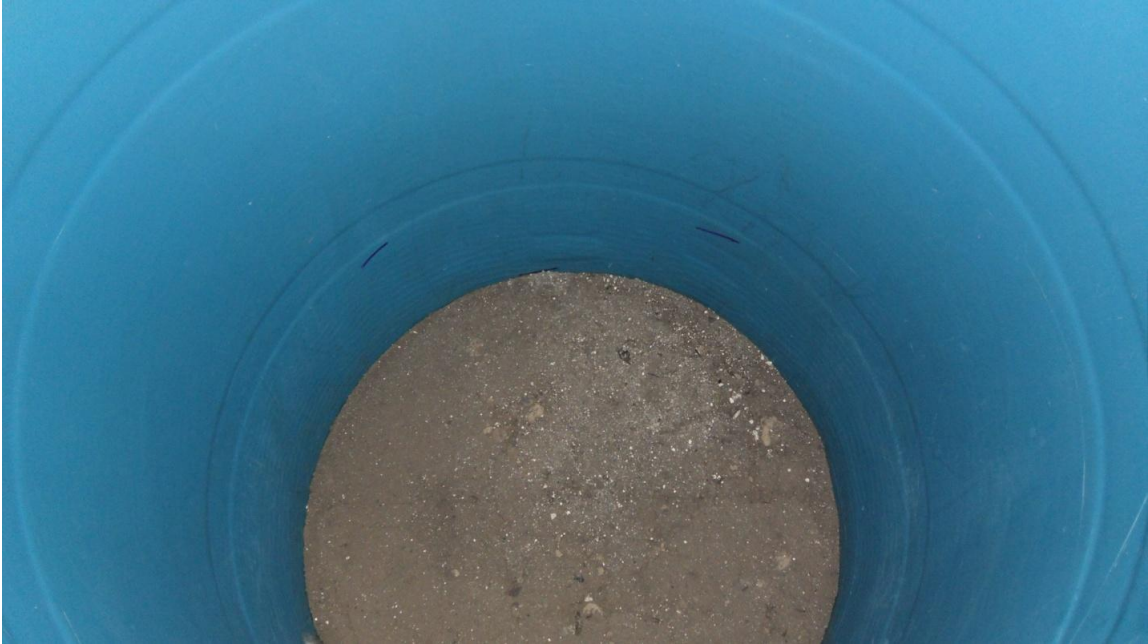
Once all of the barrels were labeled, AASHTO type A-3 soil was poured into each barrel and compacted to a height of 4 inches (Figure 20). Next, a non-woven filter fabric was laid over the soil in all of the barrels (Figure 21).

**Figure 20: 4 Inches of Compacted AASHTO Type A-3 Soil Installed**

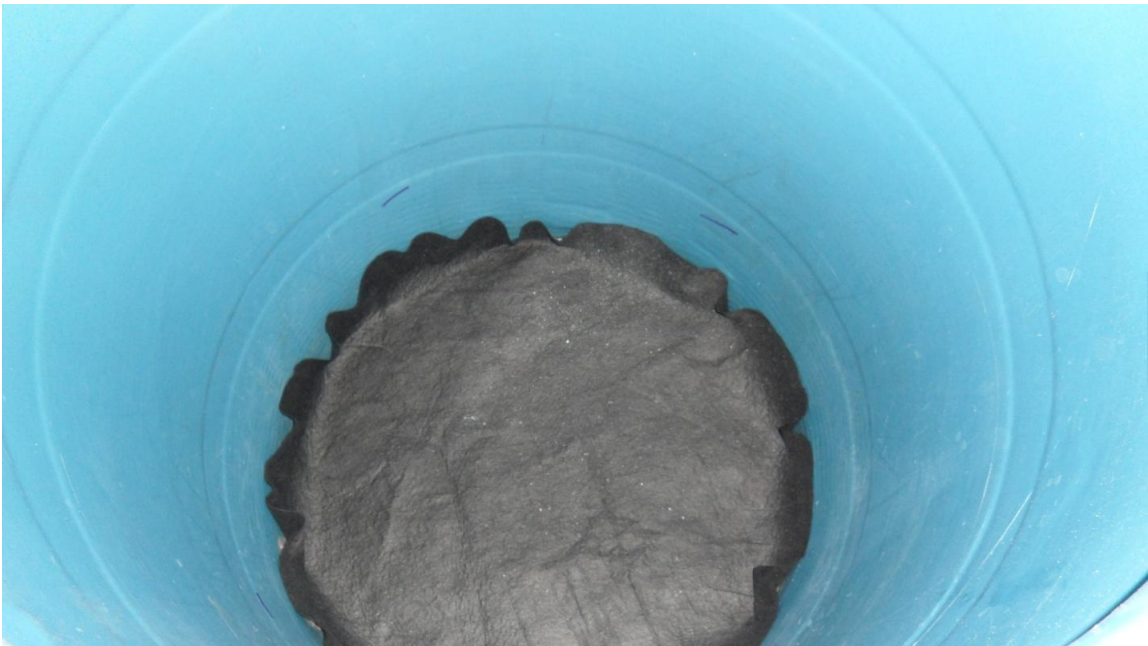
**Figure 21: Non-woven Geotextile Separation Fabric Installed**

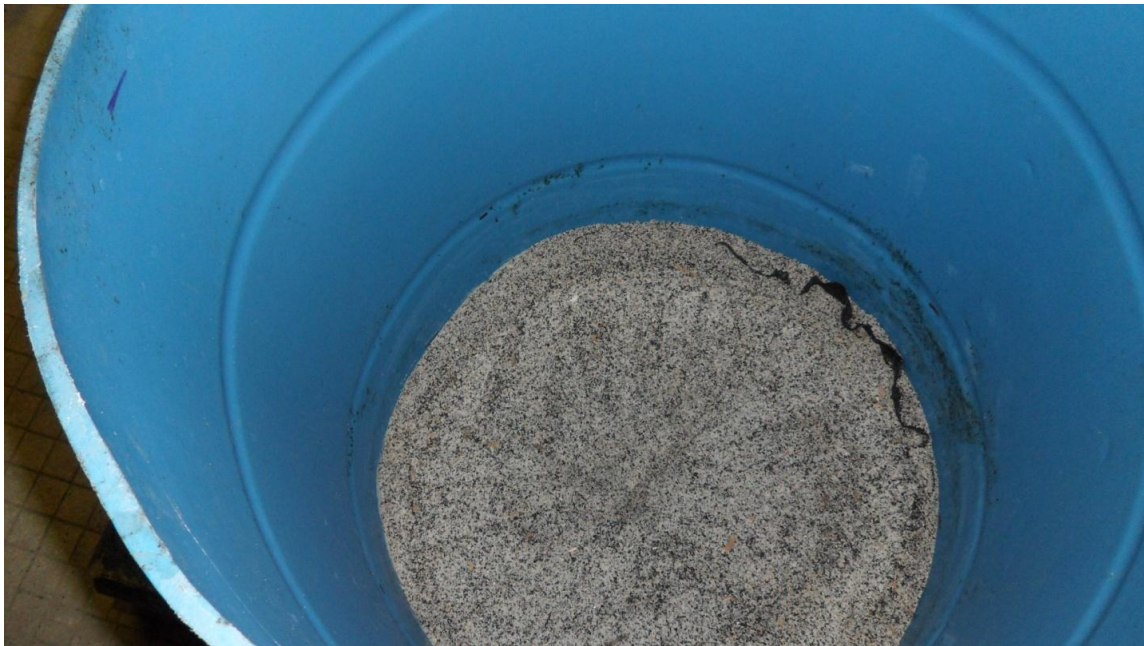
Bold&Gold™ pollution control media was then poured into the four B&G system barrels and compacted to a depth of 4 inches (Figure 22). Next, #4 Stone was placed into all 8 barrels at a depth of 5 inches, then leveled and compacted (Figure 23). #57 Stone was then placed into all 8 barrels at a depth of 4 inches, then leveled and compacted (Figure 24).

**Figure 22: 4 Inches of Bold&Gold™ Pollution Control Media Installed**

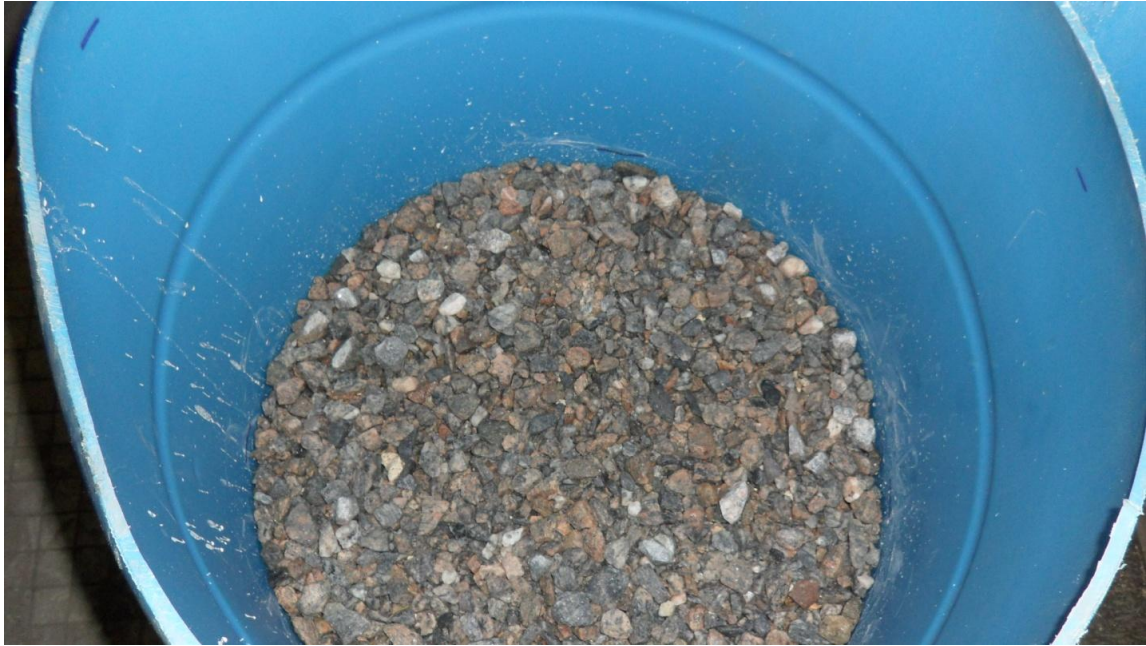
**Figure 23: 5 Inches of #4 Stone Compacted**

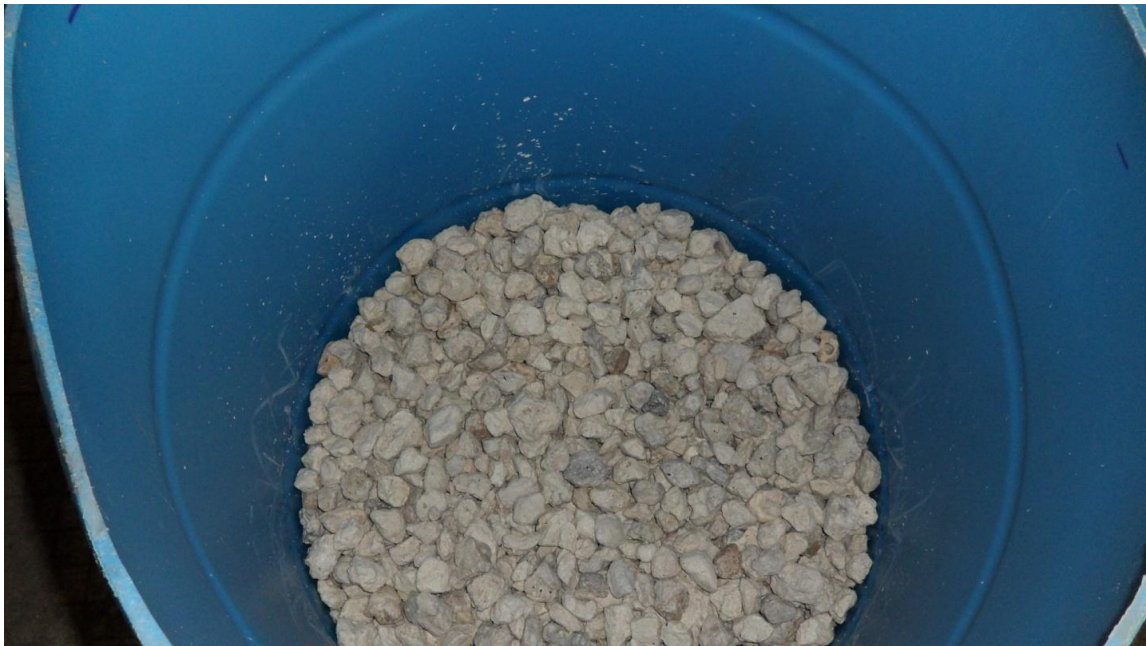
**Figure 24: 4 Inches of #57 Stone Compacted**

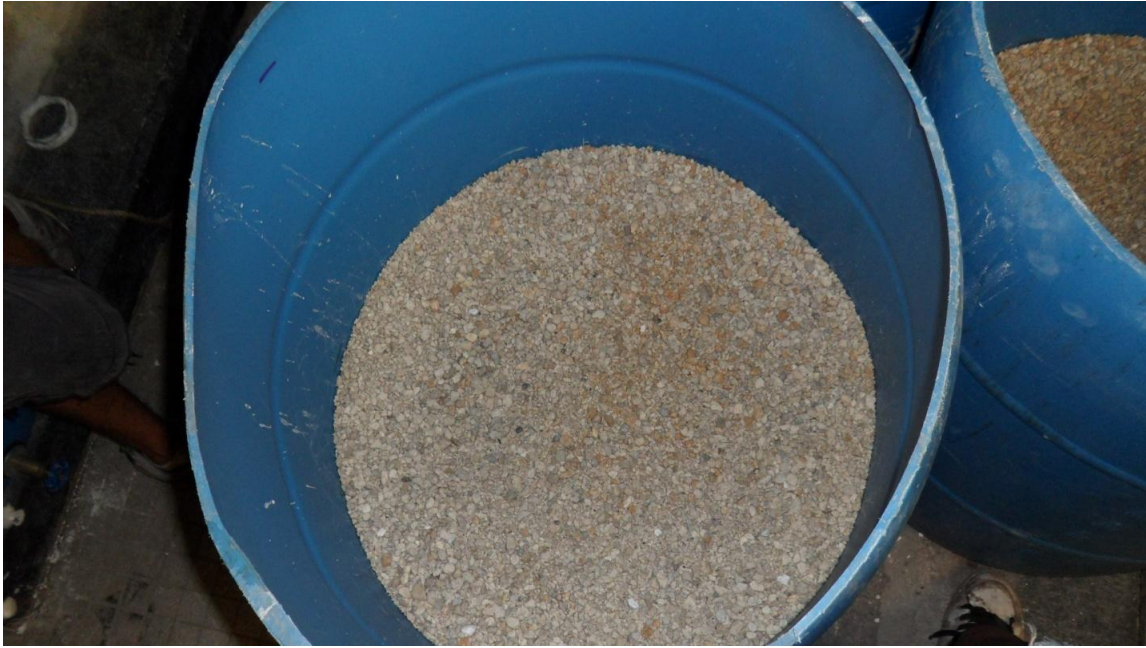
The next layer was a bedding layer consisting of #89 limestone compacted to a depth of 2 inches (Figure 25). Lastly, the brick pavers were placed into all the B&G and Fill system barrels except the two control barrels (Figure 26).

**Figure 25: 2 inches of #89 Limerock**

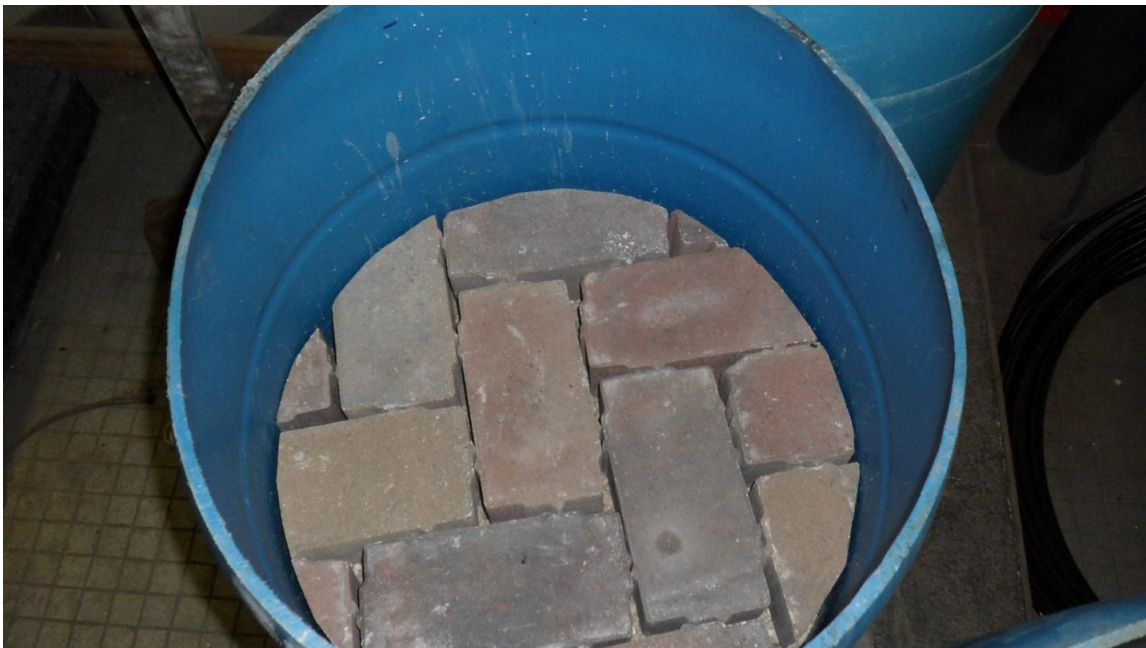
**Figure 26: Oldcastle Brick Pavers Installed**

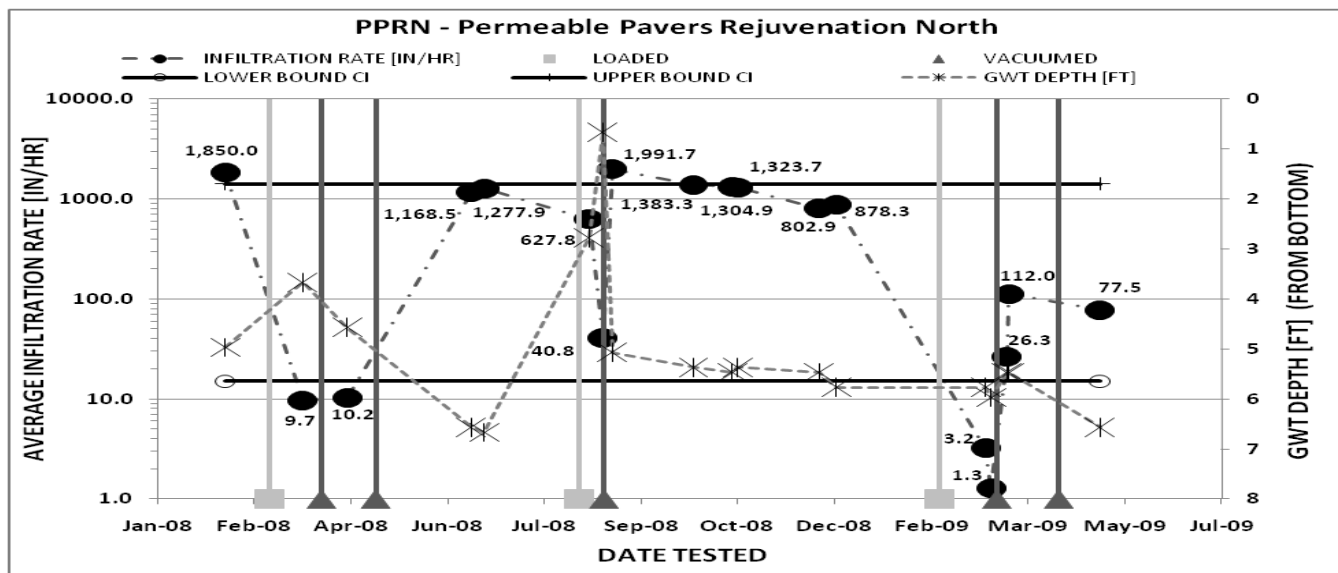
**Figure 28: Infiltration Rate (ERIK) Results for the Permeable Pavers Rejuvenation North Section Infiltrometer**

The north infiltrometer measured an initial rate of 1850 in/hr at the beginning of the study period. After sand was used to clog the system the rate was reduced to 9.7 in/hr. The first vacuum attempt only restored the rate to 10.2 in/hr but when re-vacuumed, the rate was rejuvenated back up to 1169 and 1278 in/hr. The crushed limerock fines were washed in and compacted into the surface pores next, which caused the rate to fall to 627.8 and 40.8 in/hr during the second set of post-loaded ERIK tests. The vacuum truck performed maintenance, and increased the infiltration of the pavers to 1992 in/hr followed by three tests measuring 1383, 1305, and 1324 in/hr. After about a month the rate had dropped to measured rates of 802.9 and 878.3 in/hr. Towards the end of the study period, the pavement was loaded again with the sandy soils and resulted in decreased infiltration rates measured at 3.2 and 1.3 in/hr. The restoration of the infiltrating capacity of the system was effective by increasing the measured rates to 26.3 and 112.0 in/hr during the next two tests. The pad was vacuumed once more and the post-cleaning rate measured in at 77.5 in/hr.

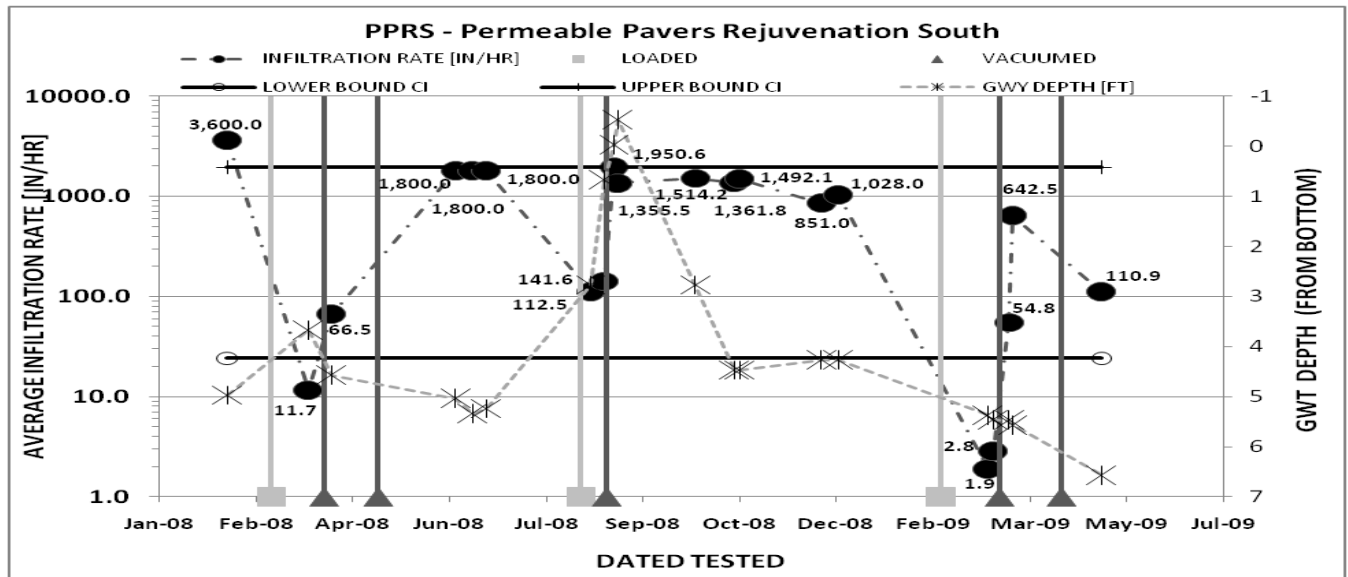
**Figure 29: Infiltration Rate (ERIK) Results for the Permeable Pavers Rejuvenation South Section Infiltrometer**

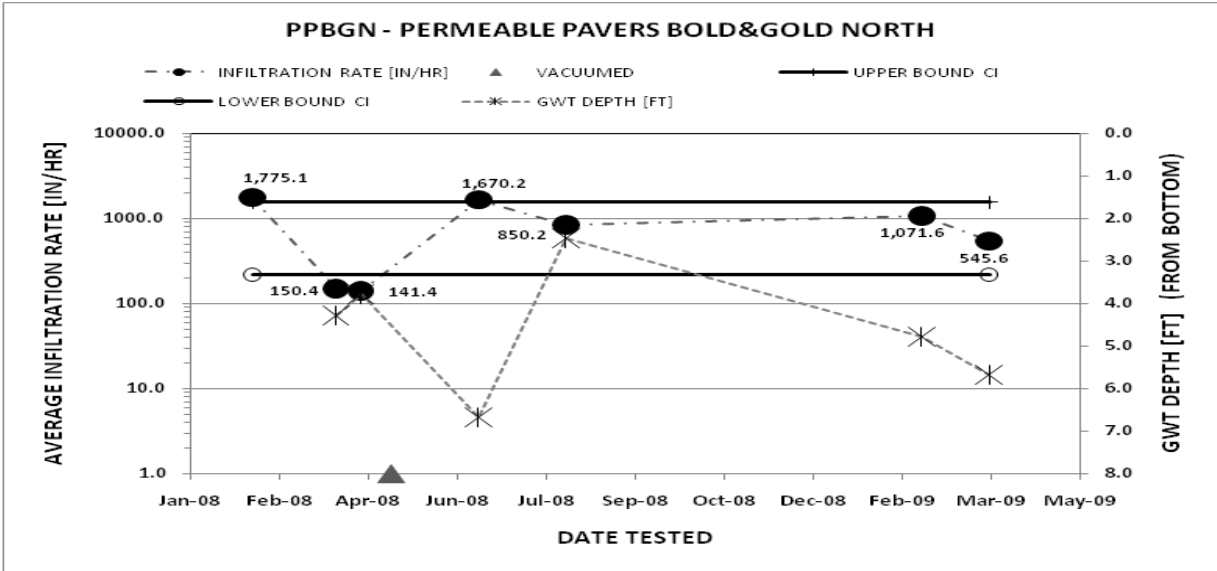
**Figure 31: Infiltration Rate (ERIK) Results for the Permeable Pavers Bold&Gold North Section Infiltrometer**

The measured rate after maintenance was 1670 in/hr and the later tests resulted in measured rates of 850.2, 1072, and 545.6 in/hr throughout the period of study. All tests were conducted when GWT levels remained lower than 3 feet from the bottom of the system except for the test that measured 850.2 in/hr while the GWT was about 2.5 feet below the bottom of the system.

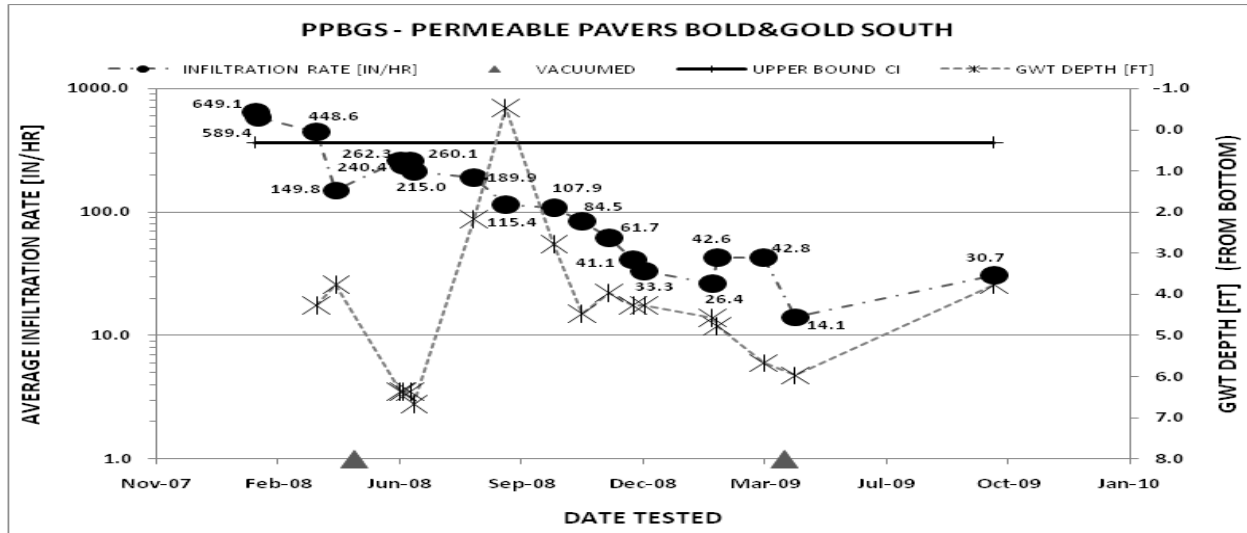
**Figure 32: Infiltration Rate (ERIK) Results for the Permeable Pavers Bold&Gold South Section Infiltrometer**

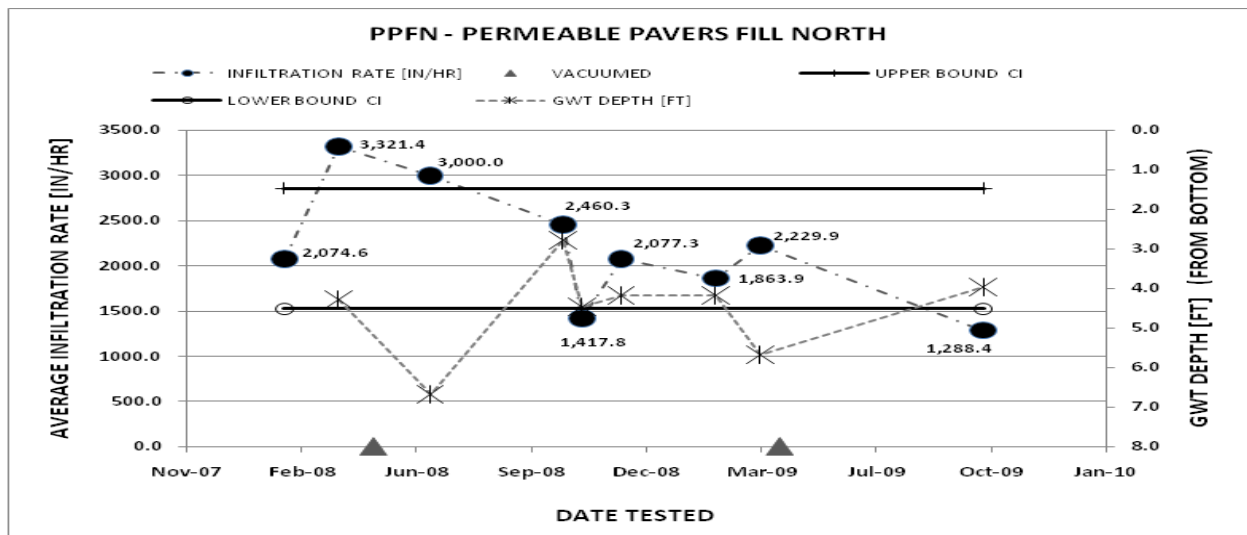
**Figure 34: Infiltration Rate (ERIK) Results for the Permeable Pavers Fill North Section Infiltrometer**

The north infiltrometer shown above in Figure 34, resulted initially in measured rates of 2075 and 3321 in/hr prior to maintenance via vacuum truck. Once vacuuming occurred the system’s measured rates were 3000, 2460, 1418, 2077, 1864, and 2230 in/hr with the GWT fluctuating within a range of about 2.5 to 6.5 feet below the bottom of the system. The system was vacuumed once more and the measured rate after about 6 months of natural loaded sediment accumulation and the final measured rate was 1288 in/hr.

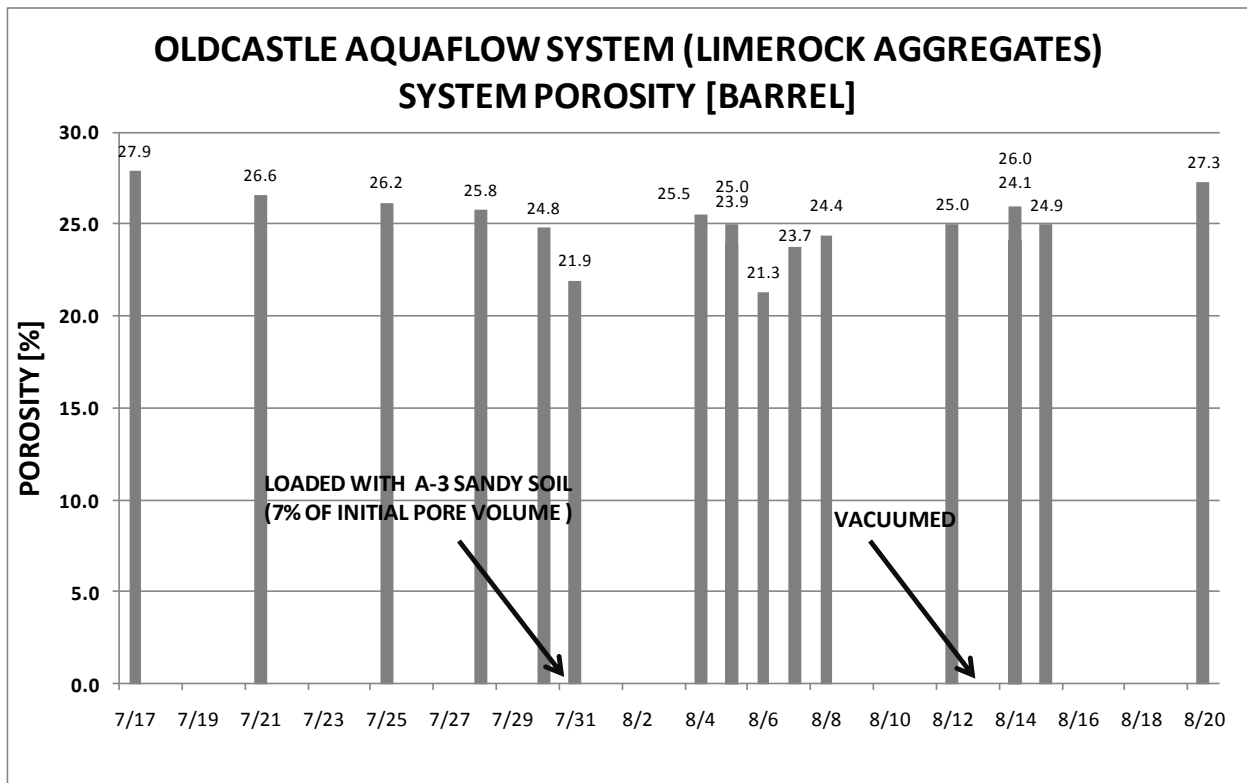
Presented below in Figure 36 is the results for testing the amount of water storage within the complete cross section (using the 55 gallon barrels) of the Oldcastle permeable pavers including the surface layer, bedding layer, and stone reservoir sub-base layers. The first five initial tests were conducted without introducing any sediment to the systems to investigate the total or maximum storage available.

**Figure 36: System porosity results using 55 gallon barrels (#4 granite)**

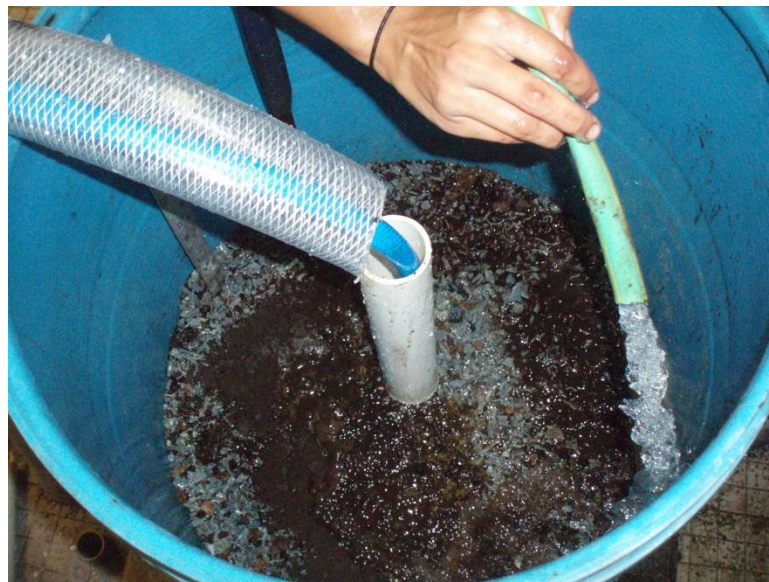
micropores in the aggregates and near the contact points, and dead-end pores small enough to prevent gravity from transmitting this water downward due to capillary pressure exceeding the force of gravity in such a small pore size are able to retain some of the water. These next four tests represent the effective porosity (26.6% - 28.8%) of the system in which can be expected of the in-situ pavement that is not oven dried to remove the residual water in the micropores. The sixth test is conducted after loading with 7% of the initial pore volume measured by the initial test using A-3 soil on the surface of the paver bricks and washing into the pores while simultaneously pumping the infiltrated water out of the well pipe from the bottom of the stone reservoir (see Figure 37 below).

**Figure 37: Washing loaded sediments into pores while pumping infiltrated water out through well pipe**

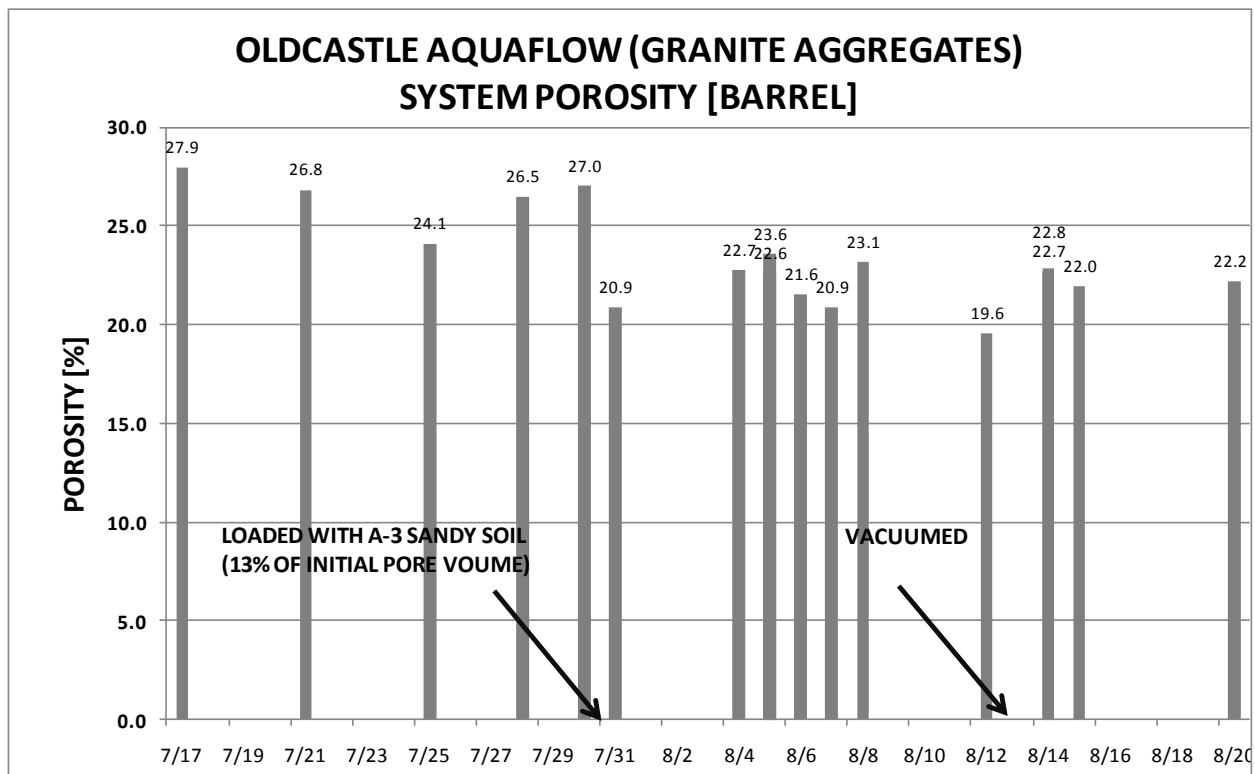
Figure 38 below presents the results of the same cross section but using granite #4 aggregates instead of limerock.

**Figure 38: System porosity results using 55 gallon barrels (#4 limerock)**

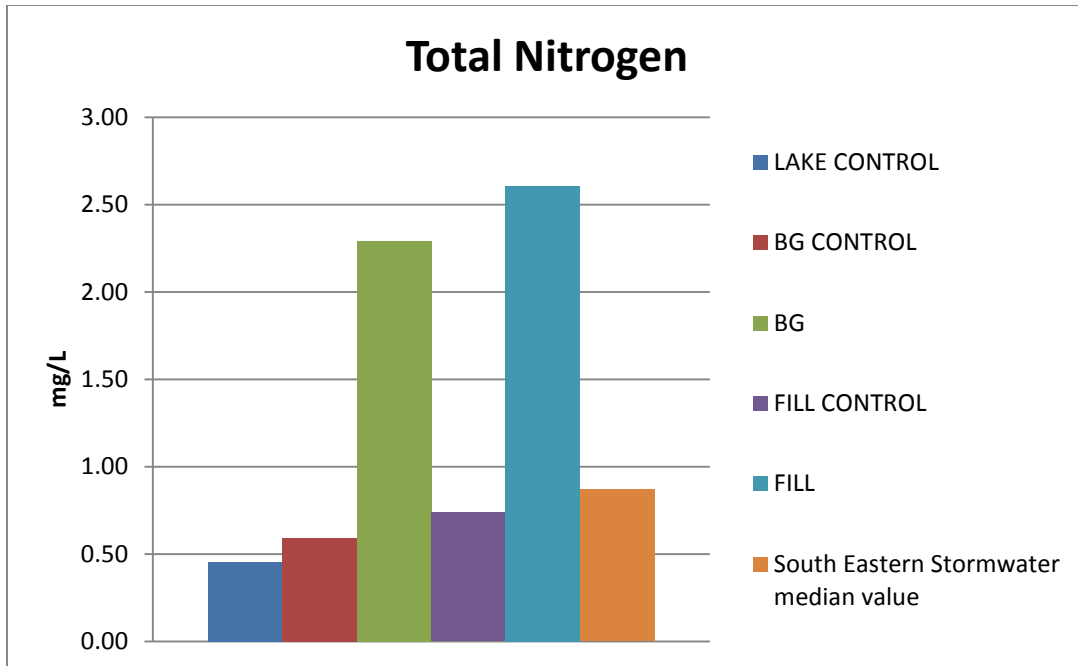
**Figure 39: Total Nitrogen Results**

Figure 39 shows the total nitrogen results for all the systems tested, the stormwater pond water used to simulate the rain events, and the south eastern stormwater median value. After analysis of the results it was shown that the Bold&Gold™ system was not significantly different ( $\alpha=0.05$ ) from the fill system. This shows that the addition of the sub-base pollution control layer has no significant effect on total nitrogen concentration. It was observed that all the systems tested had higher concentrations than the stormwater used to simulate the rain event. This was likely due to the fact that local soil was used to simulate the sub-base and likely leached nutrients, however it should be noted that both the fill control and B&G control systems were all below the south eastern stormwater median value for total nitrogen. The systems that had the Aqua Bric permeable brick pavers were observed to have a significantly higher concentration of total nitrogen which might be due to the composition of the bricks or the conditions where the bricks were stored just to name a few.

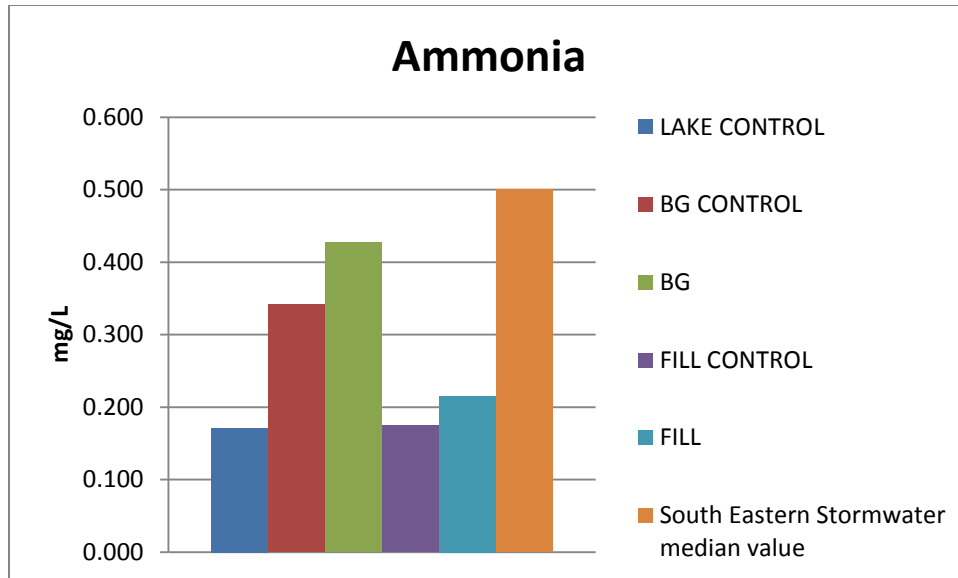
**Figure 40: Ammonia Results**

somewhat consistent. The higher ammonia concentration may be a result of the composition of the bricks, the conditions where the bricks were stored, or the level of precision of the test methods to name a few.

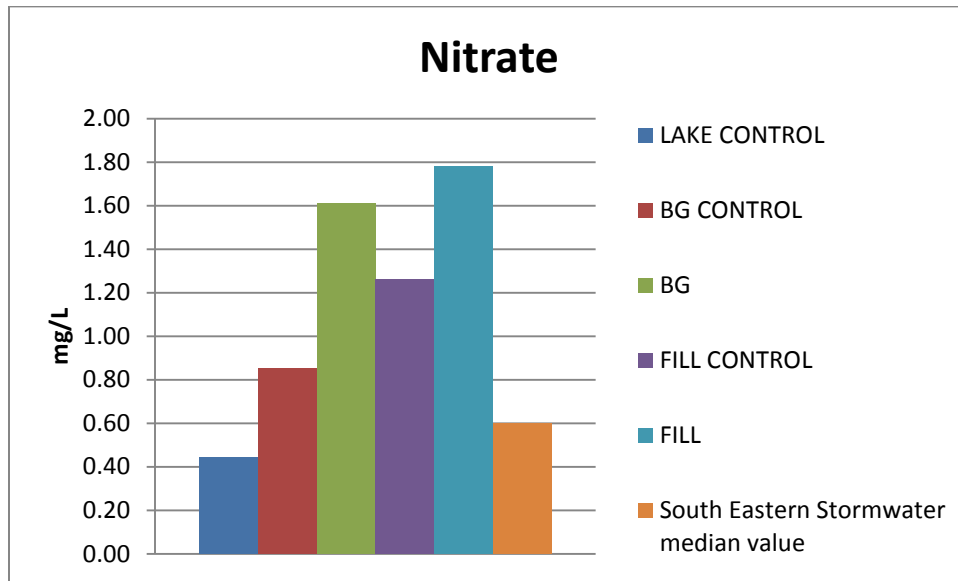
**Figure 41: Nitrate Results**

was likely due to the fact that local soil was used to simulate the sub-base and likely leached nutrients. Similar to the total nitrogen results, the systems that had the Aqua Bric permeable brick pavers were observed to have a higher concentration of ammonia. While this was not statistically significant ( $\alpha=0.05$ ), the trend was somewhat consistent. The higher nitrate concentration may be a result of the composition of the bricks, the conditions where the bricks were stored, or the level of precision of the testing methods to name a few.

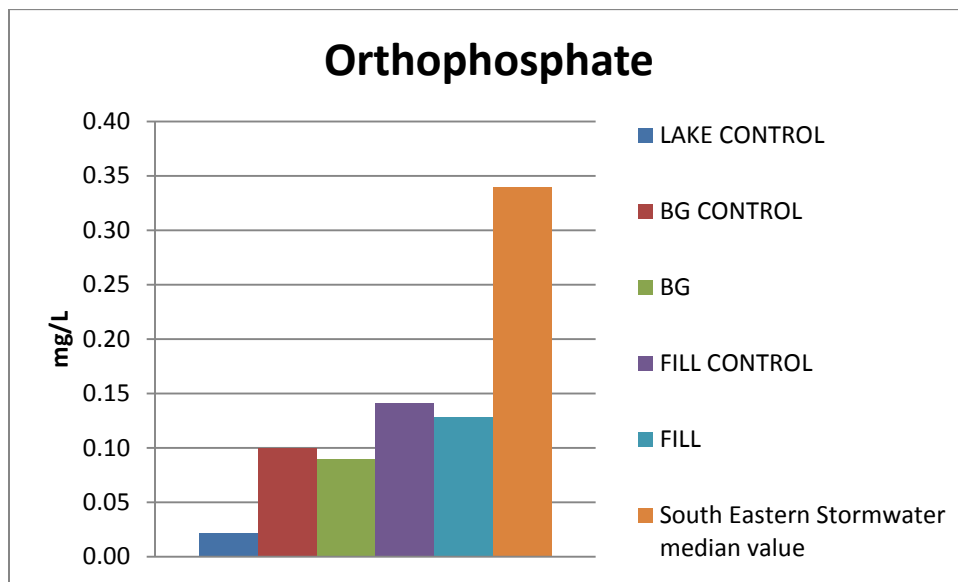
Figure 42: Ortho-Phosphate Results

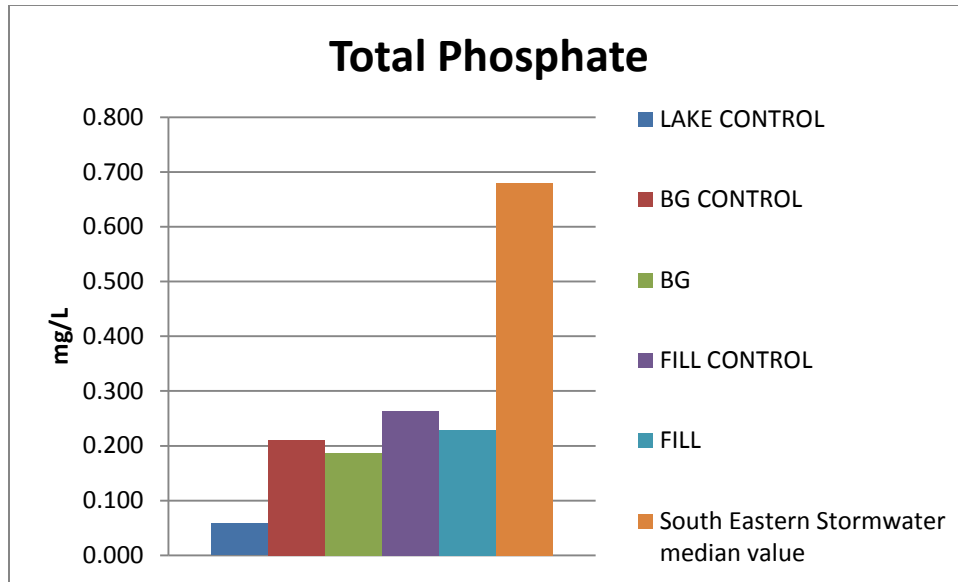
**Figure 43: Total Phosphate Results**

concentrations than the Fill control and Fill systems respectively. This was not significant however and due to the low concentrations no significant reduction should be expected.
