## Florida Department of Transportation Research

### Bridge Maintenance Monitoring Demonstration

BDK78 977-07

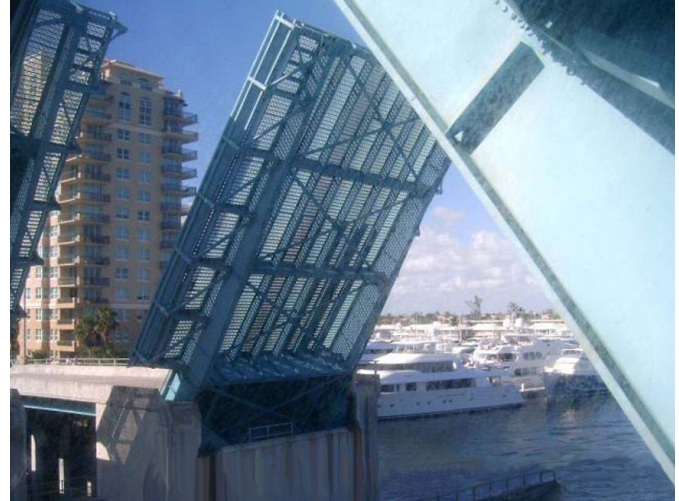
*Sunrise Boulevard Bridge in Ft. Lauderdale, shown with its movable leaves in raised position.*
