Florida Department of Transportation Research

Evaluation of Camera-Based Systems to Reduce Transit Bus Side Collisions – Phase 2

BDK85 977-35

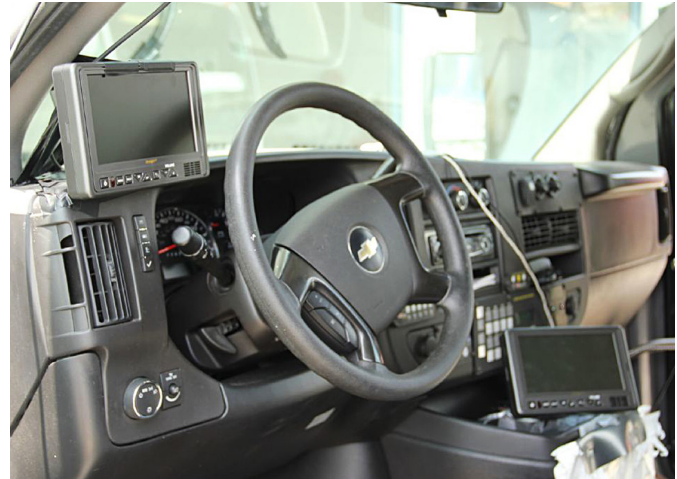
Monitors for left and right side view cameras were placed next to the steering wheel at 10 and 4 o'clock.
