Evaluation of Self-Consolidating Concrete and Class IV Concrete Flow in Drilled Shafts

February 2020

BDV25-977-25

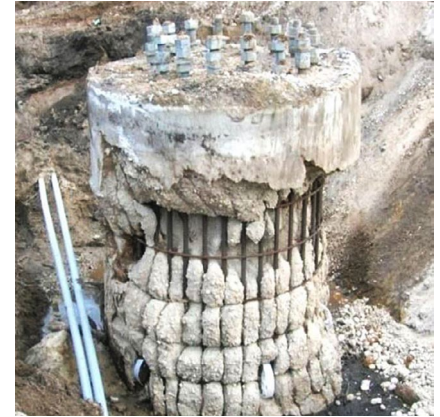
This recovered drilled shaft shows the mattressing effect caused by concrete flowing radially through the reinforcing cage.

Previous FDOT research on this problem established that concrete flows radially out through the reinforcing cage and does not rise vertically through the region between the cage and soil wall. It was also found that creases formed when mineral slurry was used in large-scale laboratory shaft specimens where the concrete was placed by a tremie (filling from bottom up). In this project, researchers identified the extent of crease formation in both laboratory and field conditions and the effects of their presence on concrete strength and durability.
