Pilot Implementation for Preventing Incorrect Turns at Highway-Rail Grade Crossings

FDOT BDV25-977-54

Final Report

USF Center for Urban Transportation Research (CUTR)

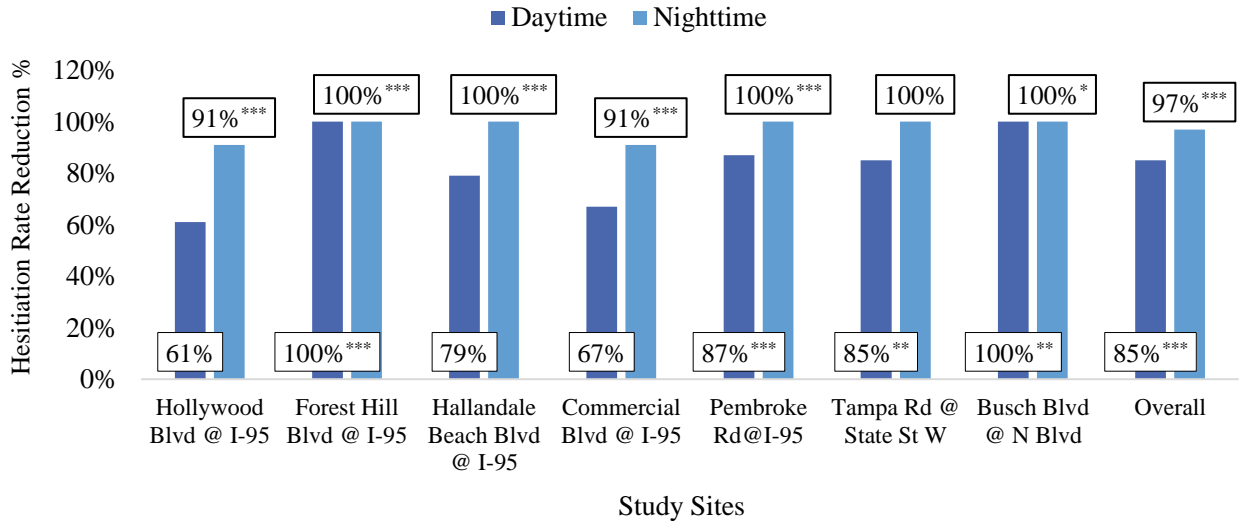
- Overall, the proposed countermeasures can significantly reduce hesitation rates of drivers at at-grade crossings by 85% in daytime and 97% in nighttime at a confidence level of 99.9%.
- The installation of Qwick Kurb can effectively reduce intentional U-turns at railroad crossings.
- There were zero observations of incorrect U-turns after installing Qwick Kurb at Site 1. The 100% reduction of U-turn intention rate in this study is statistically significant at an 87% confidence level for this countermeasure. The installation of Qwick Kurb can significantly reduce the turning radius, thus reducing the risk of intentional U-turns at railroad crossings.

Figure ES-1 Relative reduction of hesitation rates for pavement marking of straight arrow plus guidance information

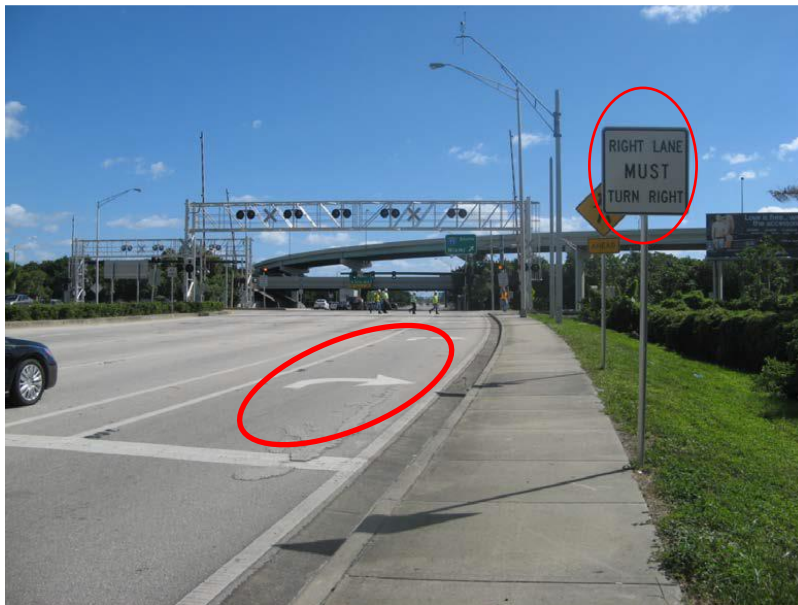
Figure 1-2 Example of potentially misleading right-turn sign and pavement markings

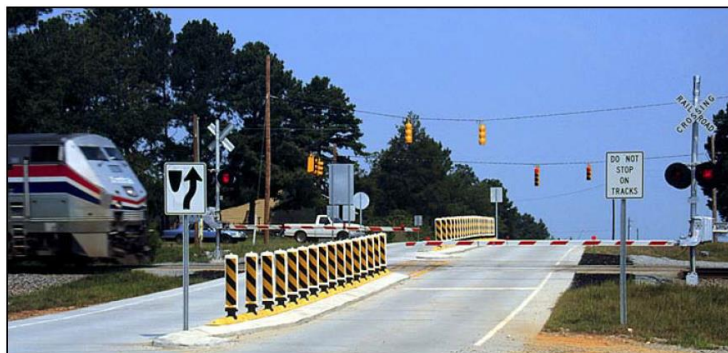
Qwick Kurb can deter motorists from turning around before or at railroad crossings, consequently preventing incorrect U-turns. The U.S. Department of Transportation (DOT) Federal Railroad Administration (FRA) promotes the use of traffic channelization devices (e.g., Qwick Kurb) at highway-rail grade crossings with active warning devices, where applicable. These traffic channelization devices provide a proven safety benefit. A previous study [6] was conducted at locations where driver violations occurred at highway-rail grade crossings and after installation of channelization devices at these locations, resulting in a significant reduction in driver violations. Figure 1-5 shows an example of Qwick Kurb at a railroad crossing.

Figure 1-5 Example of Qwick Kurb (Photo courtesy of NCDOT)

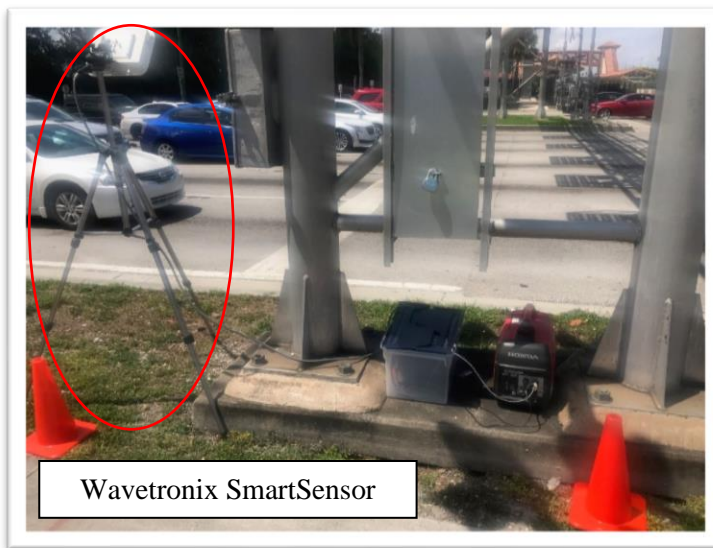
As shown in Figure 2-3, installations of a Wavetronix SmartSensor and a GoPro camera on a Pneumatic Locking Telescoping Mast were mounted at each candidate site. The Wavetronix SmartSensor uses the latest radar technology to collect and deliver traffic data, including traffic volume and classification, average speed, individual vehicle speed, lane occupancy, and presence on multiple lanes. Data for individual speeds of cars approaching the railroad crossings were processed to identify hesitation behaviors using the methodology introduced below. Traffic monitoring videos from the camera were used to verify hesitating vehicles. The two devices were powered by a gasoline-powered inverter generator. Researchers configured and monitored the SmartSensor operations on a laptop through the SmartSensor Manager software.

Figure 2-3 Installation of Wavetronix SmartSensor and GoPro on pneumatic mast

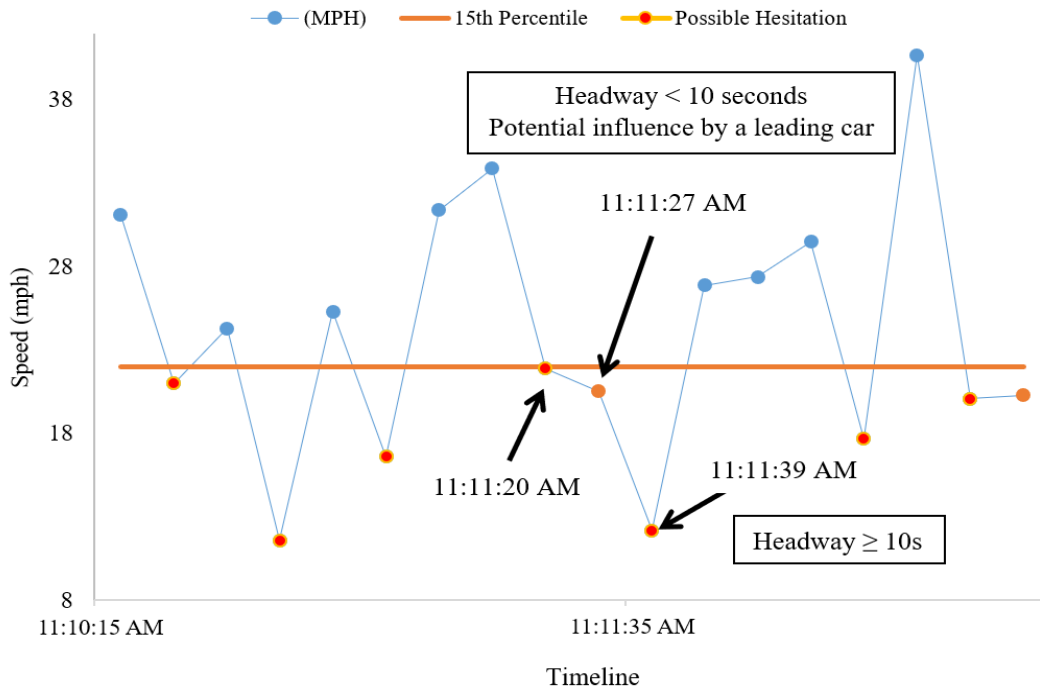
Figure 2-4 Example of visualization of Wavetronix speed data and potential hesitation filter

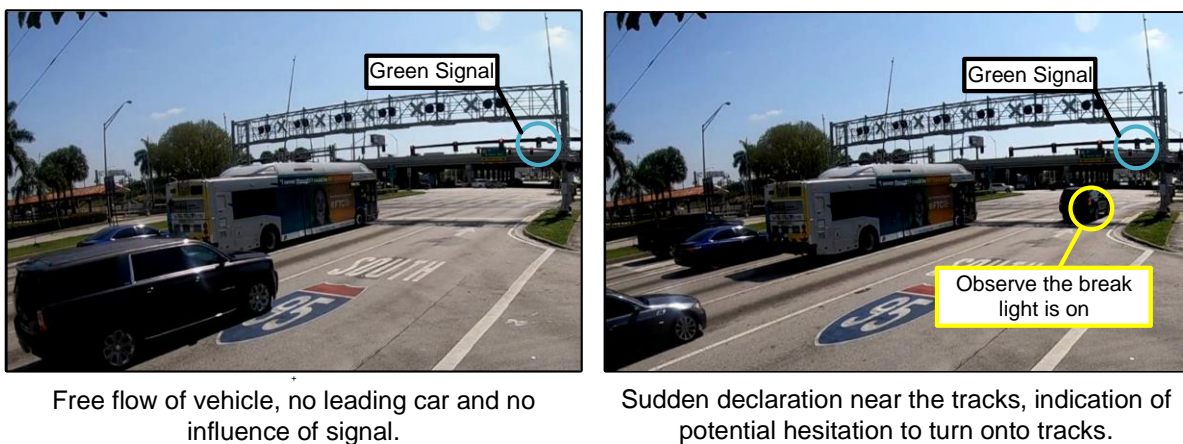
Figure 2-5 Example of hesitation behavior verification on videos

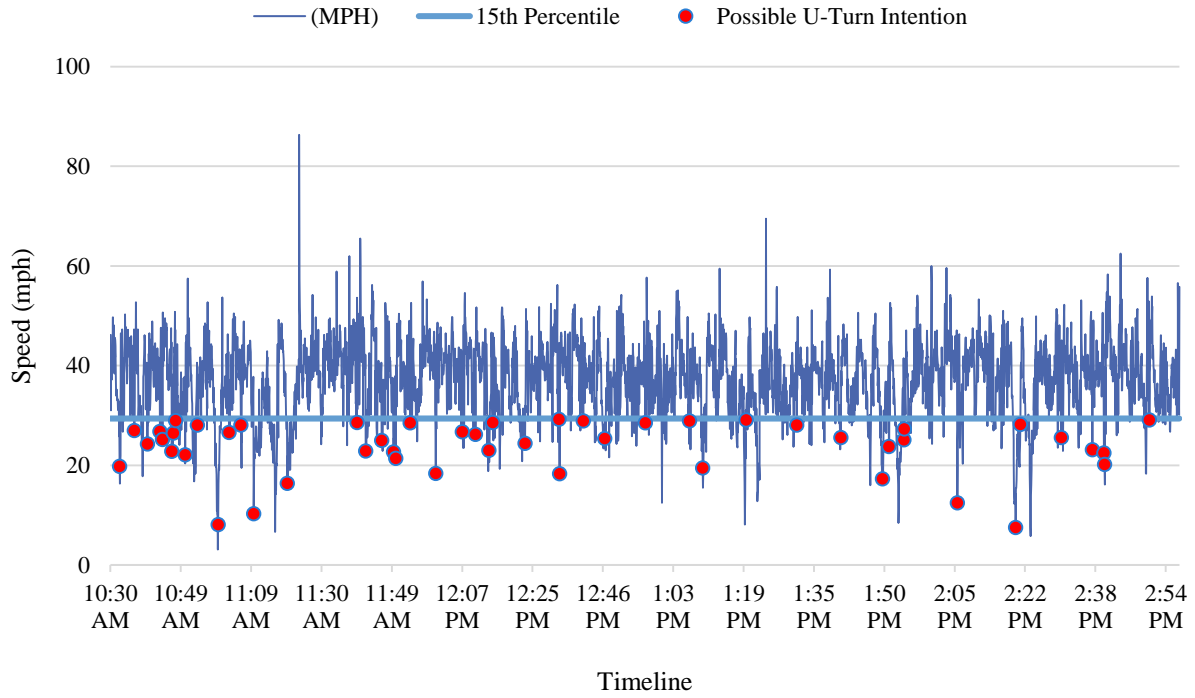
Figure 3-3 Speed profile at US-41 @ US-301, Bradenton, FL (before, daytime)

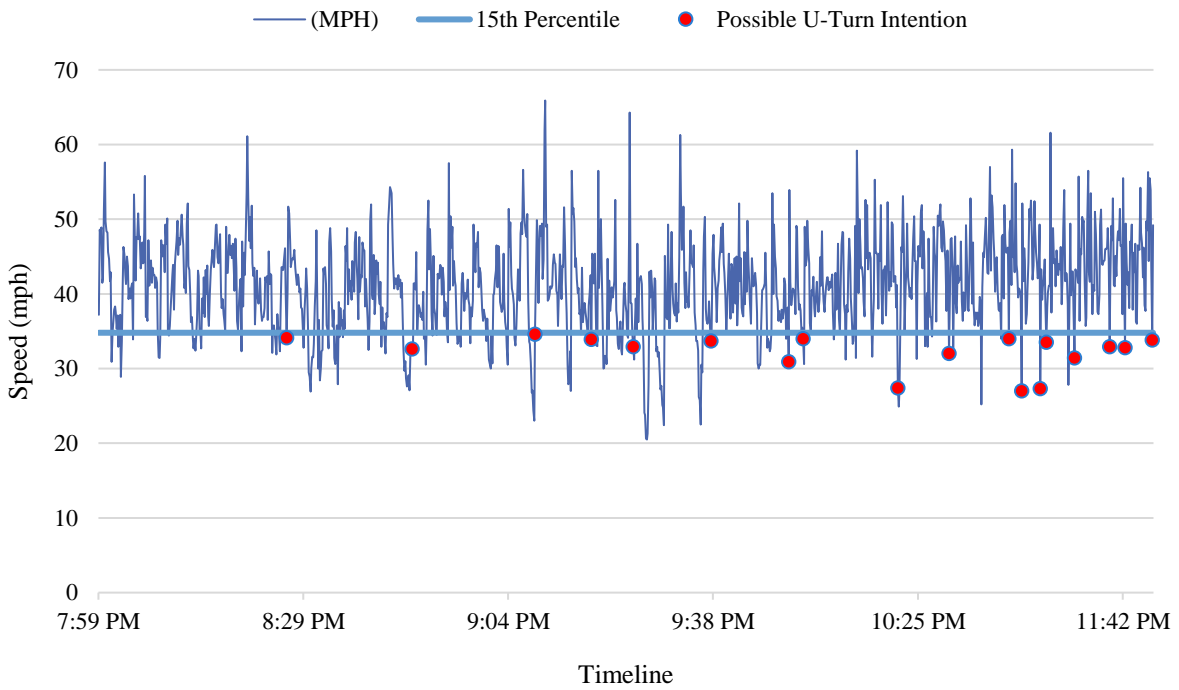
Figure 3-4 Speed profile at US-41 @ US-301, Bradenton, FL (before, night)

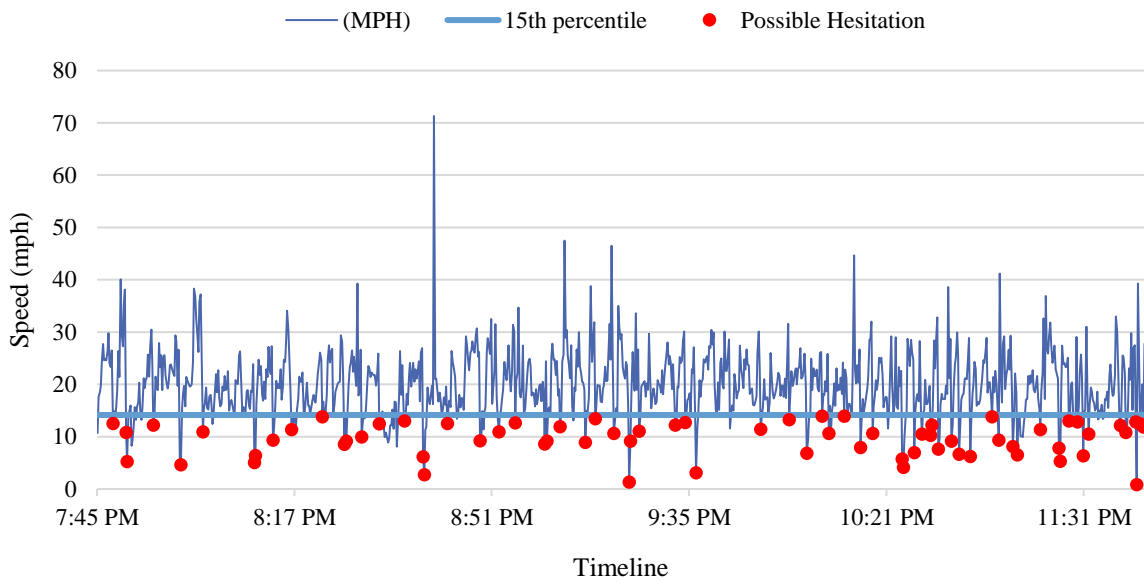
Figure 3-11 Speed profile at Hollywood Blvd @ I-95 (before, nighttime)

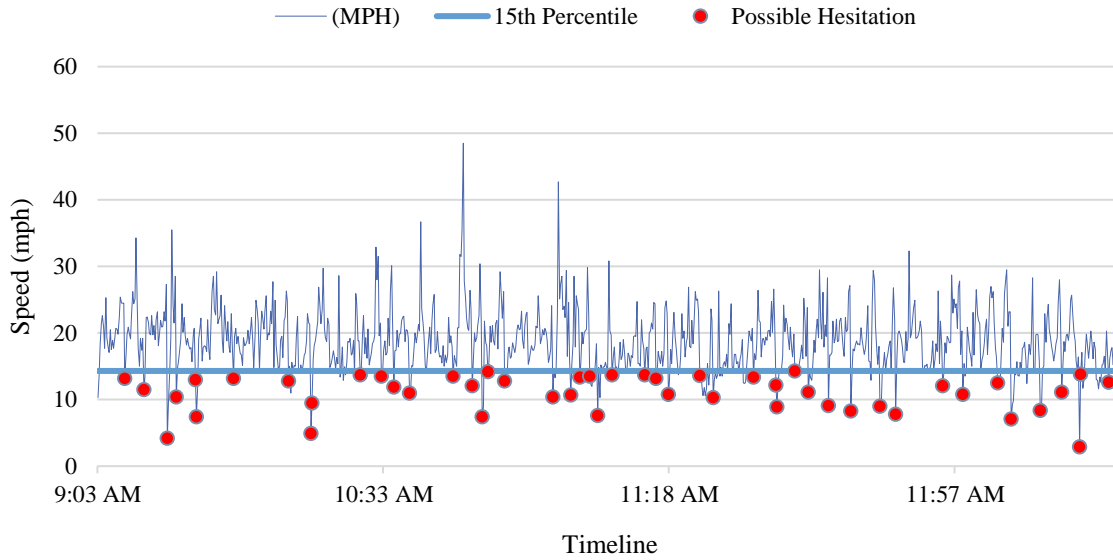
Figure 3-12 Speed profile at Hollywood Blvd @ I-95 (after, daytime)

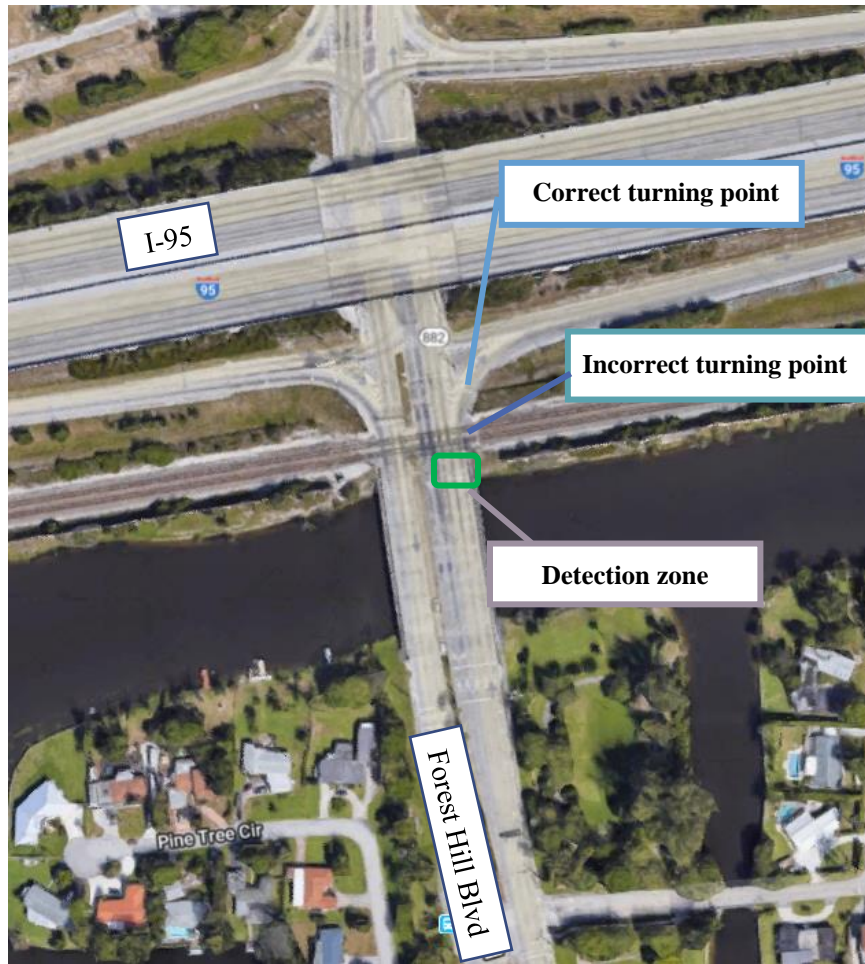
Figure 3-14 Layout of Site 3 (Forest Hill Blvd@ I-95)

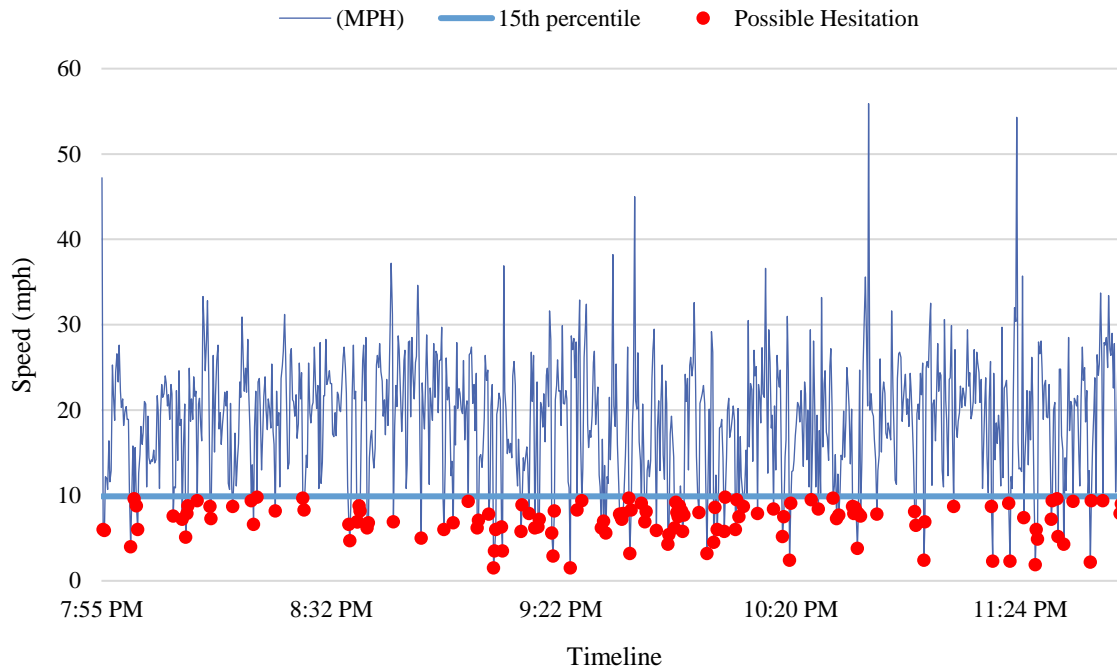
Figure 3-17 Speed profile at Forest Hill Blvd @ I-95, Lake Clarke Shores, FL (before, night)

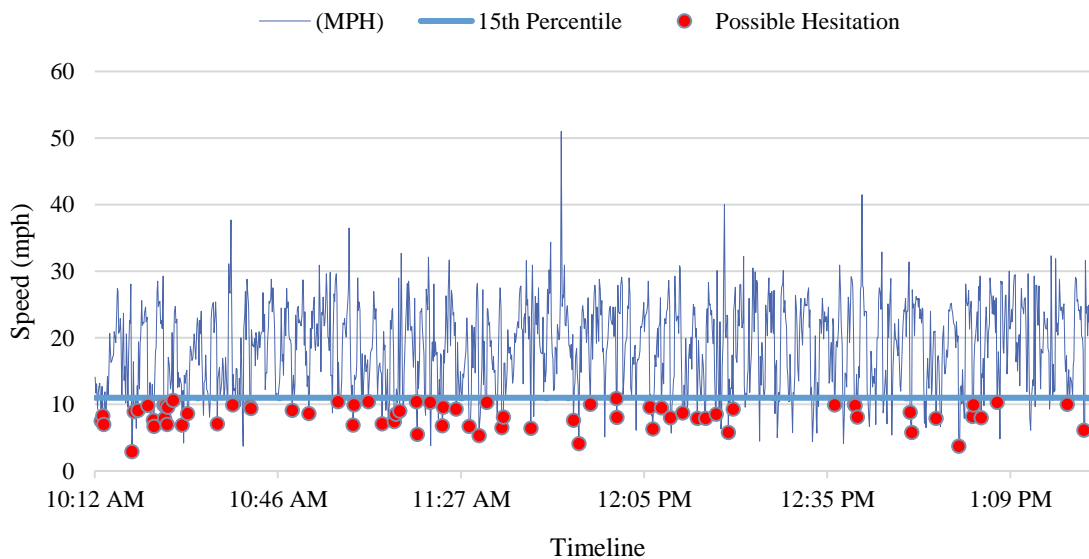
In the “after” stage, data collection for daytime was conducted from 10:12 AM to 1:27 PM; for nighttime, data collection began at 8:37 PM and lasted for three hours. The results are shown in Figure 3-17 and Figure 3-18.

Figure 3-18 Speed profile at Forest Hill Blvd @ I-95, Lake Clarke Shores, FL (after, day)

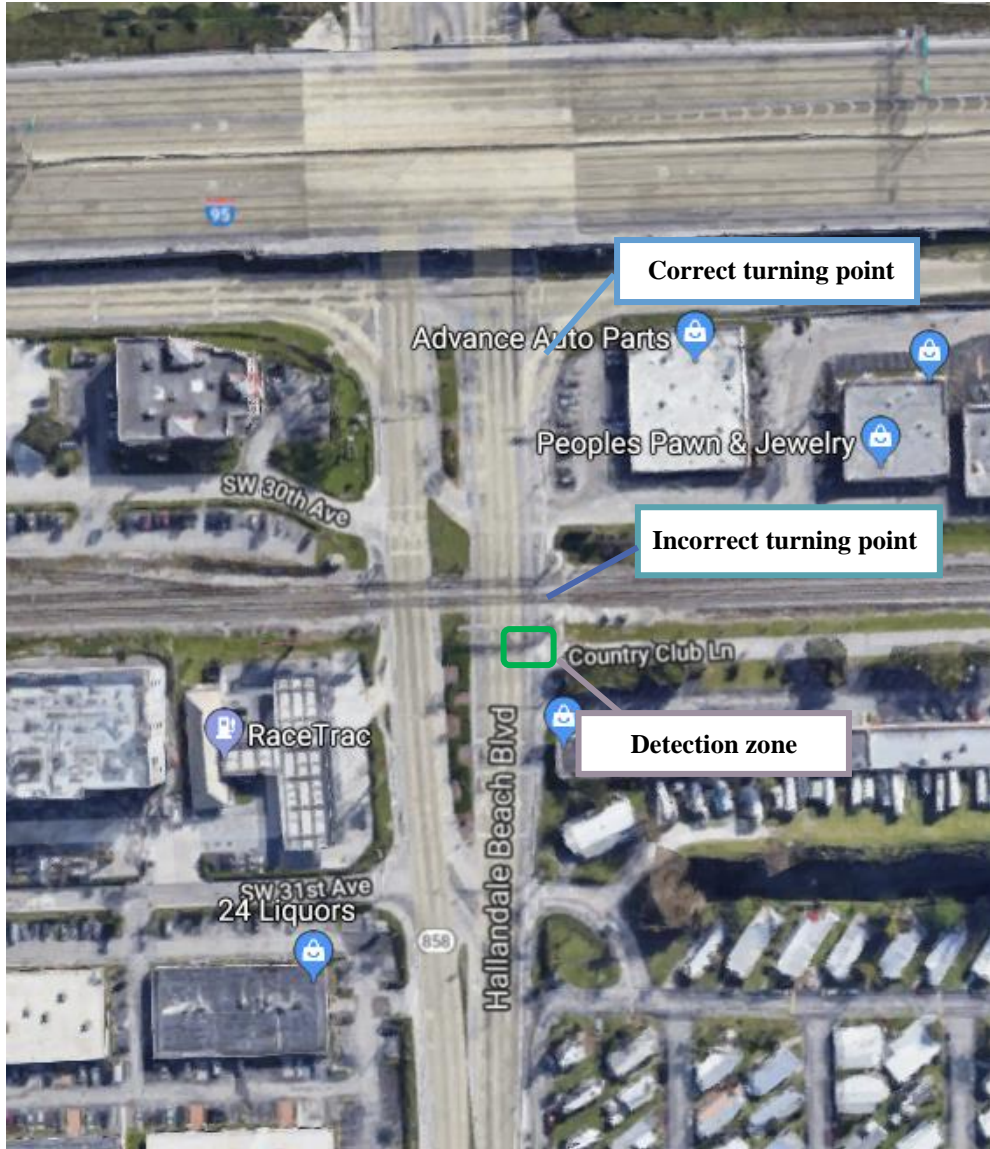
Site 4, Hallandale Beach Blvd @ I-95, has potential risks of drivers susceptible to turn onto railroad tracks from right-turn lane, as shown in Figure 3-20. Thus, this site was recommended by FDOT District 4. Two countermeasures were implemented, as shown in Figure 3-21.

Figure 3-20 Layout of Site 4 (W Hallandale Beach Blvd @ I-95)

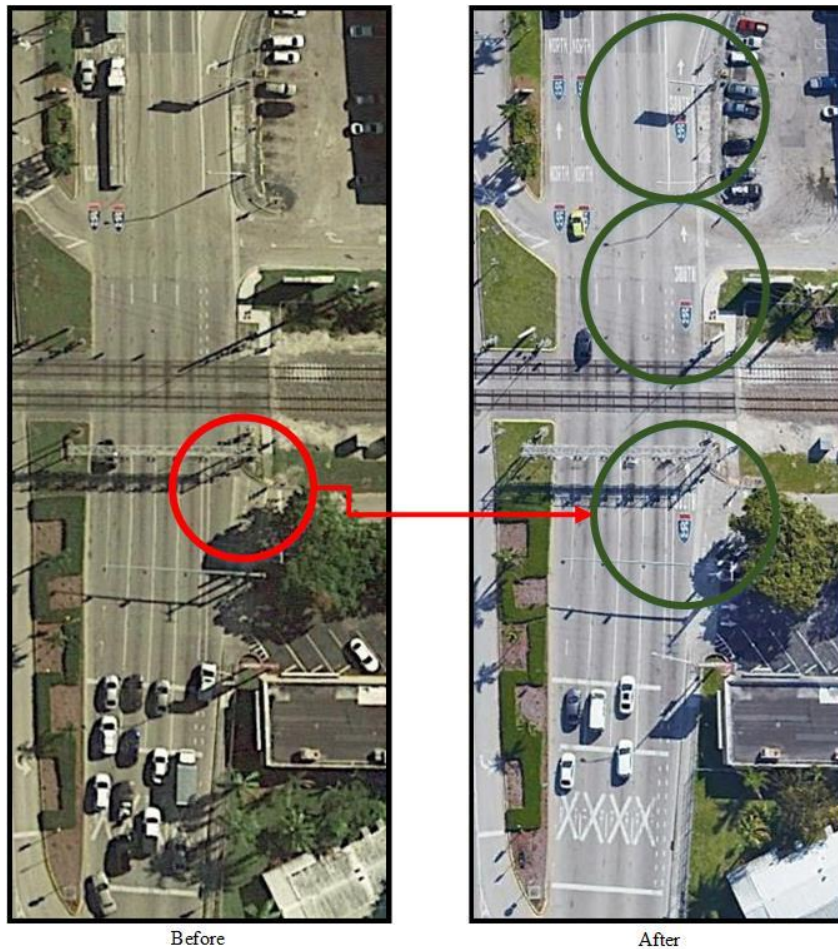
- Remove continuous right-turn arrows on the exclusive right-turn lane before the at-grade crossing.
- Add straight arrows with direction text and I-95 shields.

**Figure 3-21 Countermeasures implemented at Site 4
(W Hallandale Beach Blvd @ I-95, Pembroke Park, FL)**

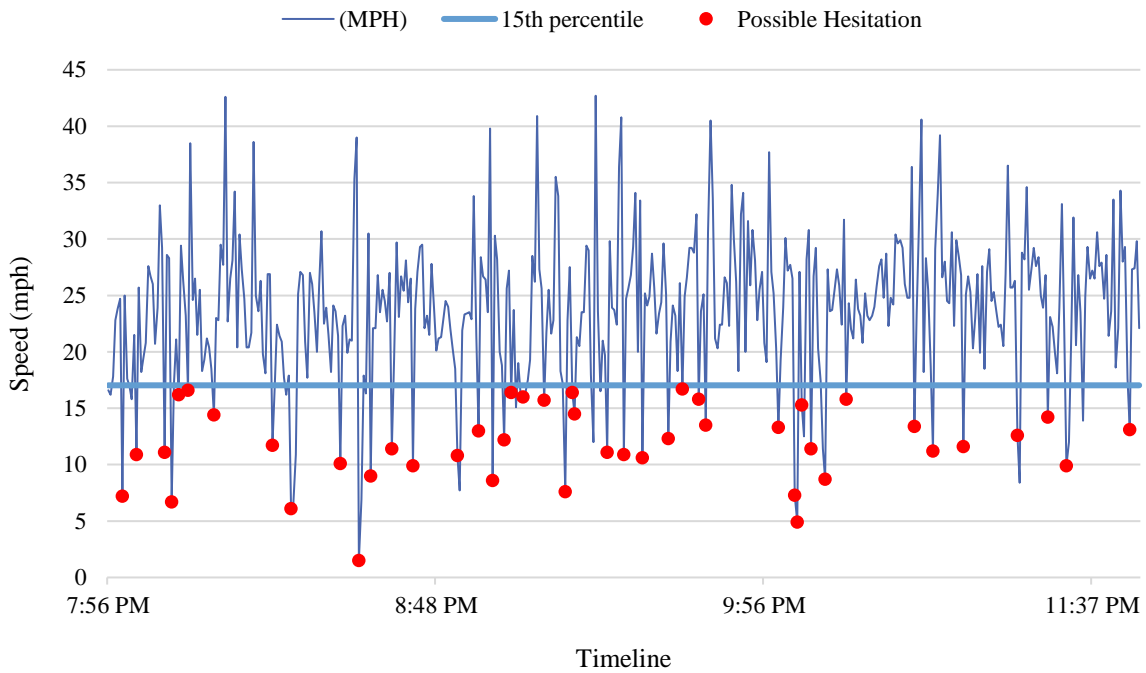
Figure 3-23 Speed profile at W Hallandale Beach Blvd @ I-95, Pembroke Park, FL (before, night)

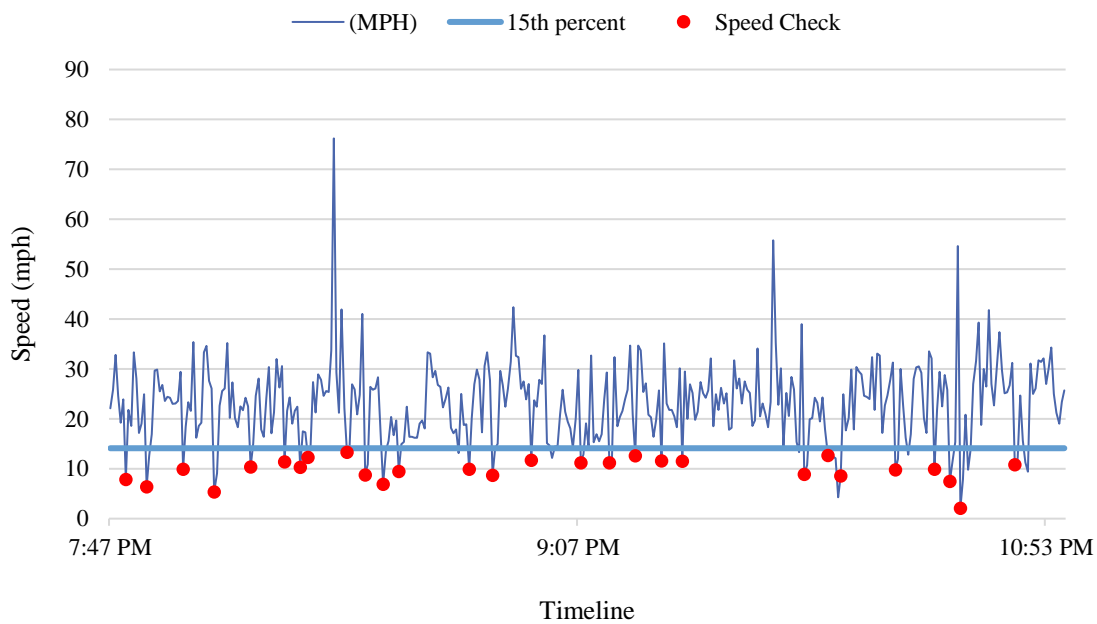
Figure 3-25 Speed profile at W Hallandale Beach Blvd @ I-95, Pembroke Park, FL (after, night)

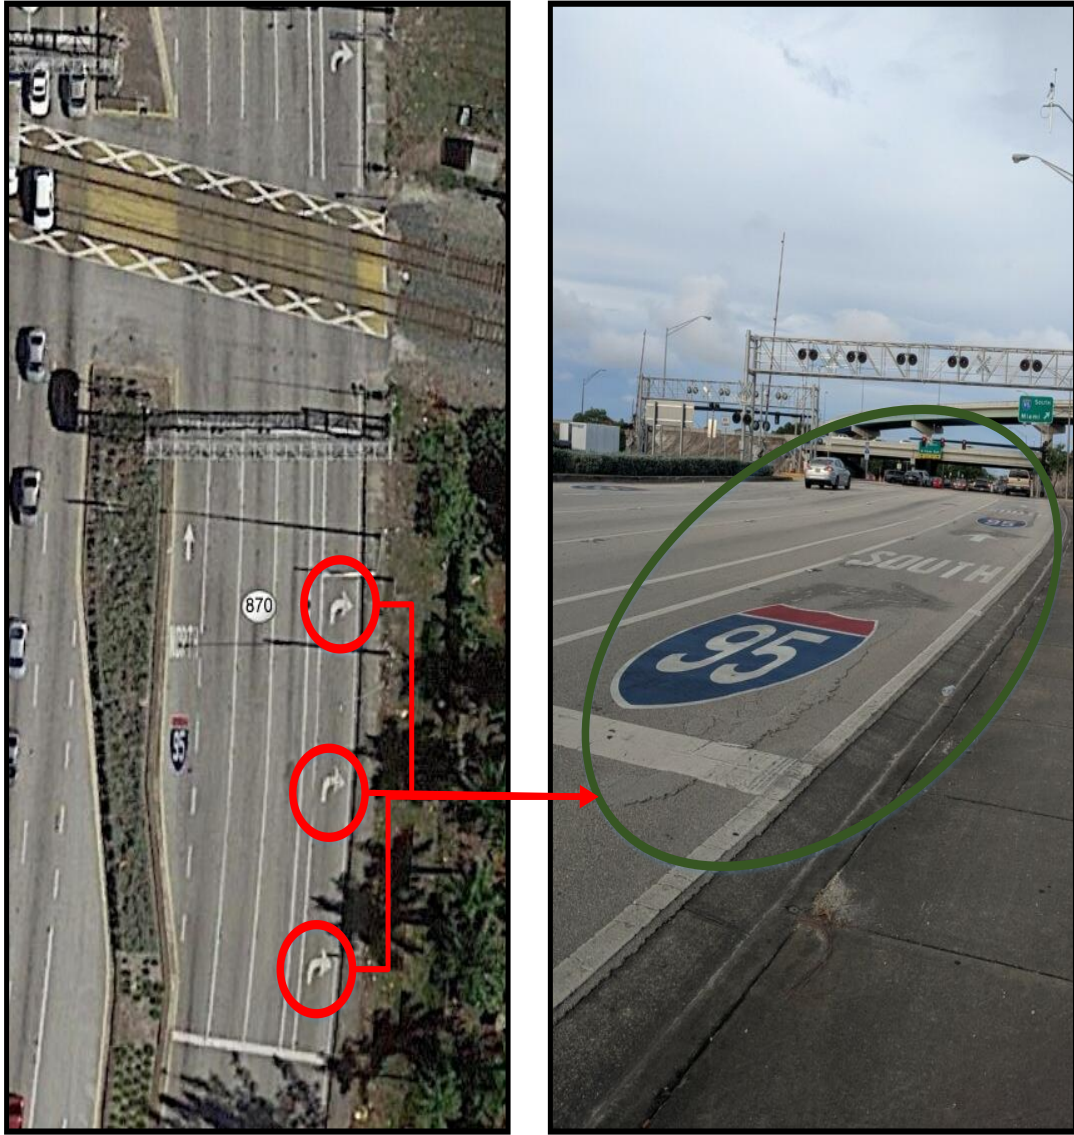
- Remove continuous right-turn arrows on the exclusive right-turn lane before the at-grade crossing.
- Add straight arrows with direction text and I-95 shields.

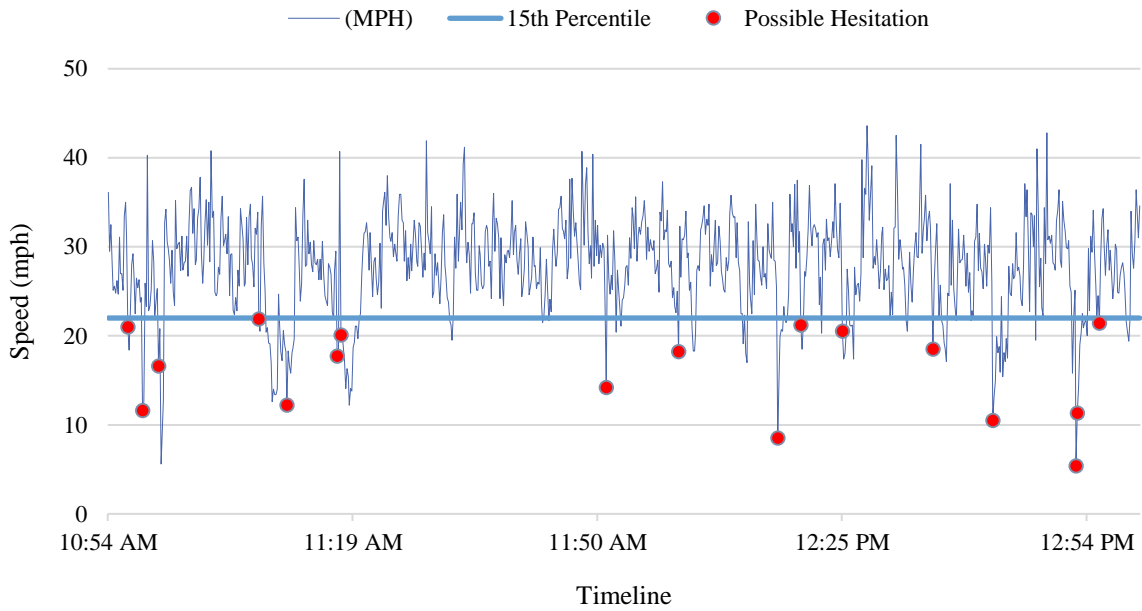
Figure 3-30 Speed profile at W Commercial Blvd @ I-95, Oakland Park, FL (after, day)

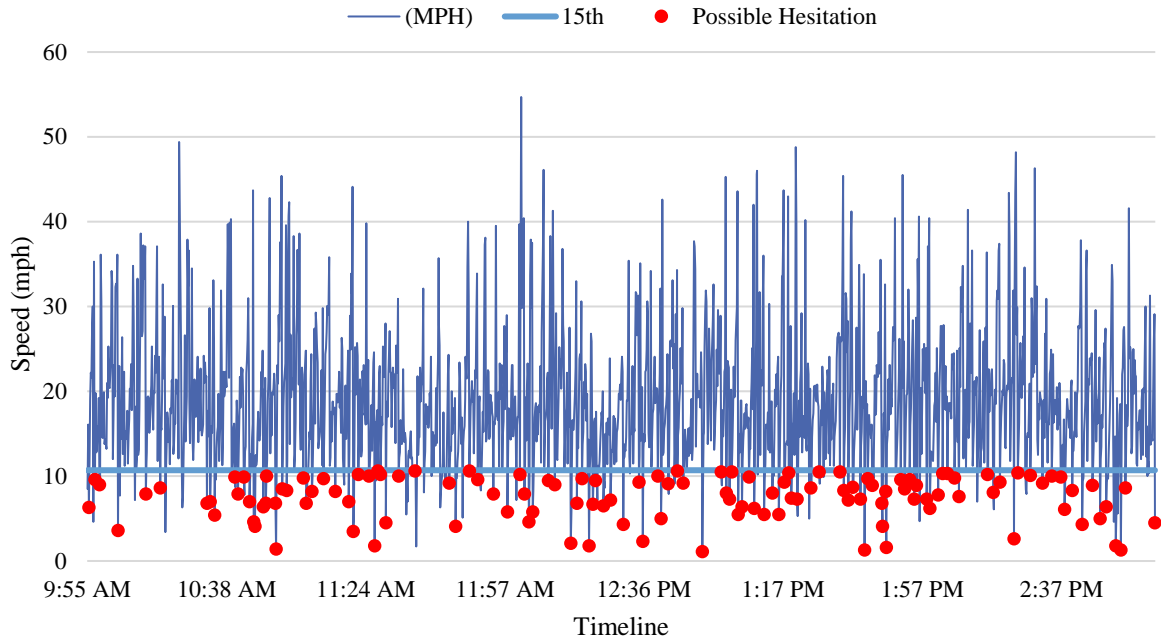
Figure 3-34 Speed profile at W Pembroke Rd @ I-95, Hollywood (before, day)

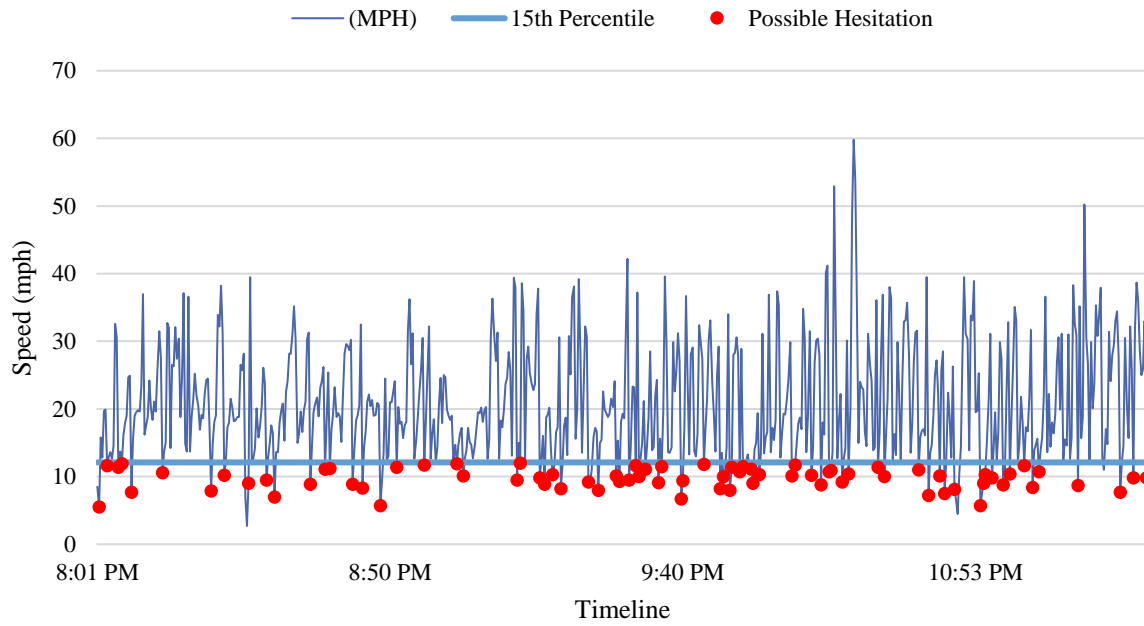
Figure 3-35 Speed profile at W Pembroke Rd @ I-95, Hollywood (before, night)

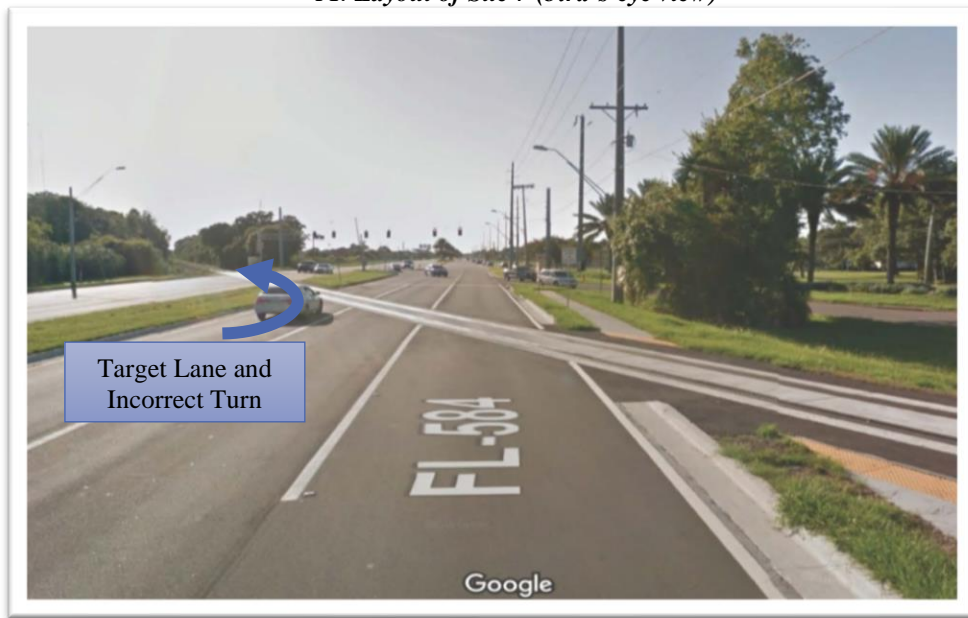
Figure 3-38 Layout of Site 7

Site 7, W Tampa Rd @ State St W, has potential risk of drivers being susceptible to making incorrect turns from the through lane, as shown in Figure 3-38 **Error! Reference source not found..** One countermeasure was implemented, as shown in Figure 3-39:

A: Layout of Site 7 (bird's-eye view)

B: Layout of Site 7 (driver view)

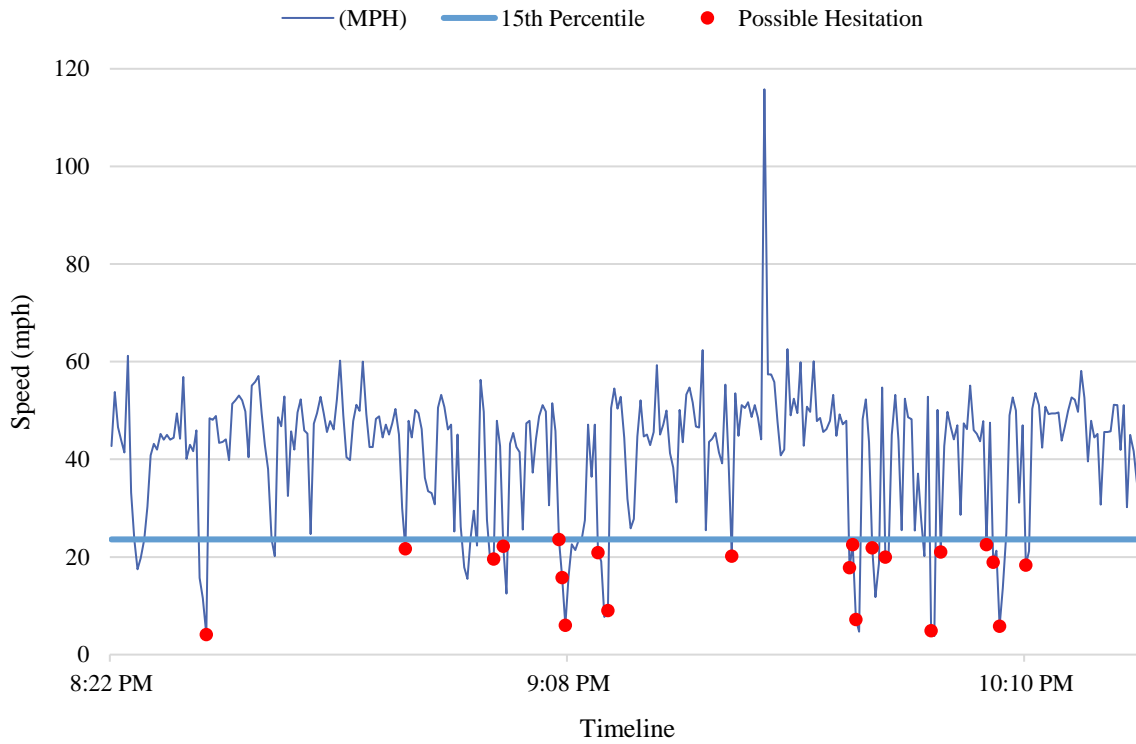
Figure 3-43 Speed profile at Tampa Rd @ State St W, Oldsmar, FL (night)

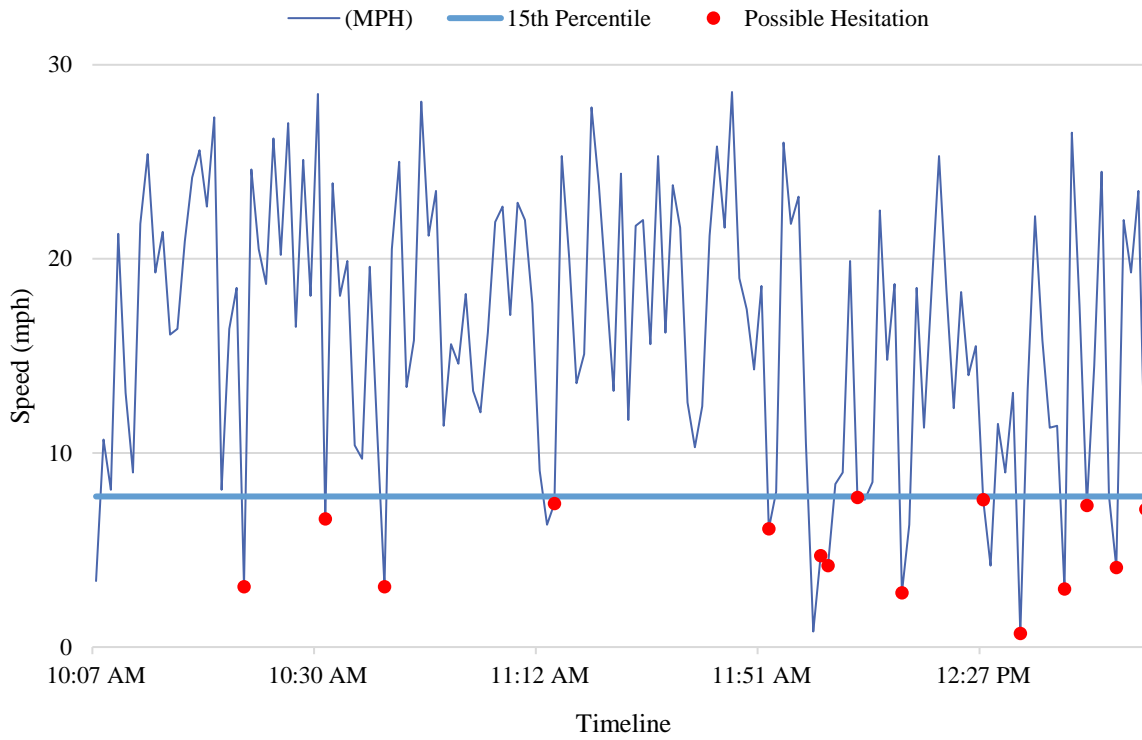
Figure 3-48 Speed profile at Busch Blvd @ N Boulevard, Tampa, FL (after, day)

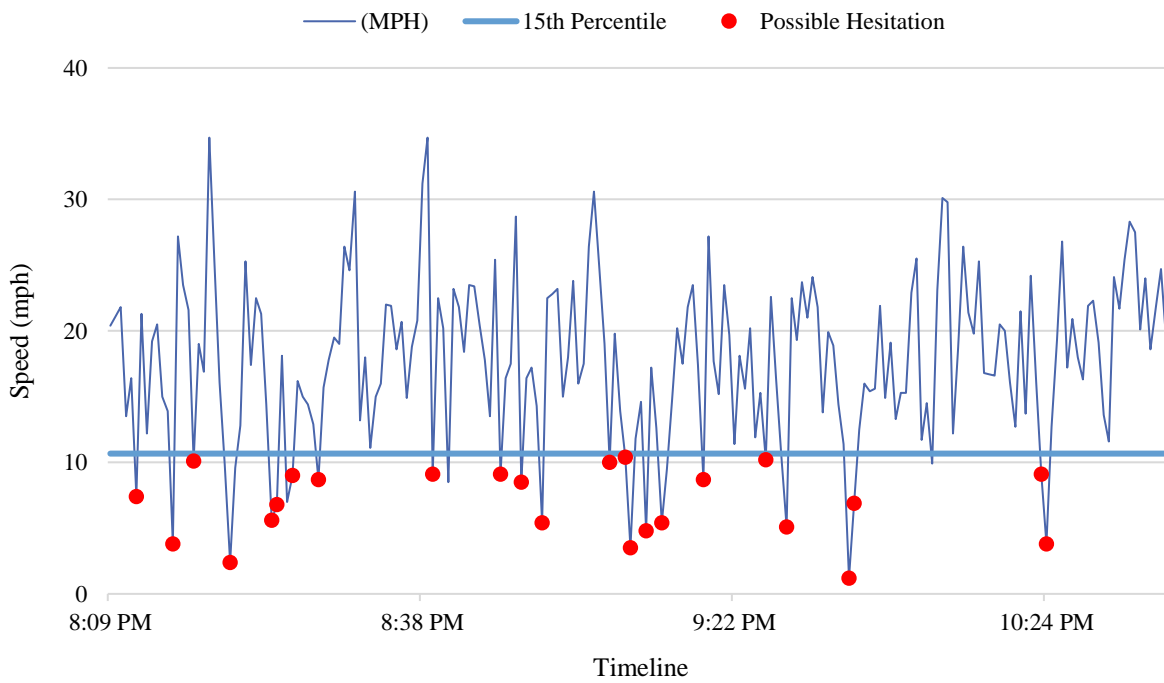
Figure 3-49 Speed profile at Busch Blvd @ N Boulevard, Tampa, FL (after, night)

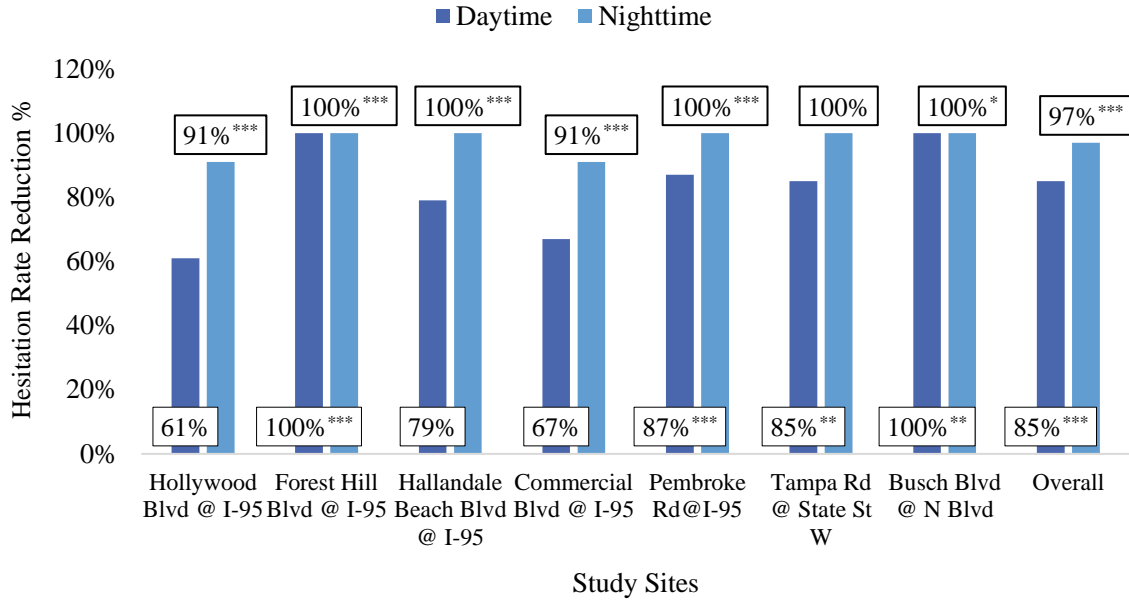
Figure 3-50 shows large reductions of hesitation rates for pavement marking of straight arrow plus guidance information for study sites 2–8. The reductions of hesitation rates were much higher in nighttime than those in daytime. The reduction in hesitation rates in nighttime at each study site after the implementation of the countermeasures was statically significant at a confidence level of 99.9%. The reduction in hesitation rates in daytime at each study site after the implementation of the countermeasures was statically significant at a confidence level of at least 90%, except for two sites with nearby driveways just ahead of the railroad crossings and one site with an existing countermeasure of dynamic envelope.
