*Non-Contact Scour Monitoring System for Highway Bridges*

*Contract: BDV27-977-16*

**Final Report**

**Submittal Date November 2020**

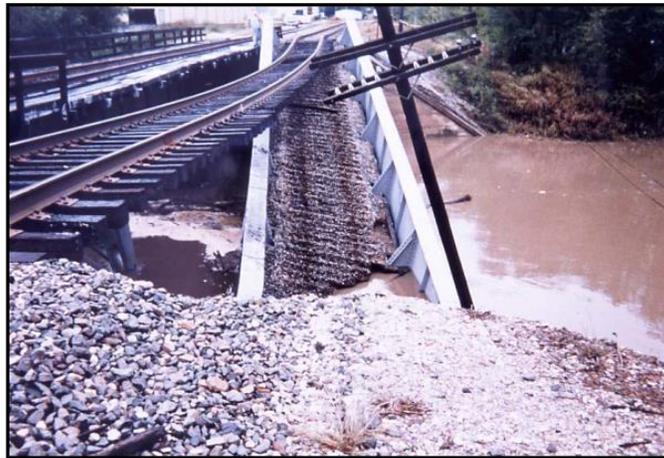
**FIGURE 1-1. Example of a bridge washout due to stream instability and or scour (1)**

Scour is a major factor that can affect the structural stability of bridges. Scour is mainly caused by the process of erosion and sediment transportation around submerged bridge piers or abutments. This permanent or temporary transportation of soils can be due to several natural and artificial factors such as the nature of bed materials (e.g., gravel, sandstone and shales), flooding due to heavy rainfall, sudden increase in the water current, and increased boat traffic. The other environmental conditions such as temperature and turbidity of water also influence the rate of the scouring process. Bridge washouts are due to scour and stream or river instability processes and are preventable. A field example of a bridge pier tipping due to scour and bridge washout is shown in FIGURE 1-1(1).

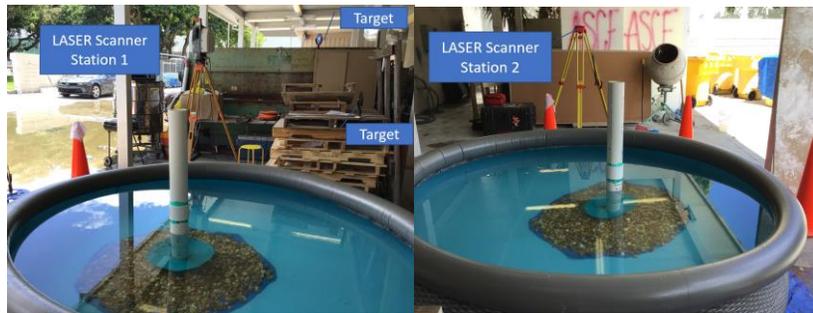
The experimental setup for underwater conditions is shown in FIGURE 4-5 where the laser scanner is mounted on a tripod on the sides of water tank, so it is clearly visible. As the simulated pier includes a part of scour hole from being seen by the laser scanner, two stations are needed to be able to capture full 360° of the scour hole and tank. Note that the locations of these stations are chosen in such a way the 360° view of the experimental setup could be acquired. For each station and trial discussed in the experiments below, the laser scanner is setup on the tripod. After horizontally leveling the equipment, it is connected through the data collection software Cyclone and 3D laser scan for the area of interest to be captured. The other scan parameters for the scan include minimum range, maximum range, minimum reflectance of laser pulse energy and point density. As for the experiments, 1 % percent reflectance of incident energy and the

point spacing of 5 mm at 15 feet range were used. These settings were fixed for all the trials discussed in the rest of the report. FIGURE 4-5 shows 2 of 5 targets used in the setup. The targets are setup in a way they are visible from both stations. These targets are used to register (tie) the 3D laser scans acquired from two stations.

**FIGURE 4-5. Laser scanner setup: station 1 (left); station 2 (right)**

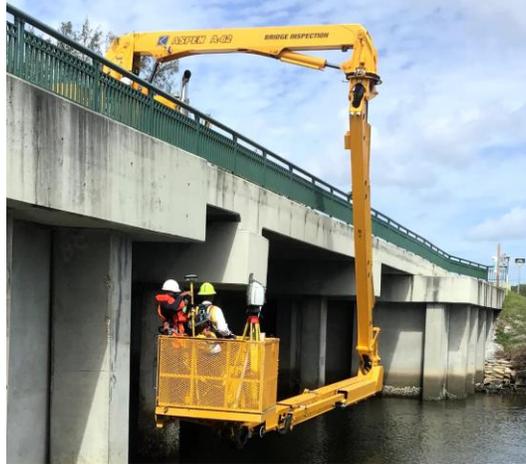
The data collection was performed on July 2<sup>nd</sup>, 2020 on a sunny day with temperature in low 90's F. Leica Scan Station 2 was used for field testing. In order to move the equipment to multiple locations under the bridge for bathymetric measurements, the snooper truck owned by Florida DOT's District 4 was used. The snooper truck has a man-basket that can move forward, backward, above and below to get closer to different parts of the bridge. The laser scanner was setup on a tripod and the laser scanning data near bridge piers was collected in a stop and go mode. The stop and go mode collects data when the scanner is stationary, and no data is collected when the man-basket is in motion. The data was collected from 6 different stations mostly focusing on near the abutment due to higher turbidity that limited the water penetration of the laser scanner. The FIGURE 5-9 shows the setup and FIGURE 5-10 shows registered point cloud of all 6 stations. The water samples were collected from the top of water surface and the average turbidity came out to be 1.720 NTU.

**FIGURE 5-9. Field data collection setup with snooper truck**
