FINAL REPORT

**Development of a Test Method for Assessing the Performance of Vehicular Traffic Signal Assemblies during Hurricane Force Winds**

Contract No.: BDV29 977-20

**Wall of Wind Research Facility**

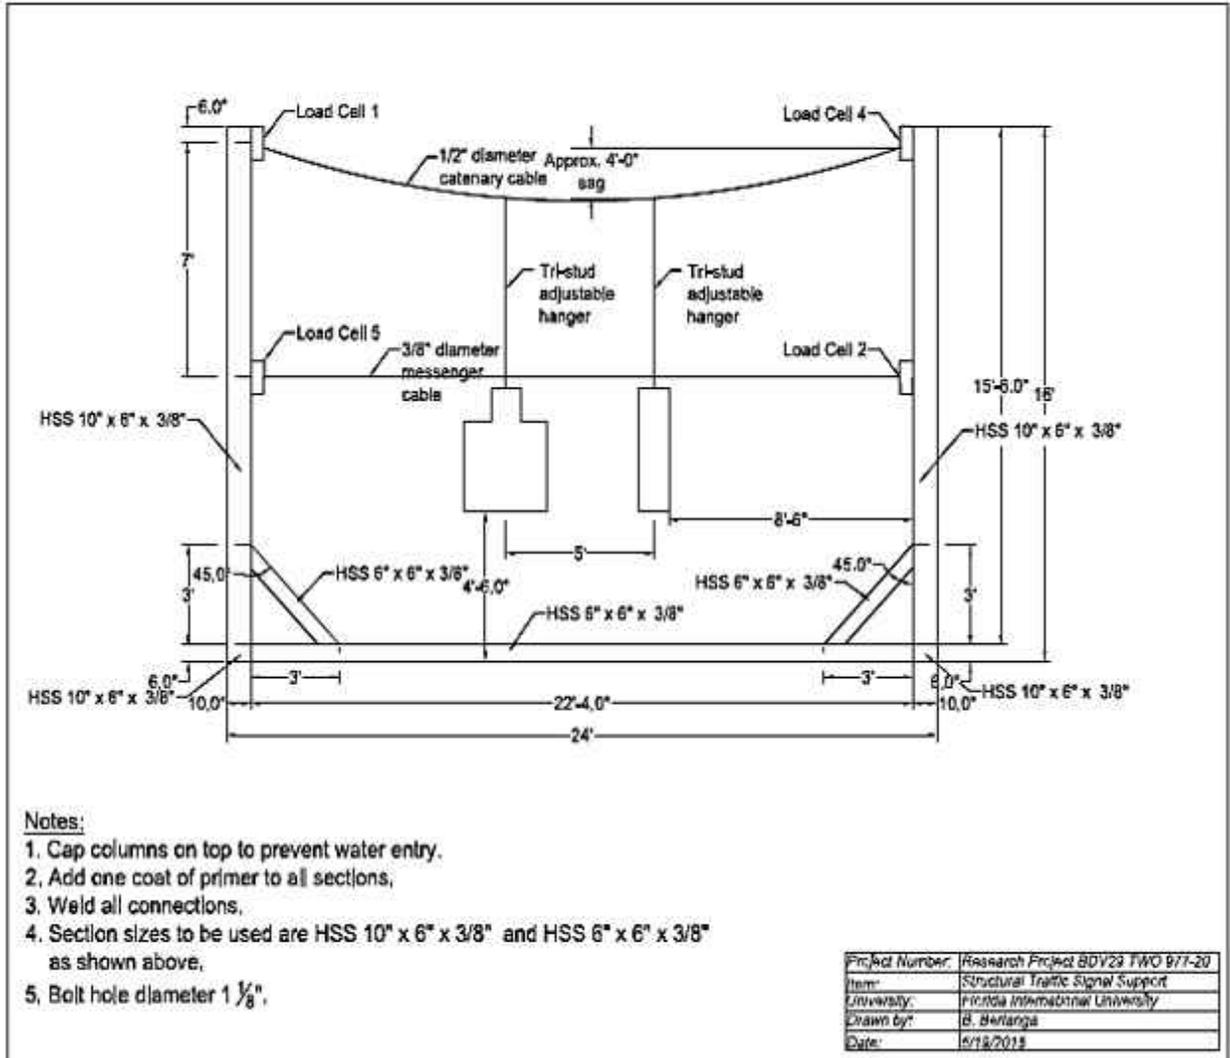
Figure 9: First signal combination setup of one 3-section and one 5-section (case 1)

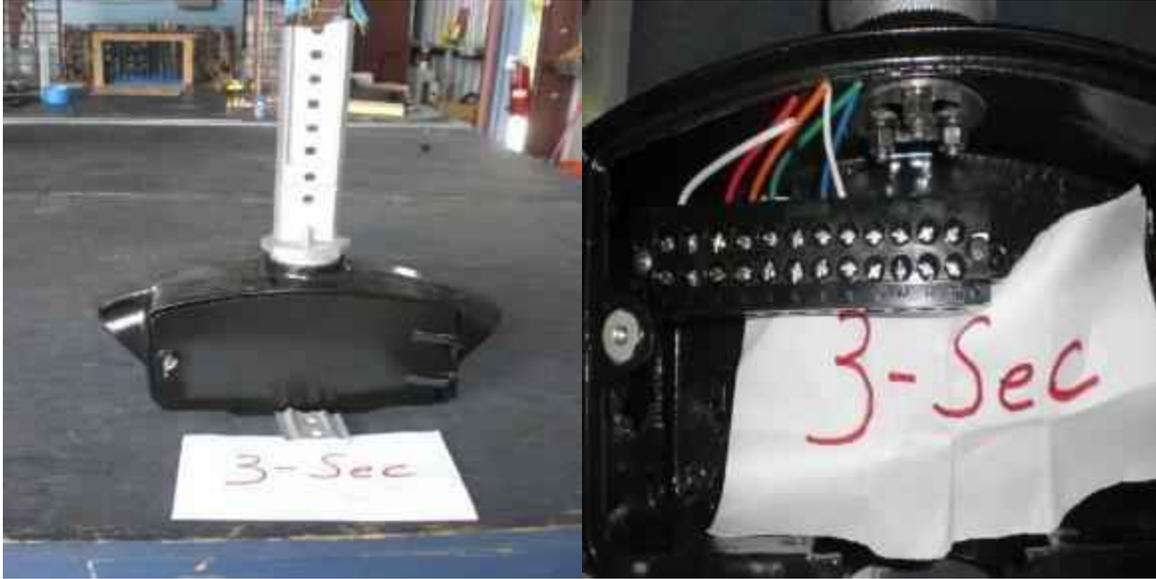
Figure 28: Disconnect box for 3-section signal after Test 1 showing no noticeable damage

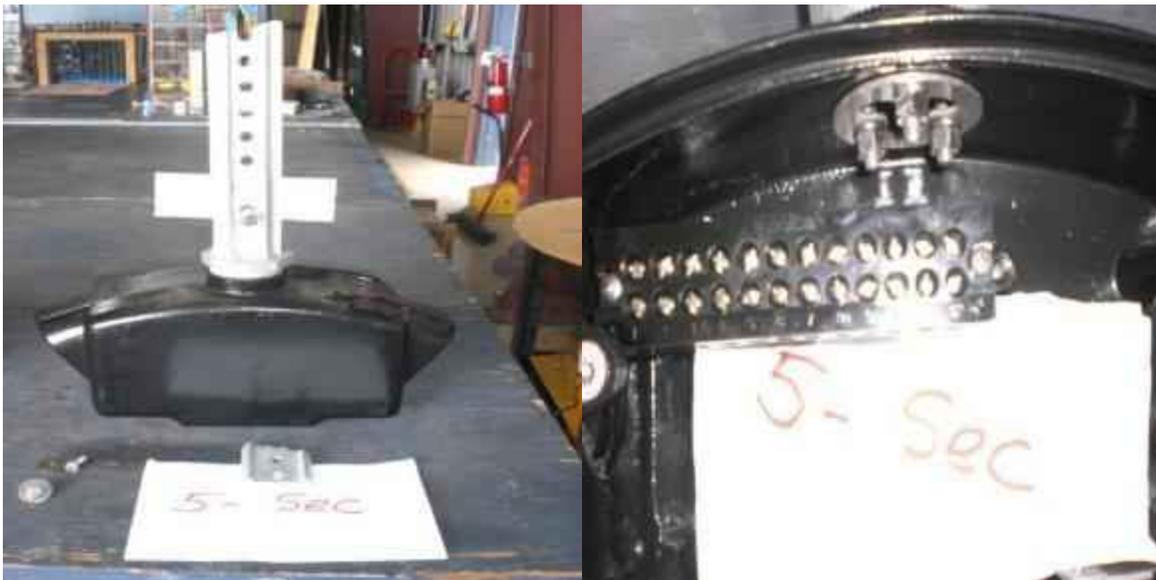
Figure 29: Disconnect box for 5-section signal after Test 1 showing no noticeable damage

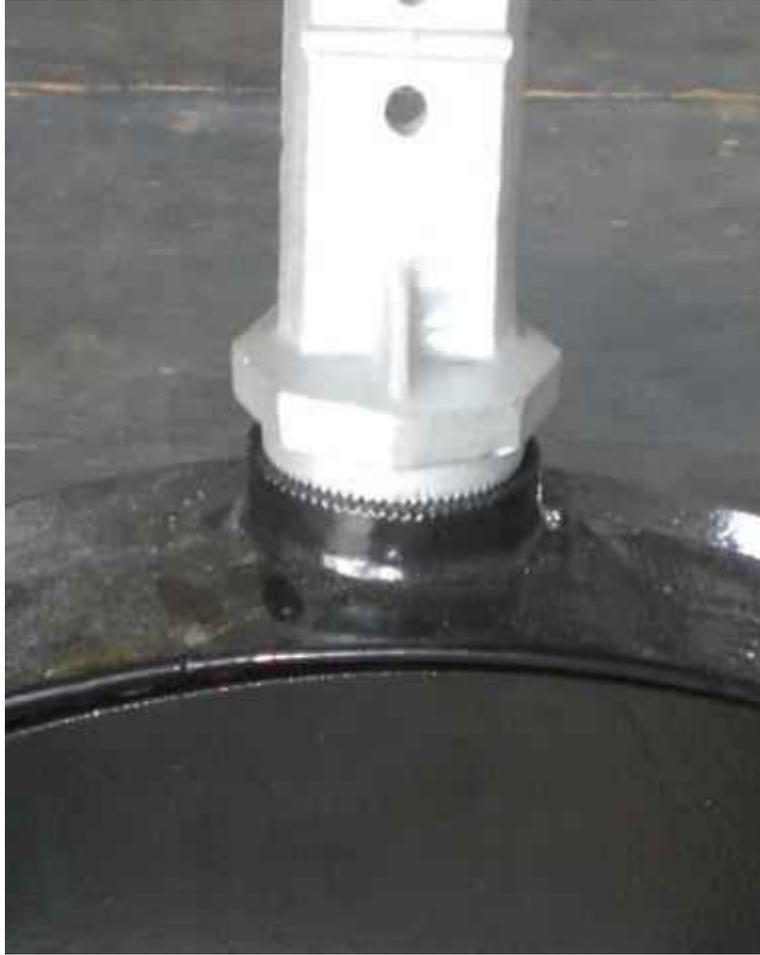
*Figure 30: Serrated teeth connection between the bracket and the top of the disconnect box with no noticeable damage*

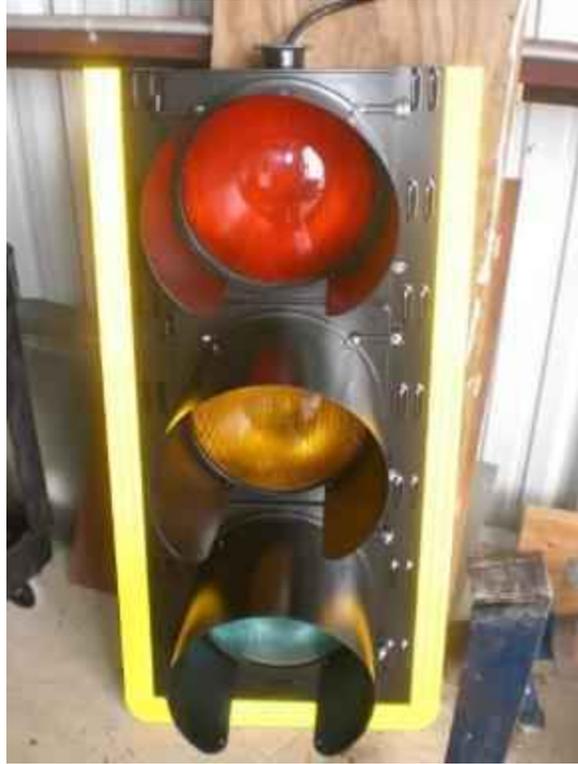
The 3-section and 5-section signals, including visors, did not sustain any damage during Test 1 as shown in Figure 31 and Figure 32, respectively. The backplates sustained minor damage as they were slightly bent backwards.

*Figure 31: 3-section signal with visors after Test 1 showing no noticeable damage*

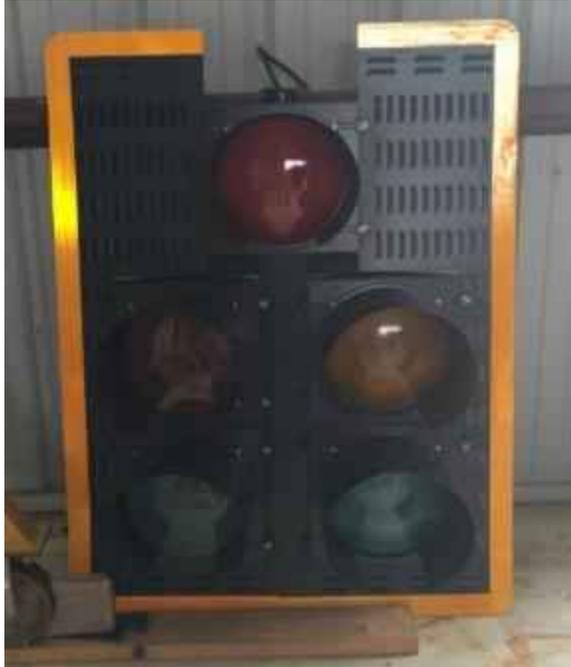
*Figure 32: 5-section signal with visors after Test 1 showing no noticeable damage*

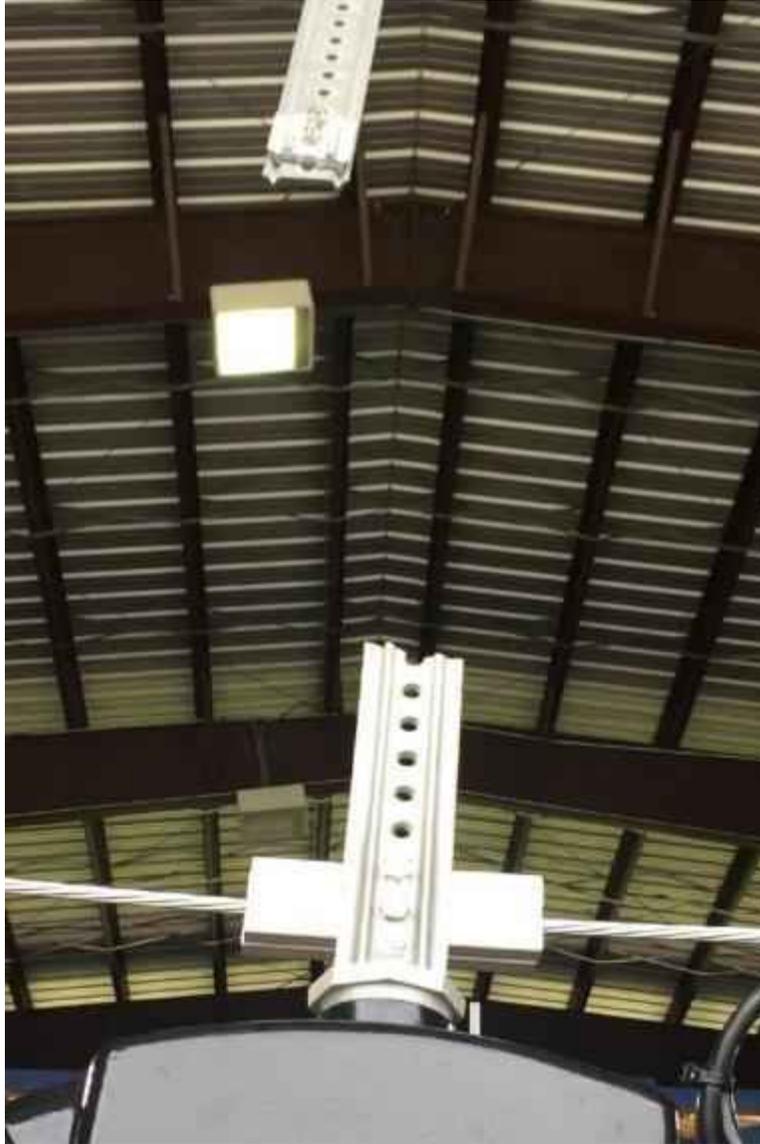
The only damage that occurred during Test 1 originated from the standard tri-stud adjustable hanger assembly utilized. These hangers were sheared off at the proximity of the connection brackets that are attached to the top of the disconnect box.

*Figure 33: Tri-stud adjustable hanger after Test 1 showing location of damage. No noticeable damage to the extruded aluminum messenger wire clamp*

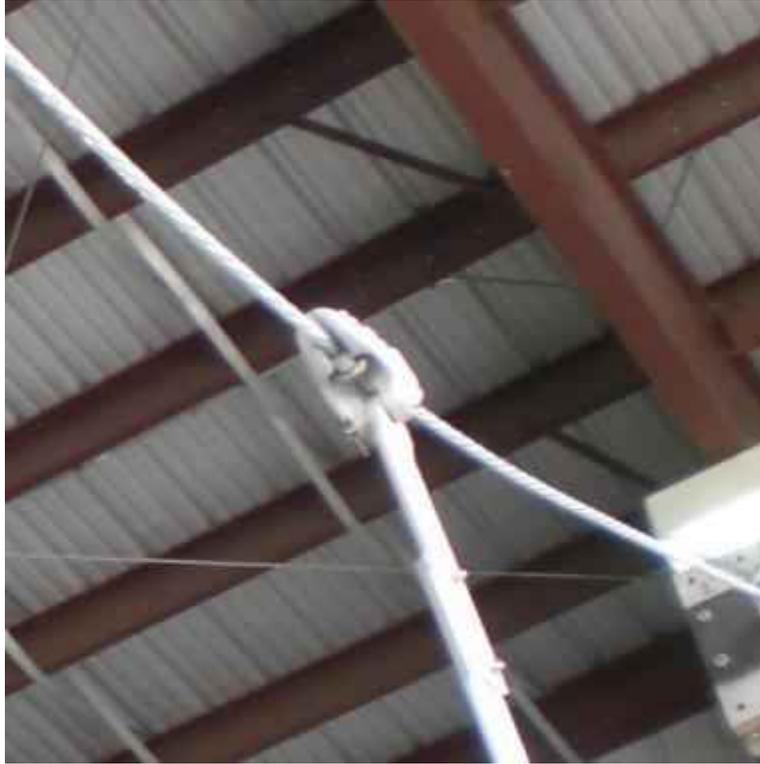
There was no notable damage observed to the span wire clamps attached to the catenary cables as shown in Figure 34.

*Figure 34: Span wire clamp attached to the catenary cable with no noticeable damage*

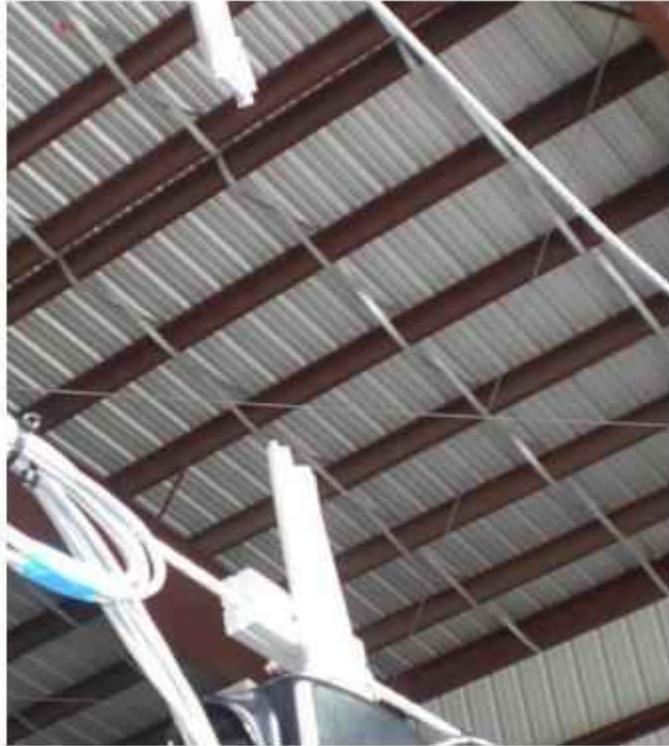
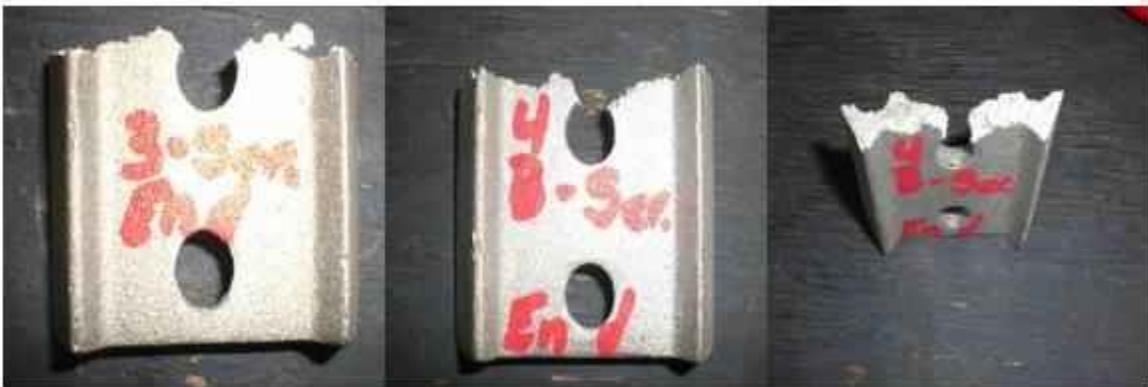
*Figure 52: Tri-stud adjustable hanger after Test 2 showing location of damage. No noticeable damage to the aluminum messenger clamp. Sections of the bottom bracket that were sheared off*

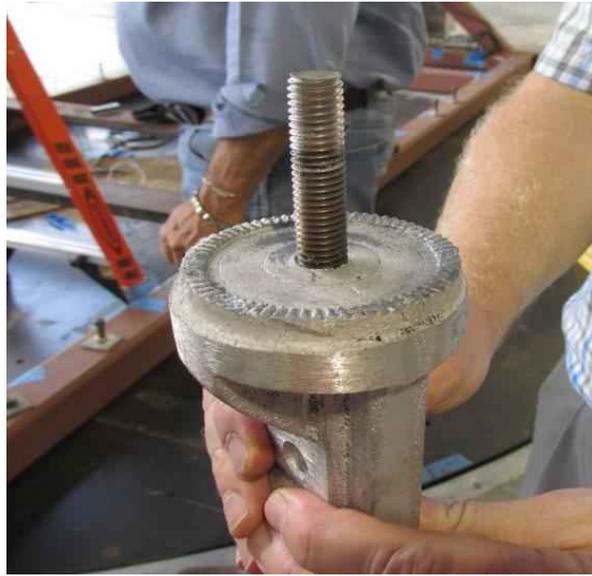
- Damage to signal hanger: pivotal adjustable hanger assembly sheared off.
- Damage to disconnect hanger (box): serrated teeth on the bracket connected above the disconnect box, as well as the serrated teeth on the disconnect box, were worn away. No other permanent visual damage observed.
- Damage to signal housing assembly: Damage to visors and back plate.

*Figure 65: Bracket above disconnect teeth*

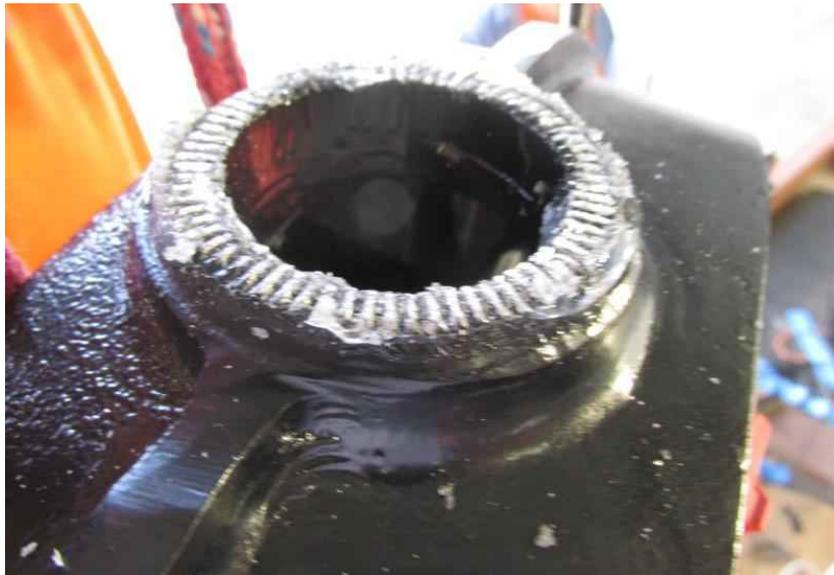
*Figure 66: Disconnect box with worn way serrated box with worn away serrated teeth*

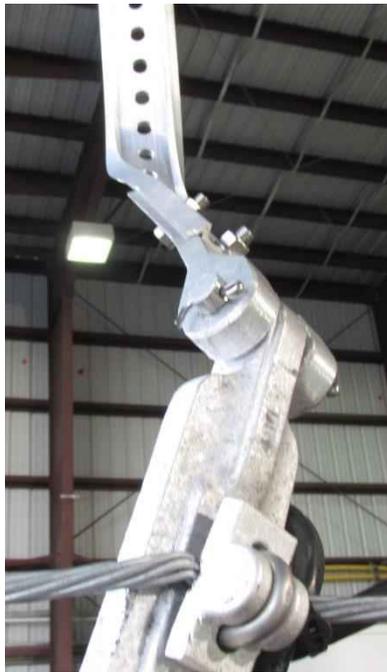
- Damage to signal hanger: Twisted adjustable extension hanger for 5-section signal.
- Damage to disconnect hanger (box): A crack was observed at the lower section of the box.
- Damage to signal housing assembly: Damage to visors and back plate. No other permanent visual damage observed.

*Figure 81: Twisted adjustable extension hanger for 5-section signal*

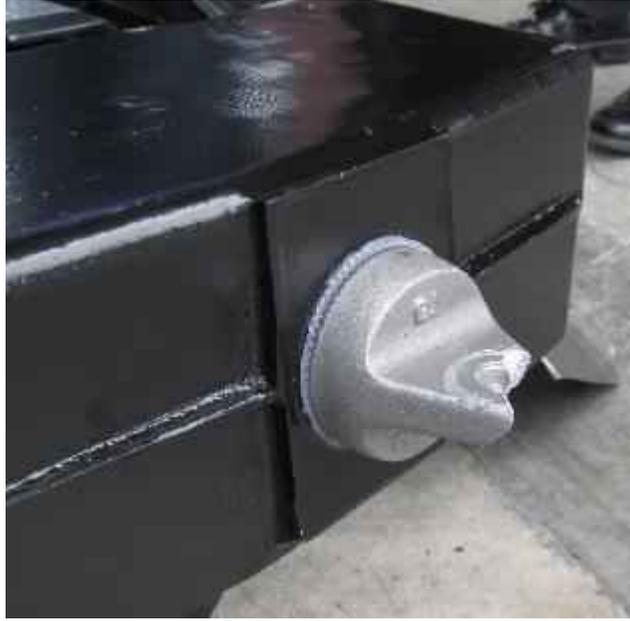
- Damage to signal hanger: The three steel cable hanger assemblies were observed to have some bending.
- Damage to disconnect hanger (box): Cracked hook on top of 5-section signal disconnect box. Cracked lower clamp inside 5-section disconnect box. The 3-section signal disconnect box had no observed damage
- Damage to signal housing assembly: The 5-section signal flew away at 70mph. For the 3-section signal, visors and back plates were completely detached.

*Figure 96: Cracked hook on top of 5-section signal disconnect box*

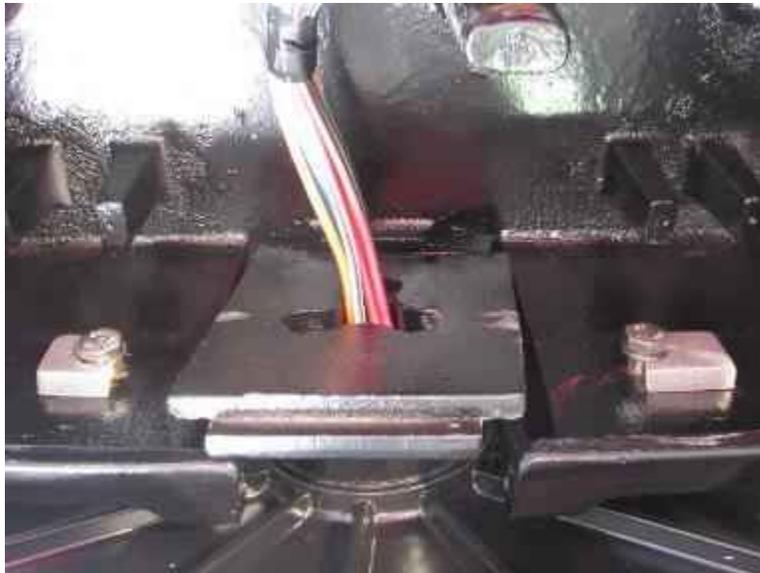
*Figure 97: Cracked lower clamp inside 5-section disconnect box*

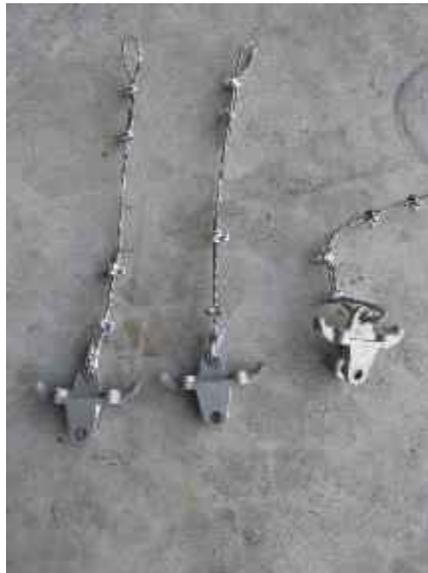
*Figure 99: Steel cable hangers after full wind test*

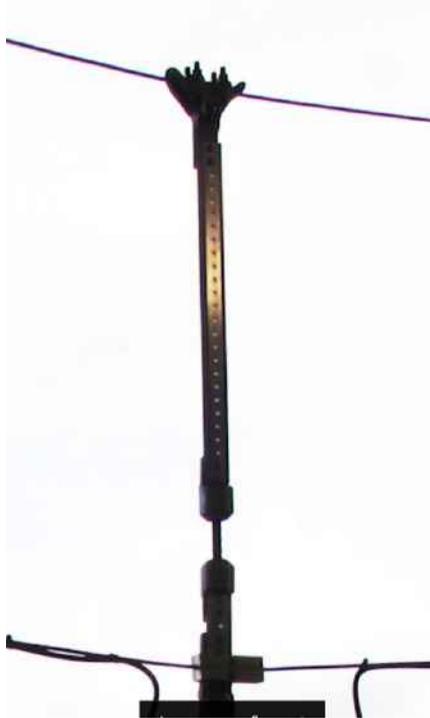
- Damage to signal hanger: Flexible bending of the cable portion. No permanent visual damage observed.
- Damage to disconnect hanger (box): No permanent visual damage observed.
- Damage to signal housing assembly: Damage to visors and back plate. No other permanent visual damage observed.

*Figure 112: Pelco adjustable hanger assembly with cable dampener after full range test*

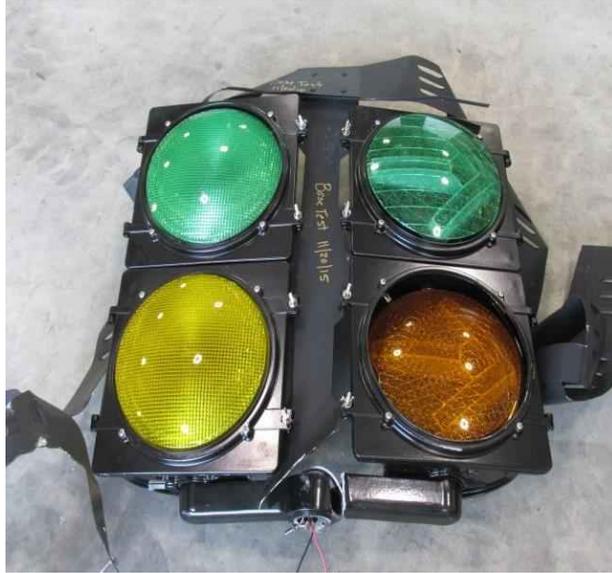
- Damage to signal hanger: One tri-stud hanger extension bar broke and the other two experienced severe and permanent bend.
- Damage to disconnect hanger (box): No permanent visual damage observed.
- Damage to signal housing assembly: Damage to visors and back plate. Lower portion of the 5-section signal severed and flew away.

*Figure 128: Lower portion of 5-section signal that severed*

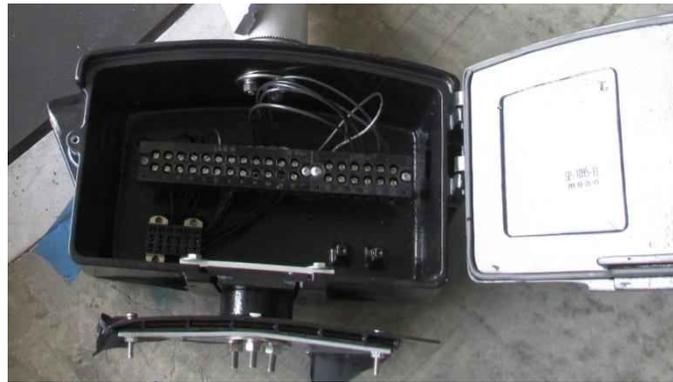
- Damage to signal hanger: Flexible bending of the cable portion. No permanent visual damage observed.
- Damage to disconnect hanger (box): No permanent visual damage observed.
- Damage to signal housing assembly: Top portion of the polycarbonate 3 and 5-section traffic signal cracked at the base of the disconnect box and the entire signal was blown away.

*Figure 147: Disconnect box after completion of test and broken top portion of signal assembly*

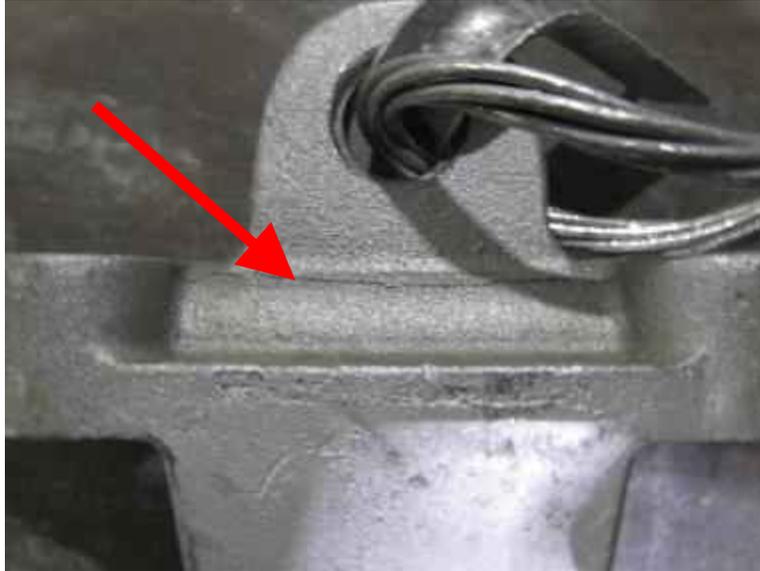
- Damage to signal hanger: The 5-section signal steel cable hanger exhibits a bend near the messenger cable clamp.
- Damage to disconnect hanger (box): No permanent visual damage observed.
- Damage to signal housing assembly: Damage to visors and back plate. Aluminum messenger clamp for the 5-section signal exhibited a hairline crack. The 5-section polycarbonate signal cracked at the upper portion just underneath the disconnect box and drifted away

*Figure 160: Hairline crack on 5-section signal messenger clamp*

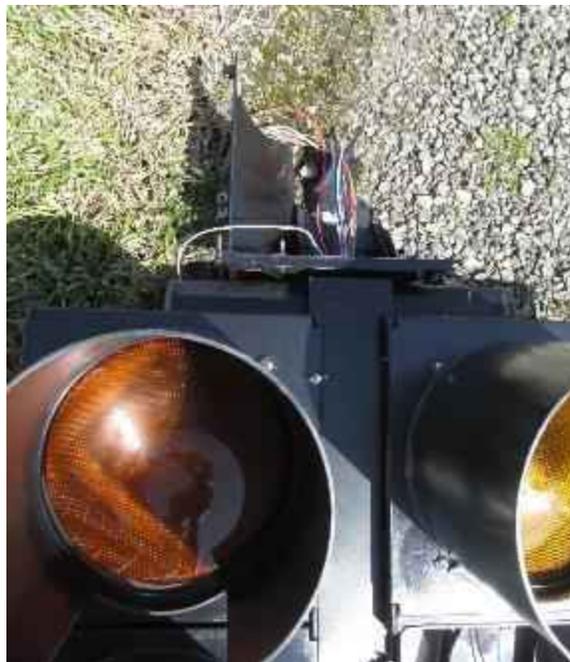
*Figure 161: 5-section polycarbonate signal cracked at the top*

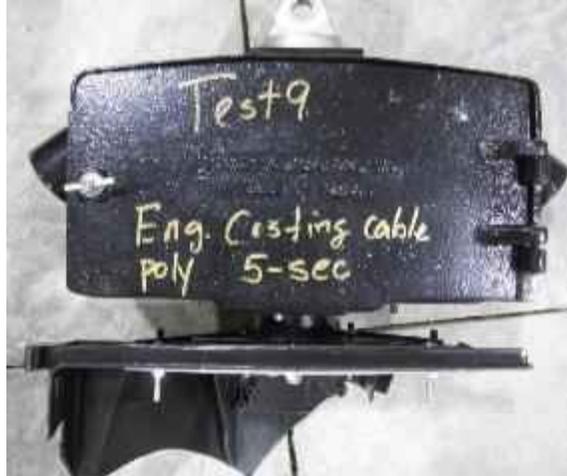
*Figure 162: Disconnect box with a piece of the 5-section signal*

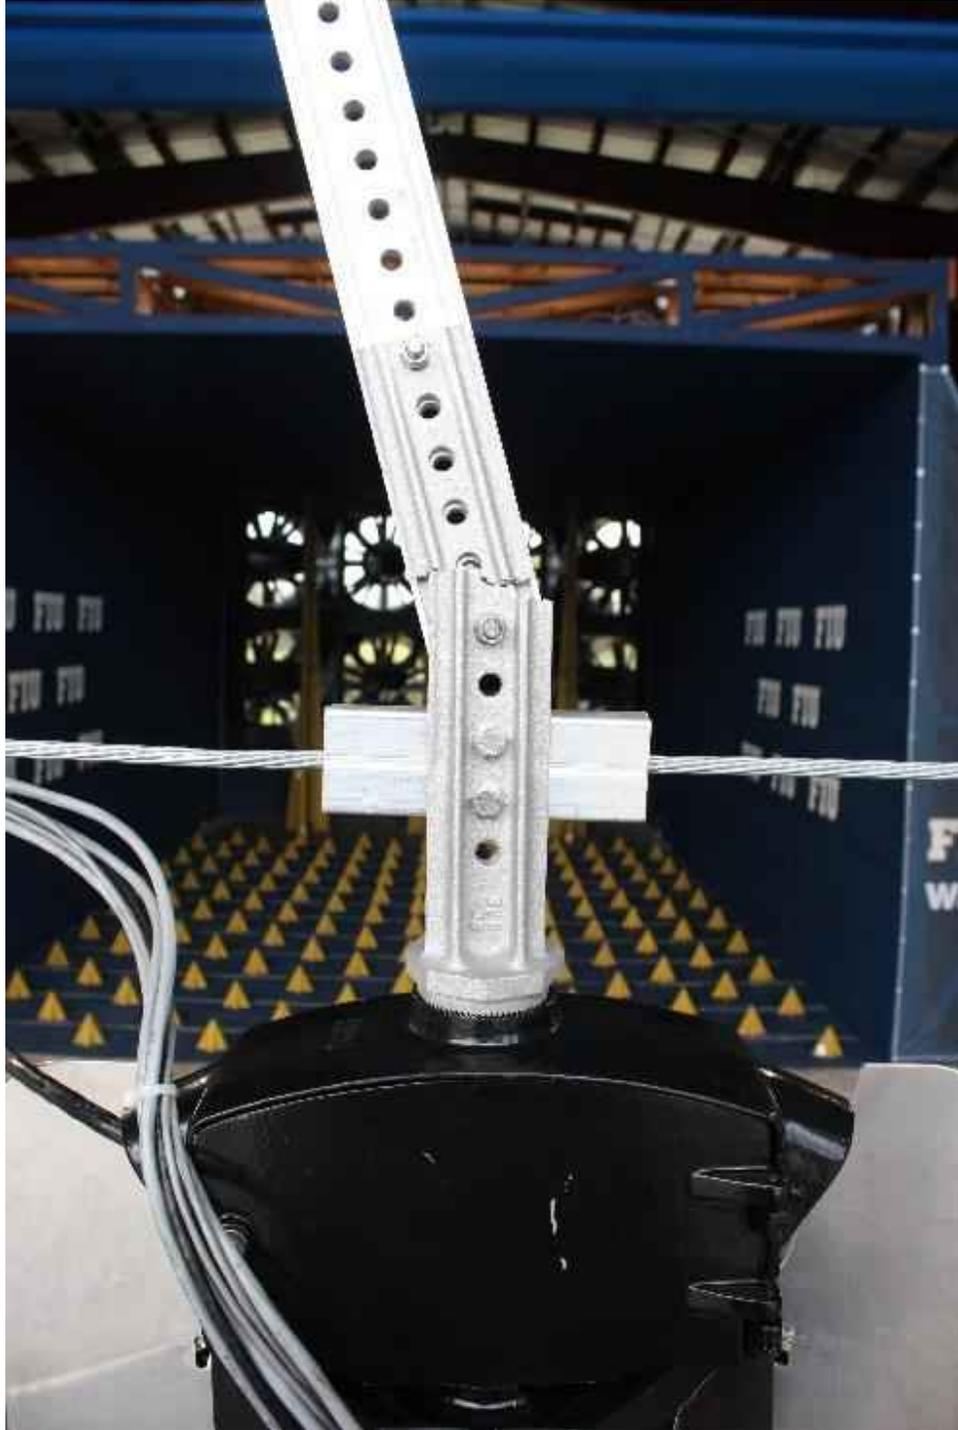
When reaching 100 mph and at 100 degrees, 3-section signal slid from the hanger-clamp to messenger wire connection causing the hanger to break at the disconnect-box to hanger connection, as shown in Figure 180. After the test was finished, it was found that the hanger was sheared, as shown in Figure 181, and that the top right backplate got disconnected from its anchorage point. No damages were observed in the disconnect box, wires nor visors.

*Figure 181: Sheared Hanger Connection*

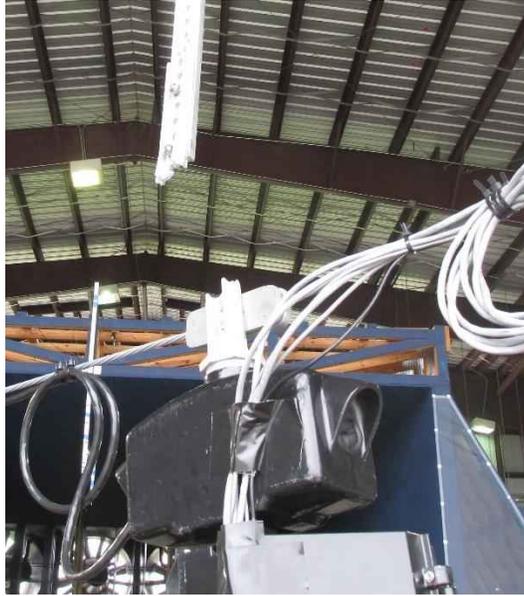
- Damage to signal hanger: Slight bending of tri-stud adjustable hanger for 3-section signals and fracture of tri-stud adjustable hanger for 5-section signal.
- Damage to disconnect hanger (box): No permanent visual damage observed.
- Damage to signal housing assembly: Damage to visors and back plate. No other permanent visual damage observed.

*Figure 194: Fractured bracket connected to the top of the 5-section signal disconnect box*

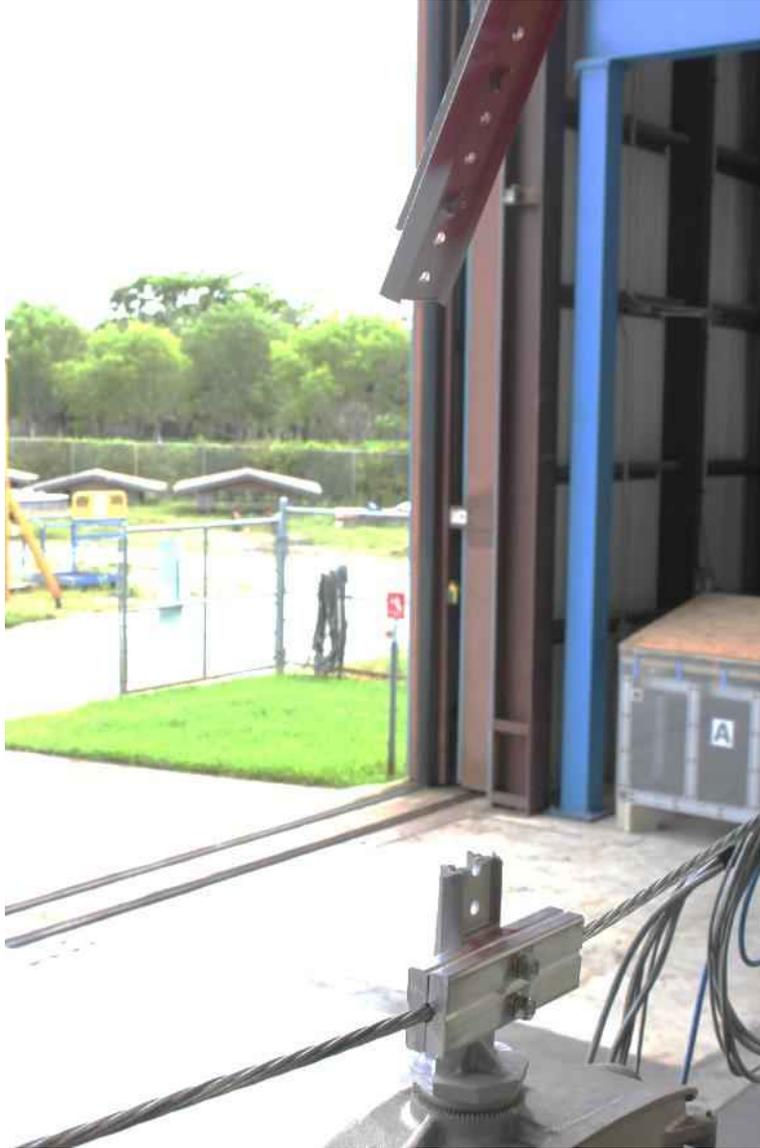
*Figure 279: "No-mitigation case" failure of adjustable-hanger at 150 mph at 0 degrees*

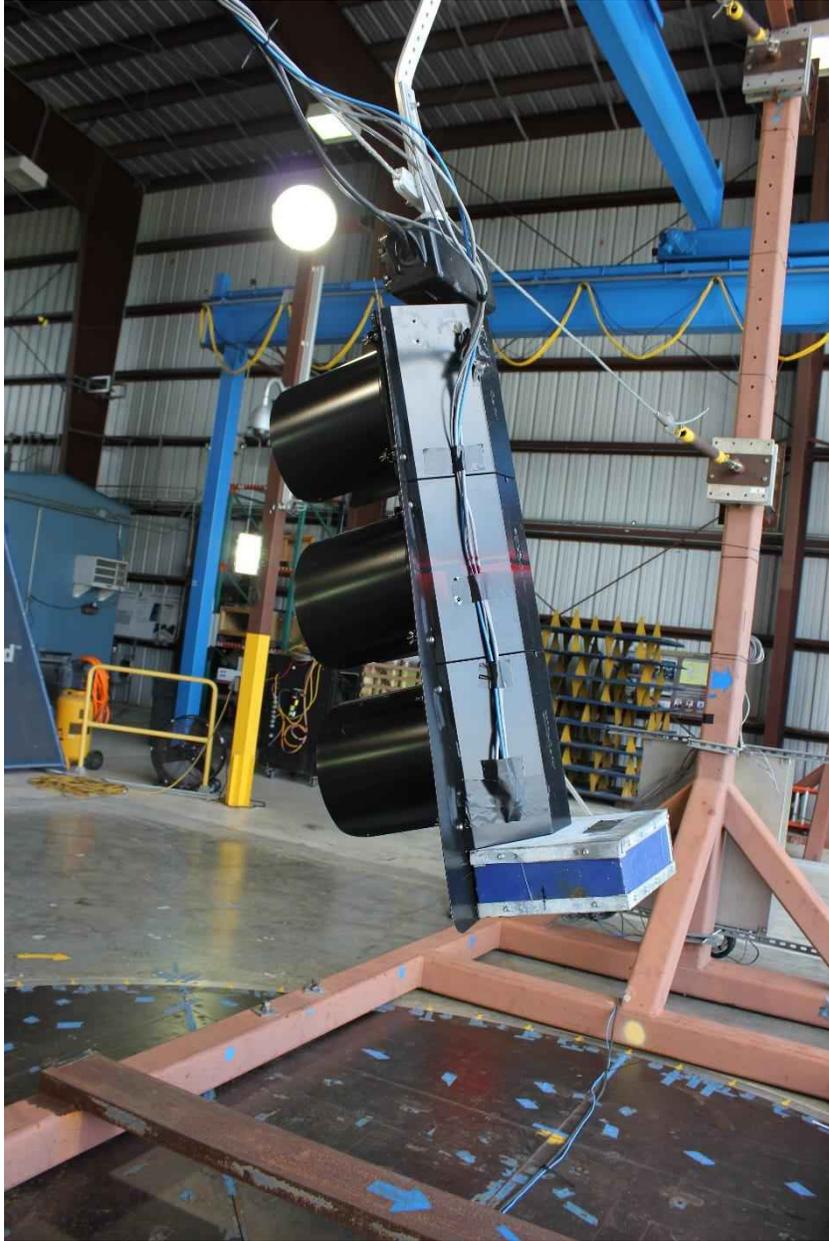
The assembly showed no damages during all wind speeds other than severe bending of the extension bar which started at about 130 mph. An aerodynamic instability was seen during the 150-mph wind speed, see Figure 284.

*Figure 284: "Metal-box case" after 150 mph at 0 degrees*
