BDV31-977-71

Shear Behavior of Webs Post-Tensioned with Tendons Containing Flexible Fillers

September 2022

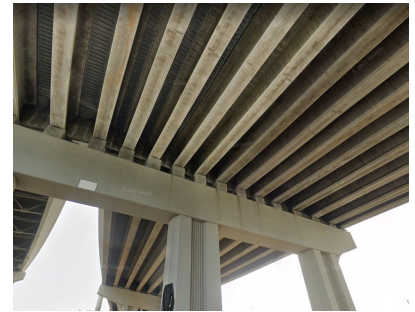
The I-beam is widely used in bridge and overpass construction because it allows for longer spans at lower weight.
