Design and Construction of an Integrated Solar Lighting Pedestrian Crosswalk(s) and Sidewalks with Enhanced Visibility

Master Agreement #: BDV31-977-78

Final Report

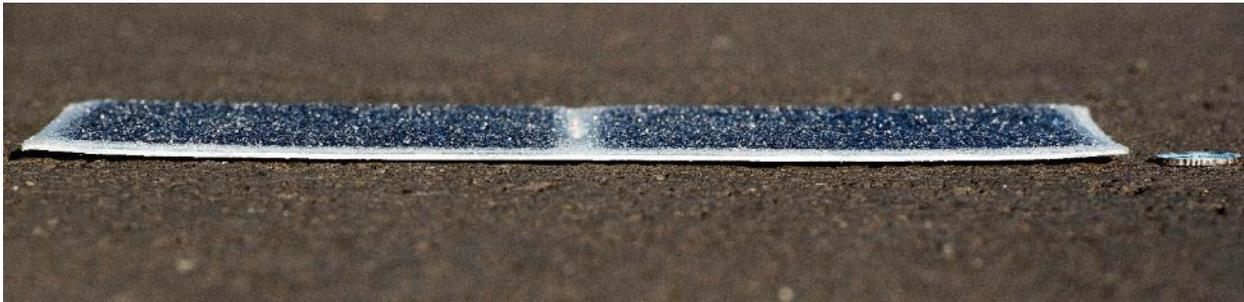
Figure 1-1. Colas’s solar module is designed to be placed directly on top of the asphalt¹. The design is streamlined, as indicated by the thickness relative to the coin on the right side.

The conclusions of this report indicated that there are two viable technologies that provide the best opportunity to meet the FDOT’s goals. The first is a slim photovoltaic module produced by Colas that sits directly on top of the roadway surface. See Figure 1-1 below for an example of the technology.

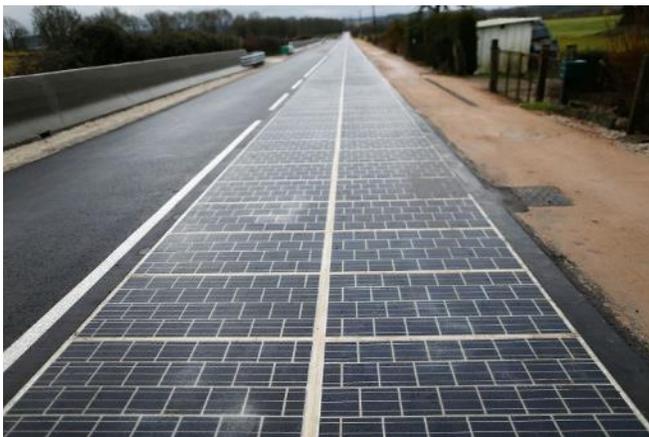
Figure 1-2. Image of a 1-km stretch of solar roadway surface in Normandy, France, completed using Colas’s solar modules⁴.

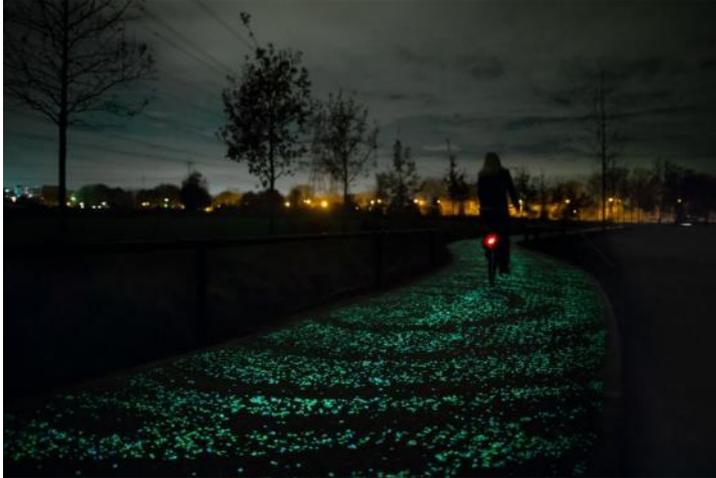
Figure 1-3. Nighttime photograph of the photoluminescent “Van Gogh – Roosegaarde Cycle Path”.³

shown to the left in Figure 1-3³. Furthermore, it has recently been demonstrated by the Texas A&M transportation institute on their campus (<https://www.fastcoexist.com/3067911/heres-the-first-glow-in-the-dark-bike-lane-in-the-us>).

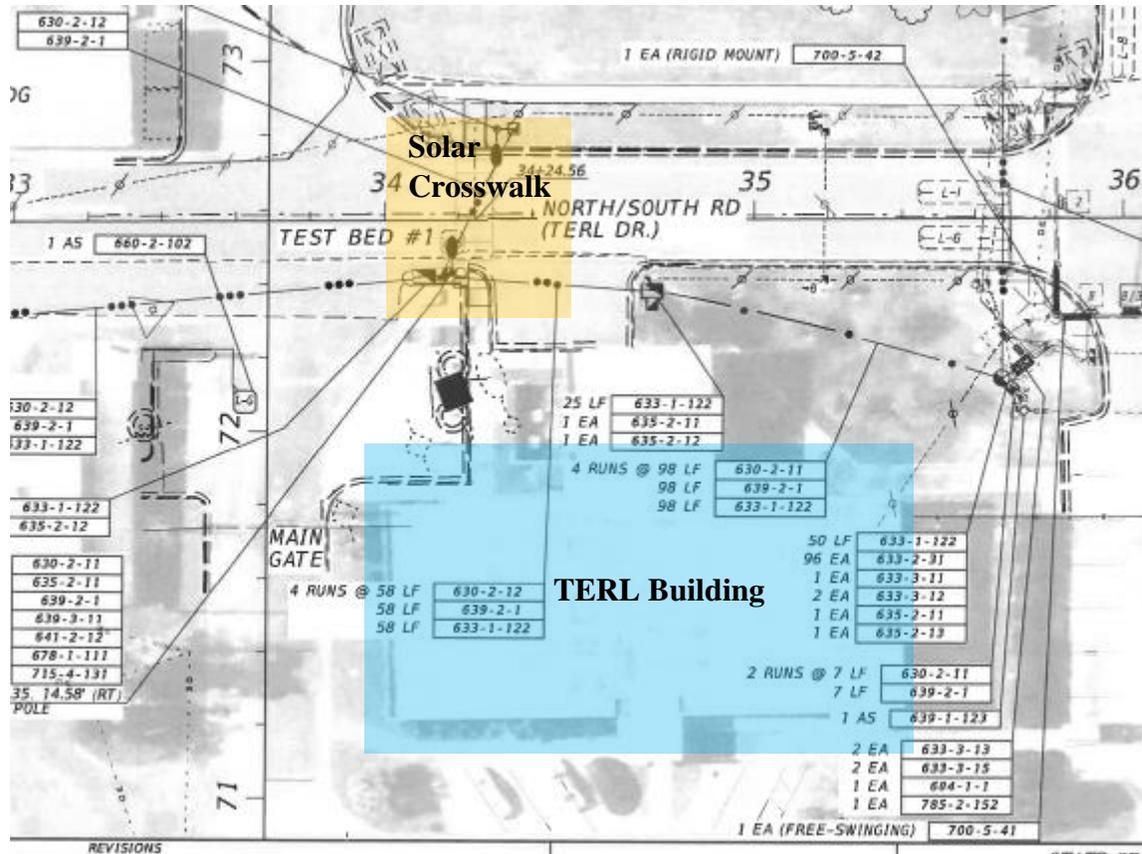
Figure 2-1. Blueprint of the TERL facility. The solar-powered crosswalk will be placed at Test Bed #1 on the west side of the main TERL building where overhead lighting is readily available.

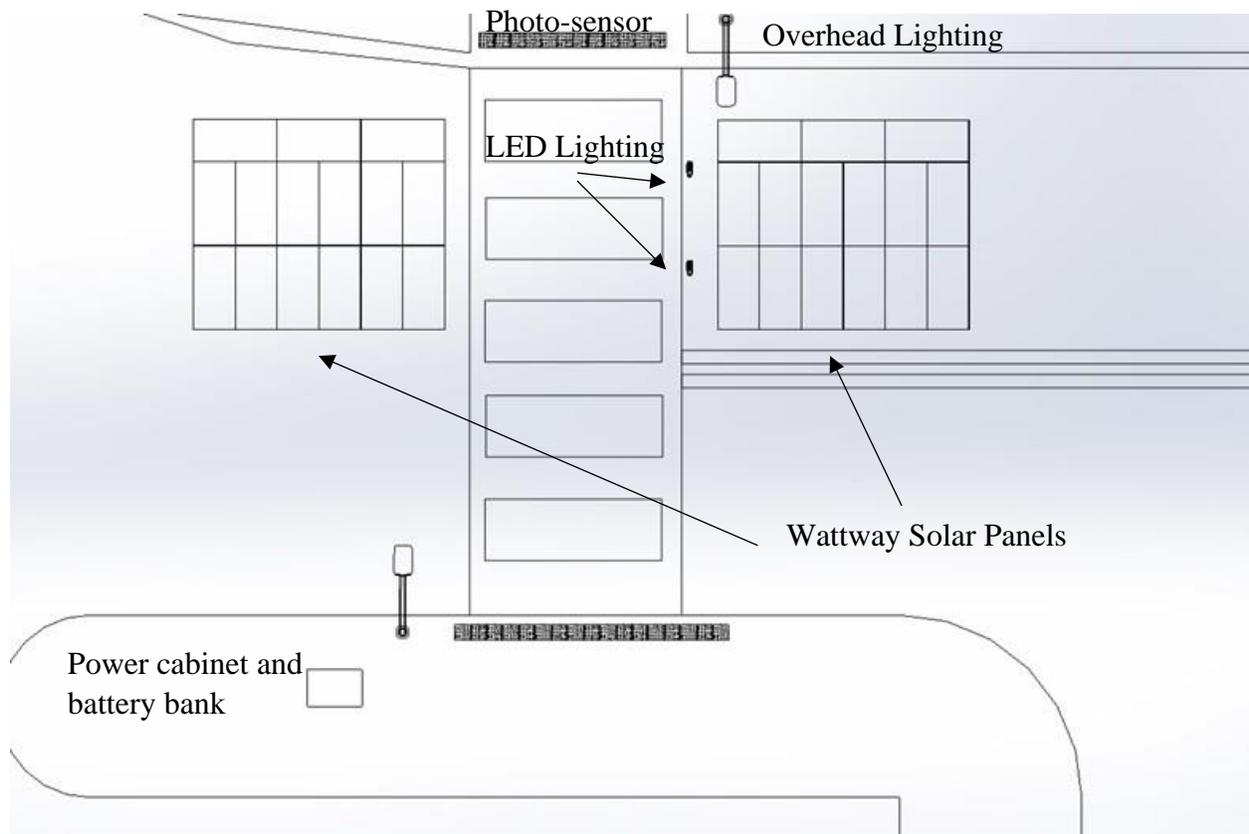
Figure 2-2. Layout of solar-powered crosswalk with solar panels located on each side of the pedestrian crossing, in-road LED lighting, overhead lighting, and motion sensors, all powered by a battery bank.

A drawing of the crosswalk layout is shown in Figure 2-2. As seen the panels (each 0.7 m by 1.4 m and 1.0 m²) are arranged in a manner where half are placed on the side of incoming traffic and half exiting traffic, with lighting placed between the crosswalk and the panels on the incoming traffic side. In addition to the in-road LED lighting, photo detectors and the battery bank, several devices specific to the Wattway installation will be placed within a power cabinet. These include:

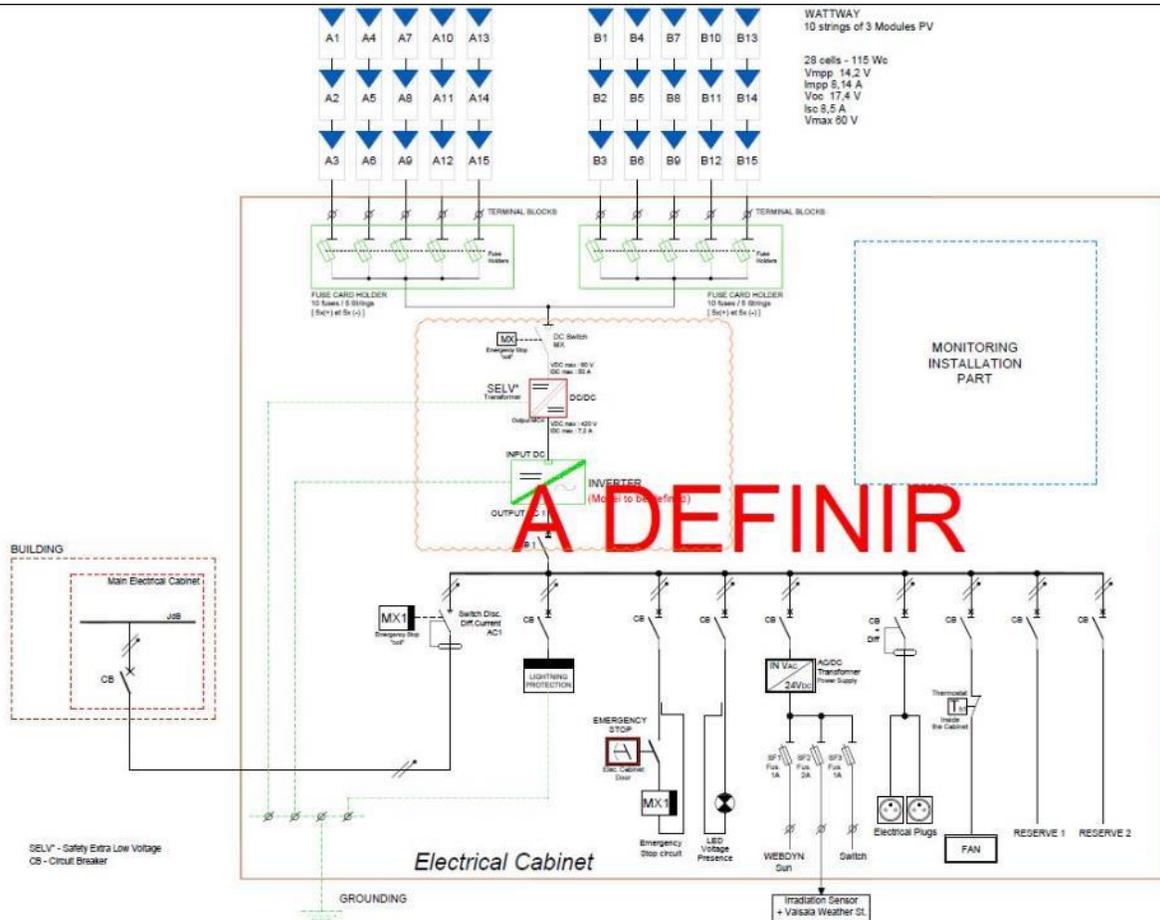
Figure 2-3. Overview of the electrical layout of the Wattway solar panels. Excess power will be relayed to the TERL main building.

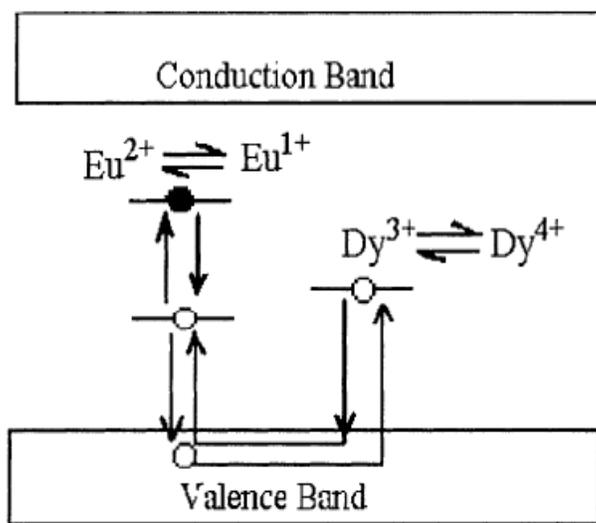
Figure 3-1. Afterglow mechanism for $\text{SrAl}_2\text{O}_4:\text{Eu}^{2+}, \text{Dy}^{3+}$, from Lin et al.⁵

A mechanism has been shown in Figure 3-1 which has been adapted from Yuanhua Lin et al.⁵. In the case of $\text{SrAl}_2\text{O}_4:\text{Eu}^{2+}, \text{Dy}^{3+}$, the europium ions act as activators which cause luminescence in otherwise non-luminescent strontium aluminate; the host material. The dysprosium ions act as hole capturing agents, which leads to the phosphorescence. They reside in traps which Randall and Wilkins¹⁷ describe as discrete energy levels within the material, due to crystal defects produced by the dopant. Upon excitation, the Eu^{2+} ions undergo an electronic transition from the 4f level to the 5d electronic level. These ions in their excited state, capture electrons from the valence band of the host material. This causes vacancies in the valence bands, called holes. Matsuzawa et al.⁶, suggest that these holes get thermally released into the valence band and are then captured by the Dy^{3+} ions. When the excitation light source is removed, these holes get released back to the valence band and migrate through it to combine with the excited Eu^{2+} . This causes charge carrier recombination and thereby leads to the phenomenon of luminescence. We can say that the trapping of the ions by Dy^{3+} prevents light emission during excitation while the afterglow occurs due to the slow release of holes and the recombination. The depth of traps and

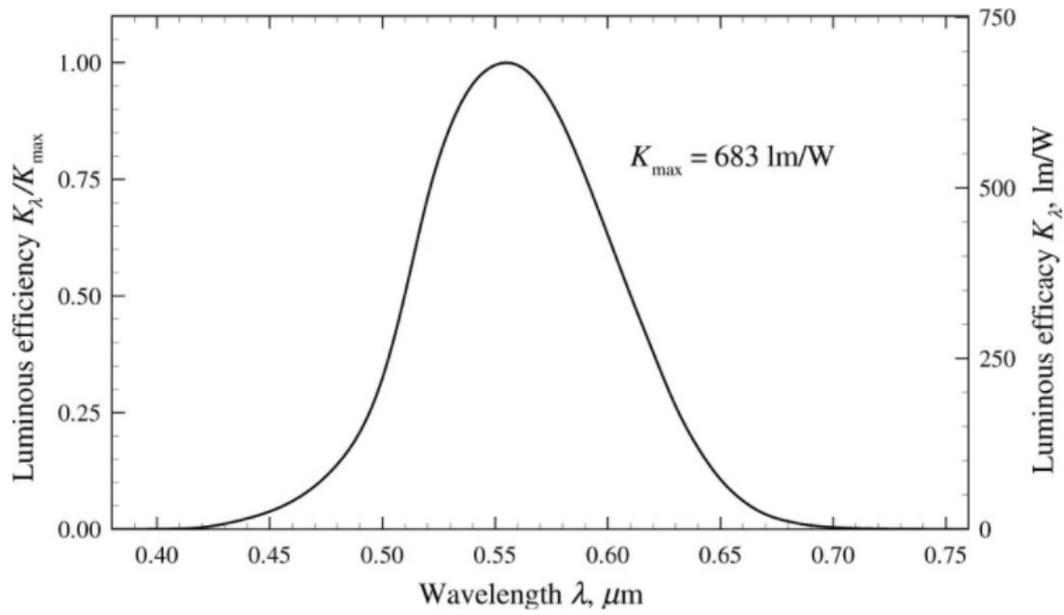
Figure 3-2. Efficiency functions (y axis) for photopic vision, adapted from Modest². The efficacy is listed on the right-hand side with the highest value being at 555 nm.

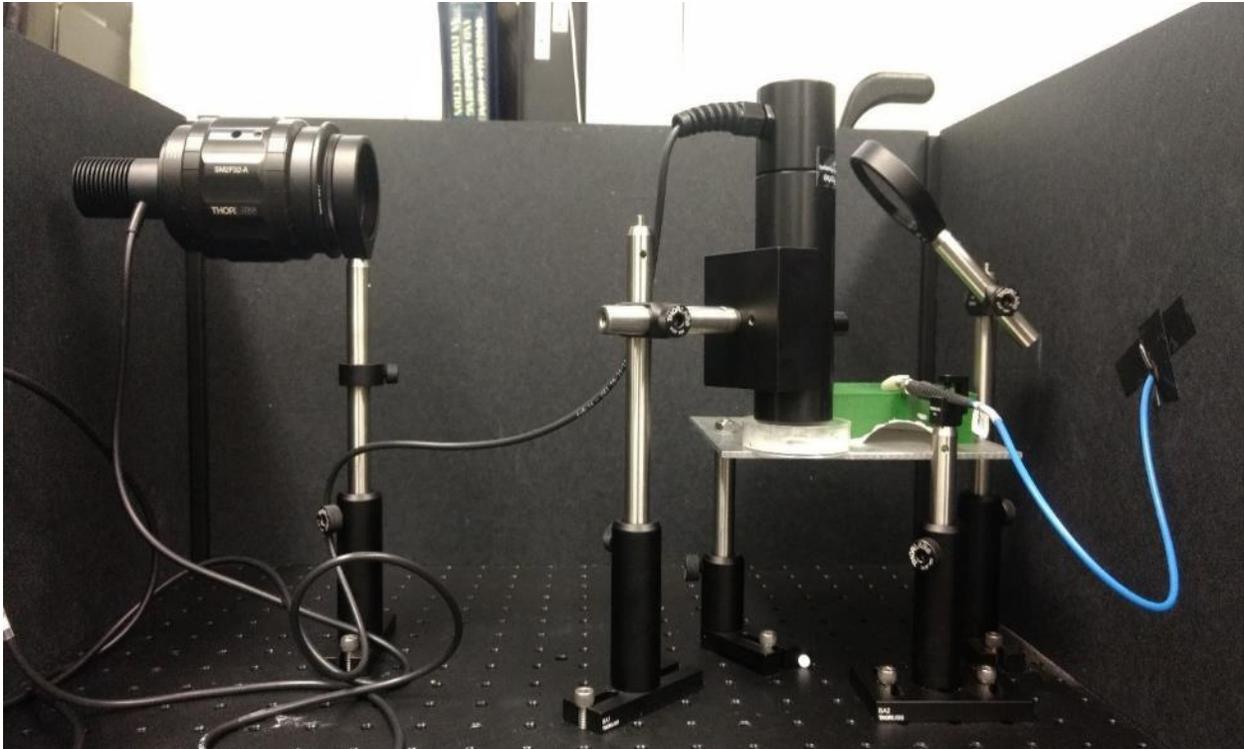
Figure 3-3. The experimental setup. The light from the LED arrives at the mirror which reflects it downwards. An optical fiber can be seen touching the stone to make spectral measurements.

To illuminate the samples, a Neutral White LED was used which had a wavelength range of 400-700 nm. The LED was coupled with a collimator which worked to collimate the beam, and an LED driver which controlled the power output. The maximum power output of the LED after collimation was measured with a S314C Thor Labs thermal power sensor and was found to be 264.5 mW with an output flux of 233 W/m². The light from the LED was then directed onto the sample placed on a mounting table after reflection from silver coated plane mirror set at 45 degrees. The mirror has a 2 inch diameter and was again procured from Thor Labs Inc.

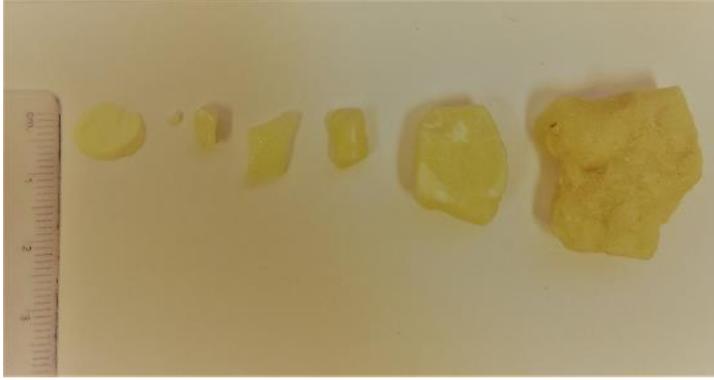
Figure 3-4. Size specification for samples. From left to right: powder, 1-mm pebble, 3- to 4-mm stone, 5- to 8-mm chip, 5- to 8-mm stone, 11- to 14-mm stone and a 25-mm rock.

Samples having 5 different glow colors were acquired from 6 distributors for the experimental campaign. These were CoreGlow, Phosphor Ltd., Ambient Glow, Glowstones, Rare Earth Sciences and Ruby Lake Glass. All samples procured from these companies had various sizes and a sizing specification is shown in Figure 3-4. Table 1 gives the list of distributors and the samples they provided. The samples were designated IDs for keeping track of them on the basis of a nomenclature.

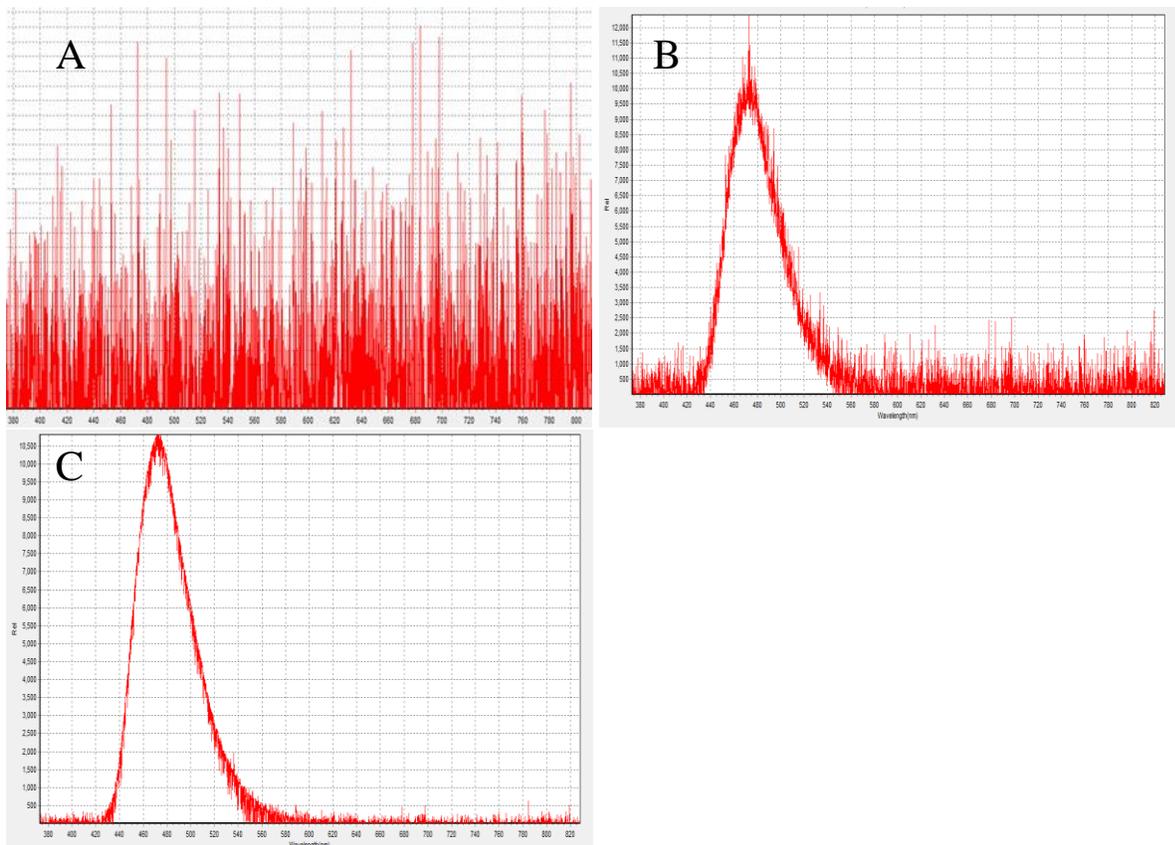
Figure 3-5. Spectrum Capture Process: (A) dark spectrum, (B) raw spectrum data, (C) true spectrum

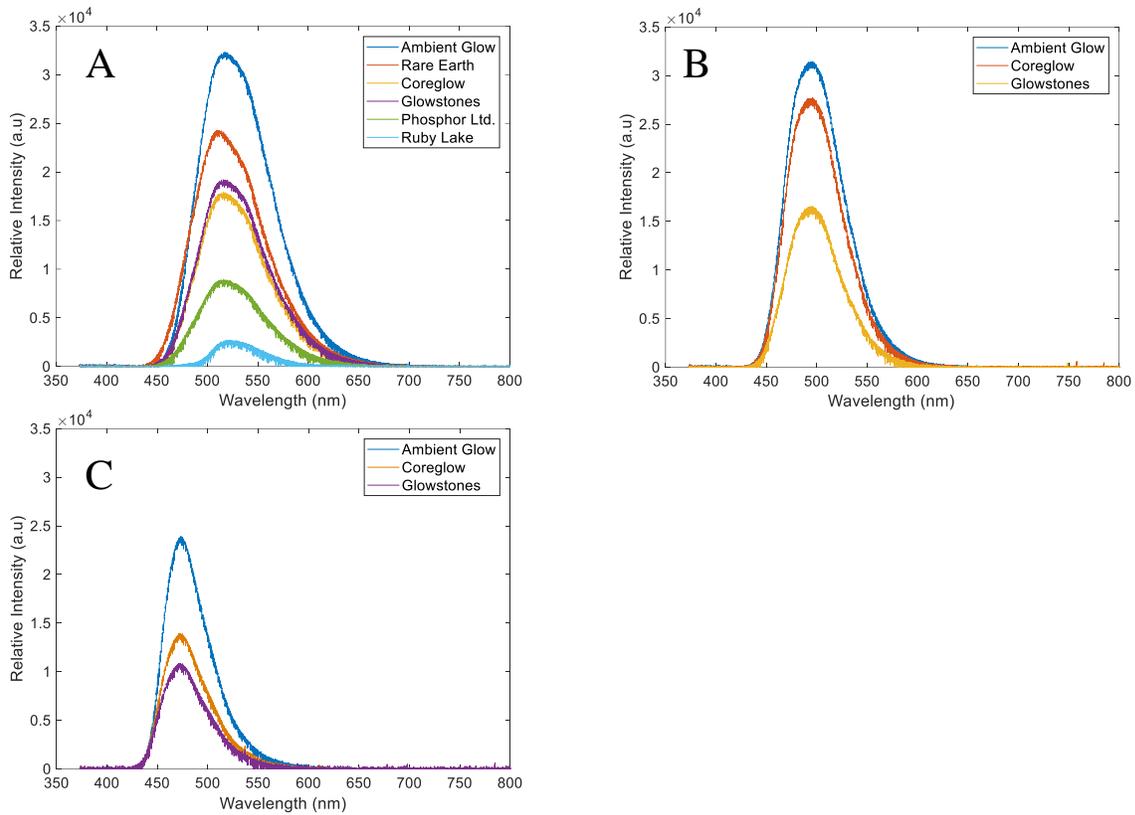
Figure 3-6. Spectrums compared between colors green, aqua, and blue procured from different companies: (A) the spectral curves compared for green; (B) aqua spectrums with the peak at 496 nm; (C) blue spectrums with the peak at 473 nm. Overall, Ambient Glow’s samples had the highest intensities and Ruby Lake’s were the lowest.

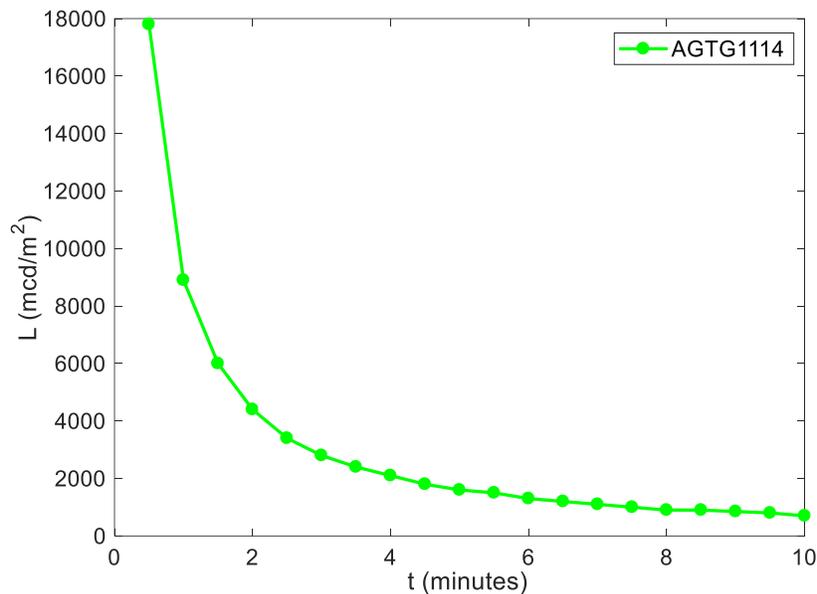
Figure 3-8. Luminance decay trend for Ambient Glow's 11- to 14-mm stones. The trend is dependent on the material, and we observed the same trend for all samples except for the color red.

A general decay trend for the Ambient Glow's 11 - 14 mm samples is shown in Figure 3-8. The material used over here was the long afterglow $\text{SrAl}_2\text{O}_4:\text{Eu}^{2+}, \text{Dy}^{3+}$. Looking at the figure, we can see that the decay is exponential in nature with a rapid rate for the first 2 minutes and a flattening out after 5

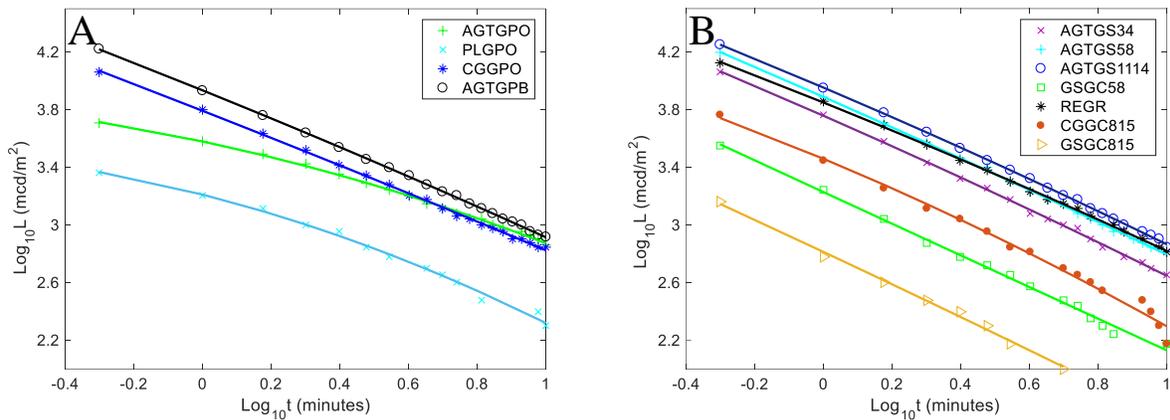
Figure 3-9. (A) Luminescence decay curves for green powders and pebbles, fit through a second-order polynomial. The values on the x- and y-axes were converted to logarithmic values to compare decay rates between companies. (B) Luminescence decay curves for other sample sizes. As can be noticed from this figure and the one above, Ambient Glow's and Rare Earth's samples performed the best.

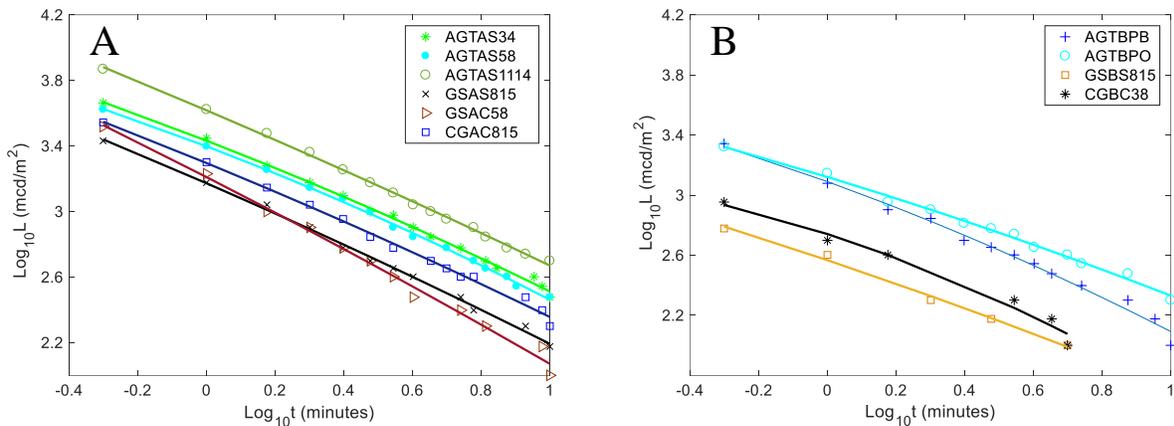
Figure 3-10. (A) Luminescence decay curves for aqua samples. Notice a decrease in the luminance values when compared to the green case. (B) Luminescence decay curves for blue samples

The log-log curves were also plotted for aqua and blue in Figure 3-10 A and Figure 3-10 B, respectively. AGT's samples performed the best in this case as well. To compare the effect of different colors on the luminance, Figure 3-11 serves as a reference. It is noticed that the green samples would have the longest luminance duration of all the colors which makes them a good candidate for further tests. Finally, Figure 3-12 compares an extrapolated curve for green with results in literature. A decay time of 12 hours was predicted after extrapolating to 3 mcd/m^2 (full moon on a dark street) which closely agrees with the estimation by Matsuzawa et al.⁶ which is 11.5 hours. Hence, AGT's green samples serve as viable candidates for concrete and asphalt testing.

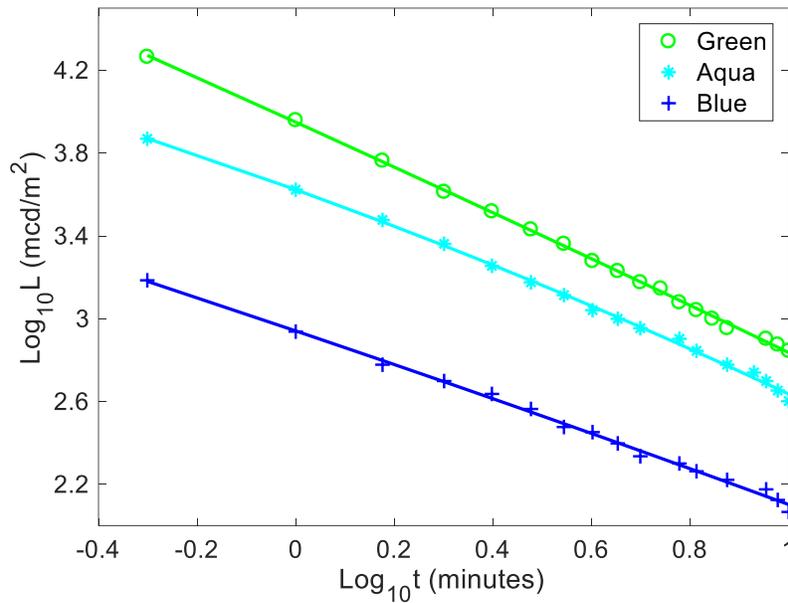
Figure 3-11. Comparison of the rate of decay between AGT's green, aqua, and blue samples

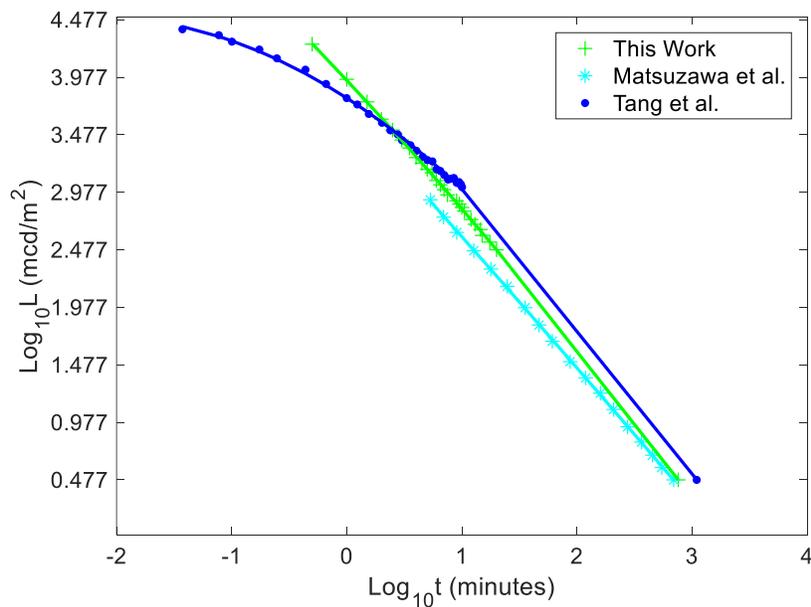
Figure 3-12. Comparison of decay curves between this work and literature. We notice that the decay time estimated by the experiments conducted in the thesis approximates the decay time from Matsuzawa et al.⁶ experiments. The curve for this work was a long-term extrapolation while the curve from Matsuzawa et al. was extrapolated from a luminance of value of 3.84 mcd/m² to 3 mcd/m² (log value = 0.477), which is what we require.

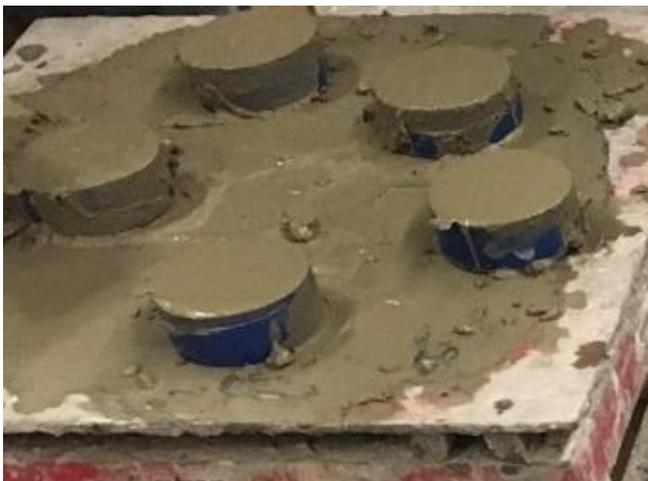
Figure 3-13. Flattened concrete samples placed on a vibrating table. The vibration allows the stones to set into the mix.

minutes to allow it to slightly harden. The top surface of concrete was flattened using a putty knife. Stones of various sizes were then sprinkled on top of the concrete layer. These were the 3-4 mm, 11-14 mm, and powder samples. The glow color was not fixed for this test because it was performed in conjunction with the color comparison tests discussed in the prior section. The dishes were then placed on a vibrating table, which allowed the stones to set into the concrete. Figure 3-13 shows the table with some dishes on the top. Powder samples were not used for Test Set 1 because they require an epoxy sealant for stability in the mix. Hence, only stones

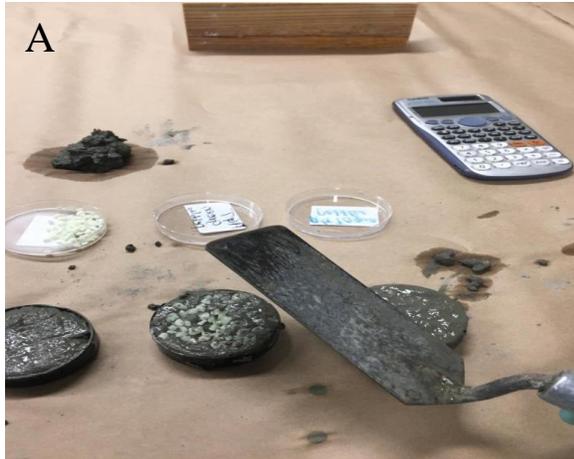
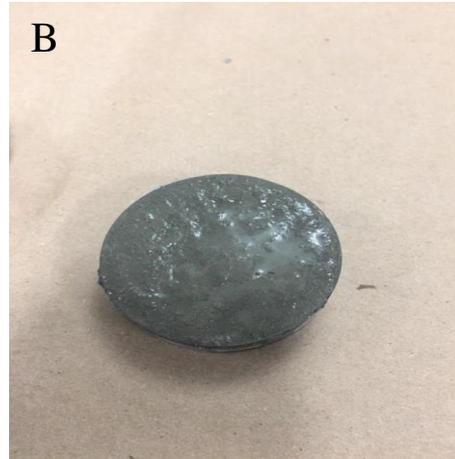
Figure 3-14. Experimental steps for stone placement: (A) Applying stones and smoothing with a trowel and (B) after retarder applied on the surface.

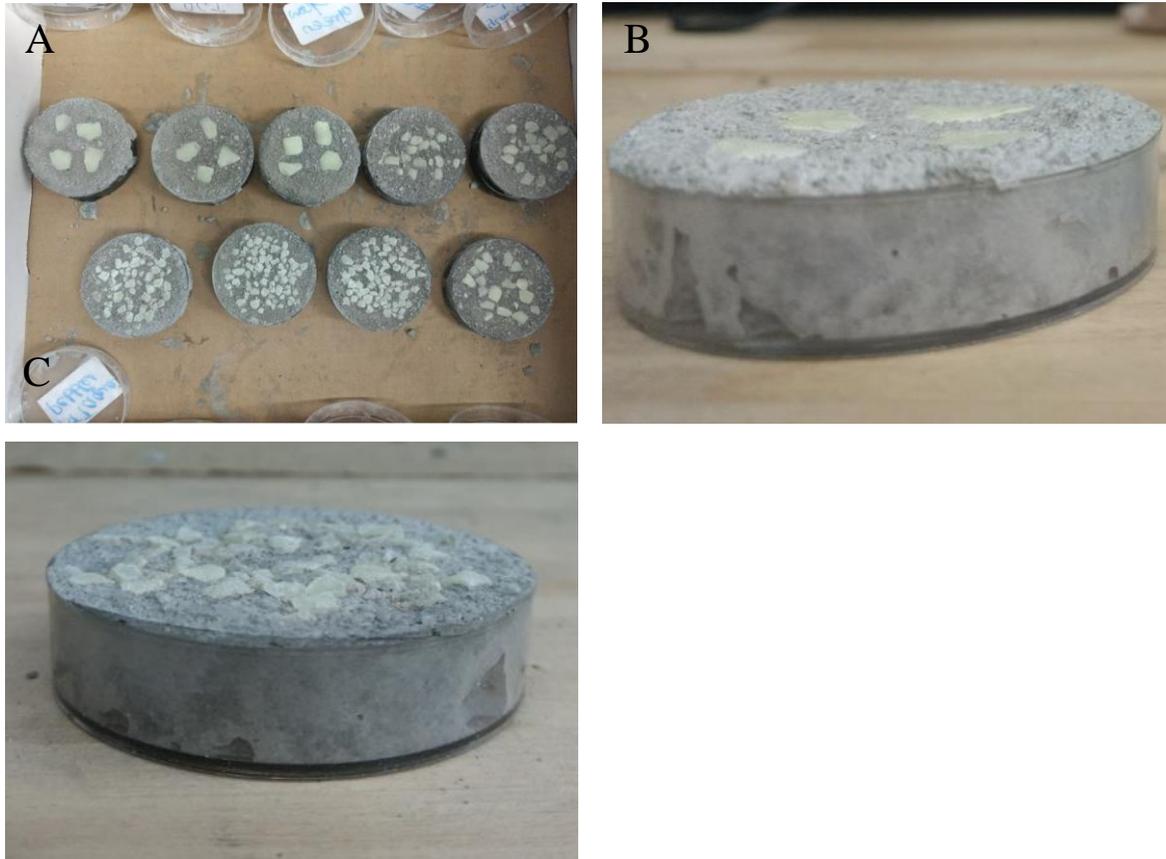
Figure 3-15. Retarder testing stages for the concrete sample: (A) Samples uncovered after 48 hours, (B) and (C) Samples compared for their flatness.

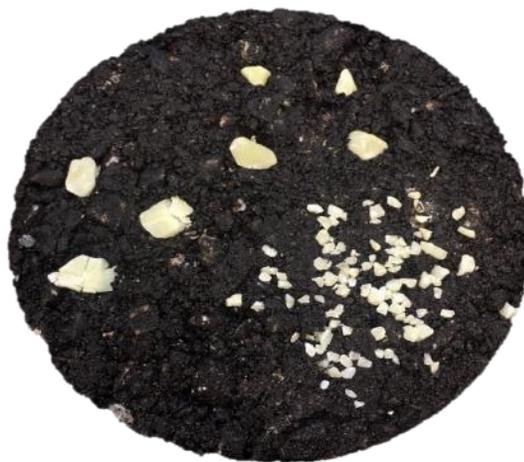
Figure 3-16. Compacted asphalt cylinder. Going in a clockwise manner, notice the 11- to 14-mm, 5- to 8-mm and 3- to 4- mm stones.

in Figure 3-16. All three stones were placed in the single mix. This is contrast to the case in concrete where a single mix was reserved for only one stone size due to the small nature of the samples.

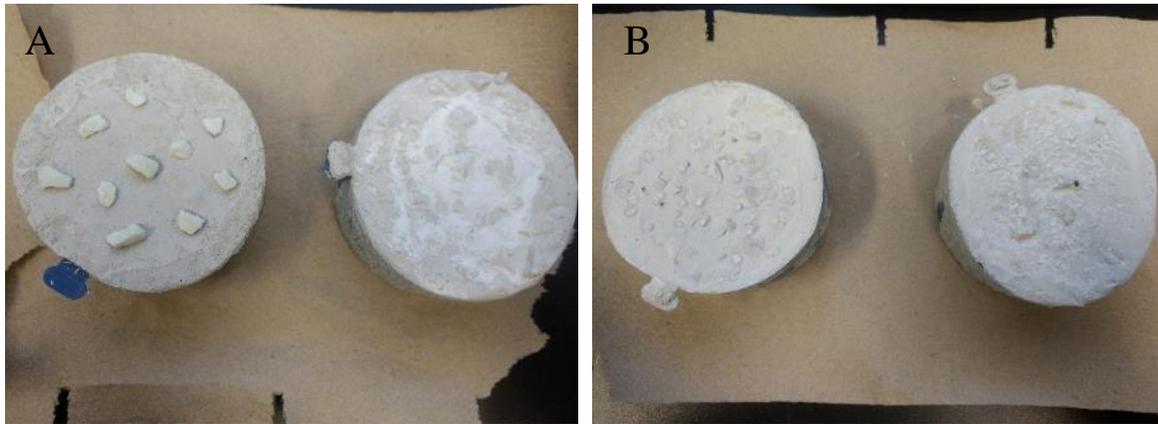
Figure 3-17. Results of vibrating table tests: (A) Stones sticking out and covered portions of applied powder, to the right, (B) Stones sitting overexposed in the left and pebbles covered with concrete to the right.

Looking at Figure 3-17 A and B for Test Set 1, it is apparent that that larger stones are sticking out of the mix and smaller stones tended to settle more. This disparity was caused by the vibration table as the vibration process cannot easily control the depth of immersion of the stones.

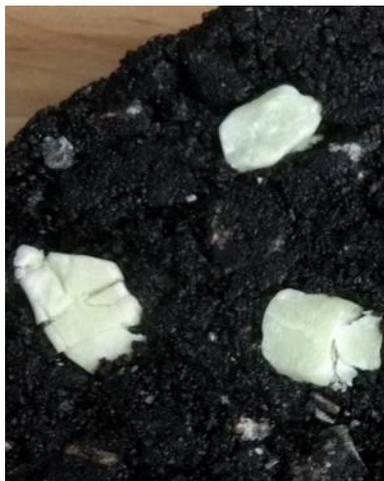
Figure 3-18. Cracked stones as a result of their large size and the compaction process.

As seen in Figure 3-18 it is apparent that the 11-14 mm stones cracked after the high compressive forces during the compaction process. This was cause due to the compaction process where these stones were too large to be forced into the voids. The smallest stones experience a different issue wherein, they did not sit in the voids properly as they were too small to bind

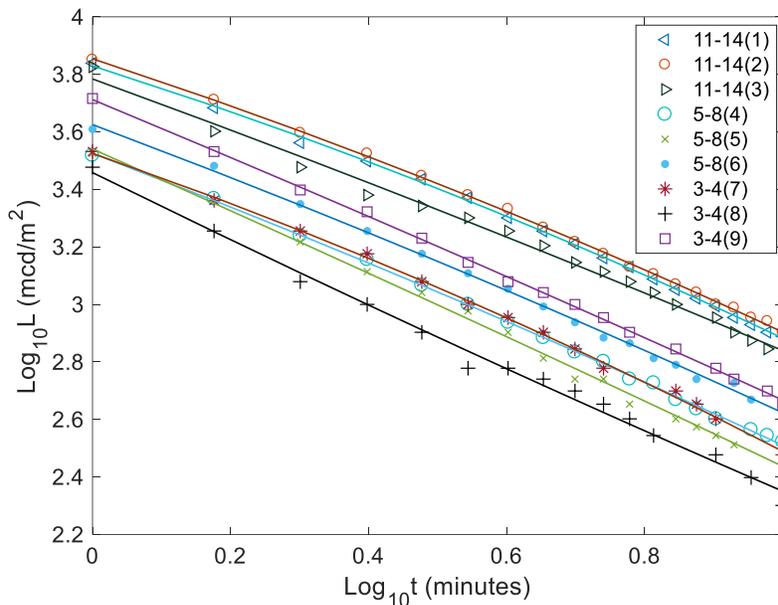
Figure 3-19. The luminance curves for nine samples made. As can be seen, the 11- to 14-mm aggregates gave the best results after the optical testing.

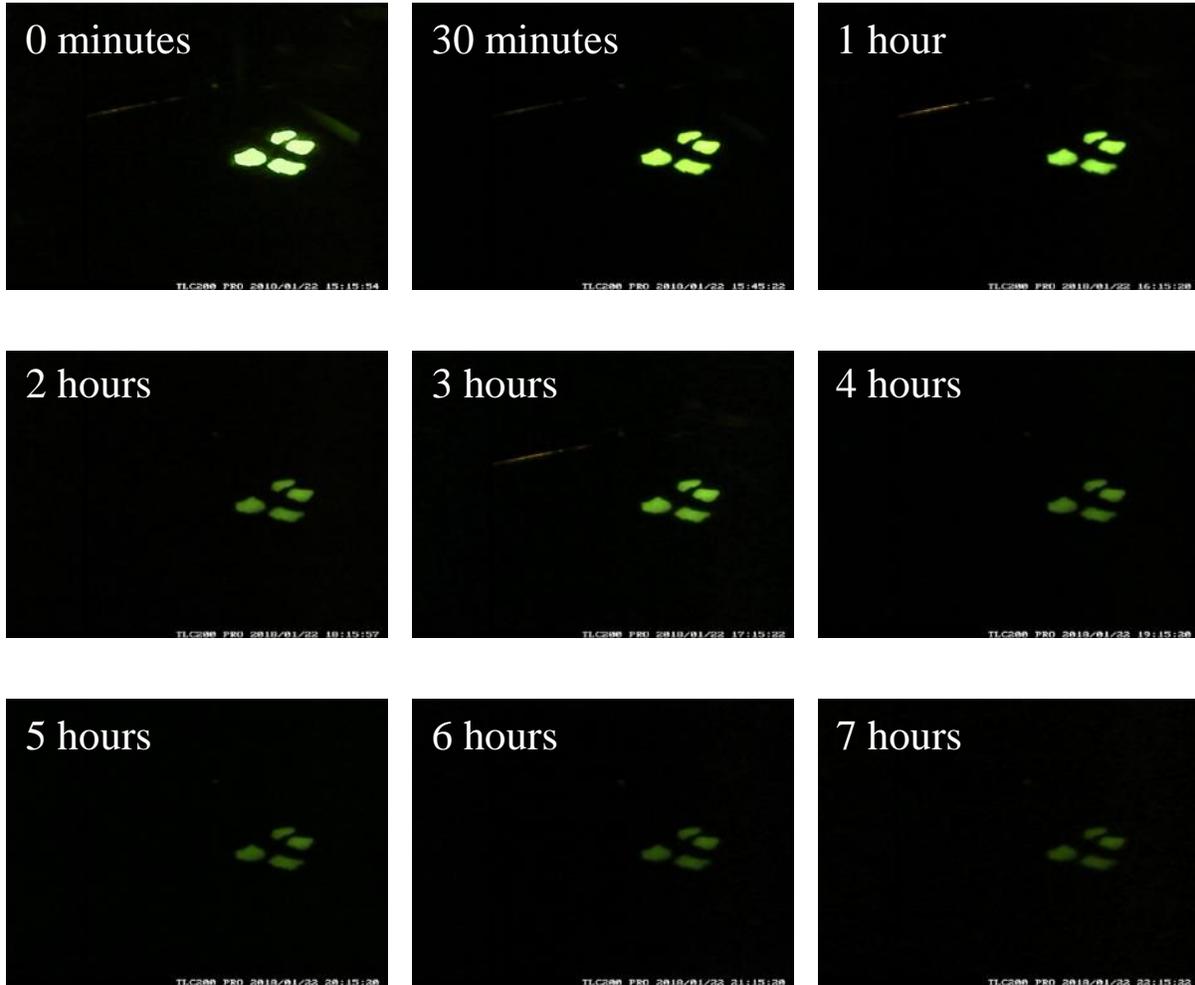
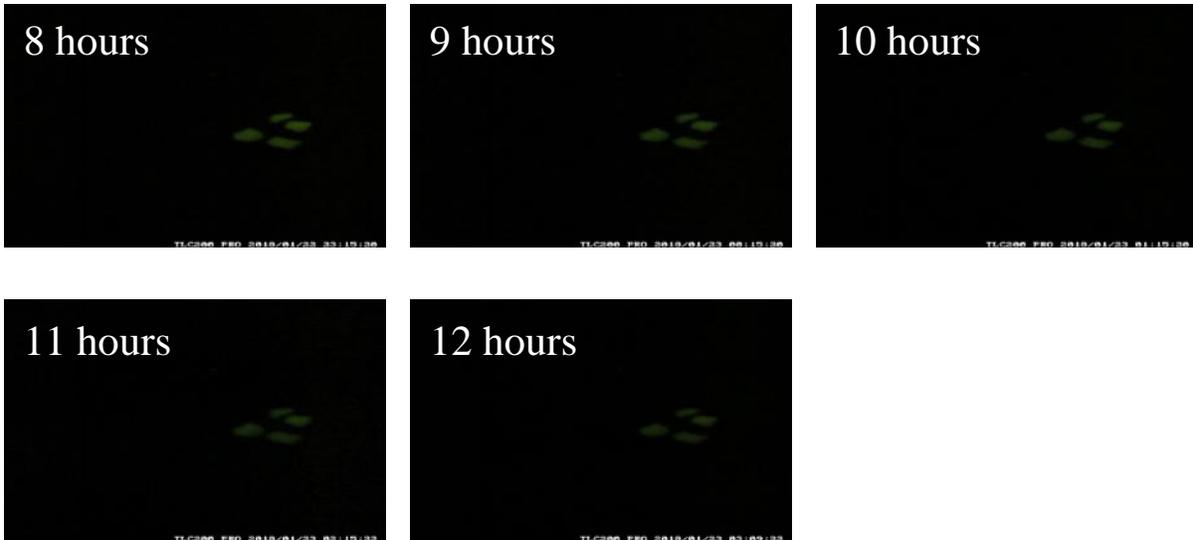
Figure 3-20. Afterglow pictures for concrete. The time stamps have been written at the bottom of each of the figures. We notice that the decay is fairly rapid for the first 2 hours with it being slow thereafter until the 12-hour limit is reached. The stones are still faintly visible after 12 hours.

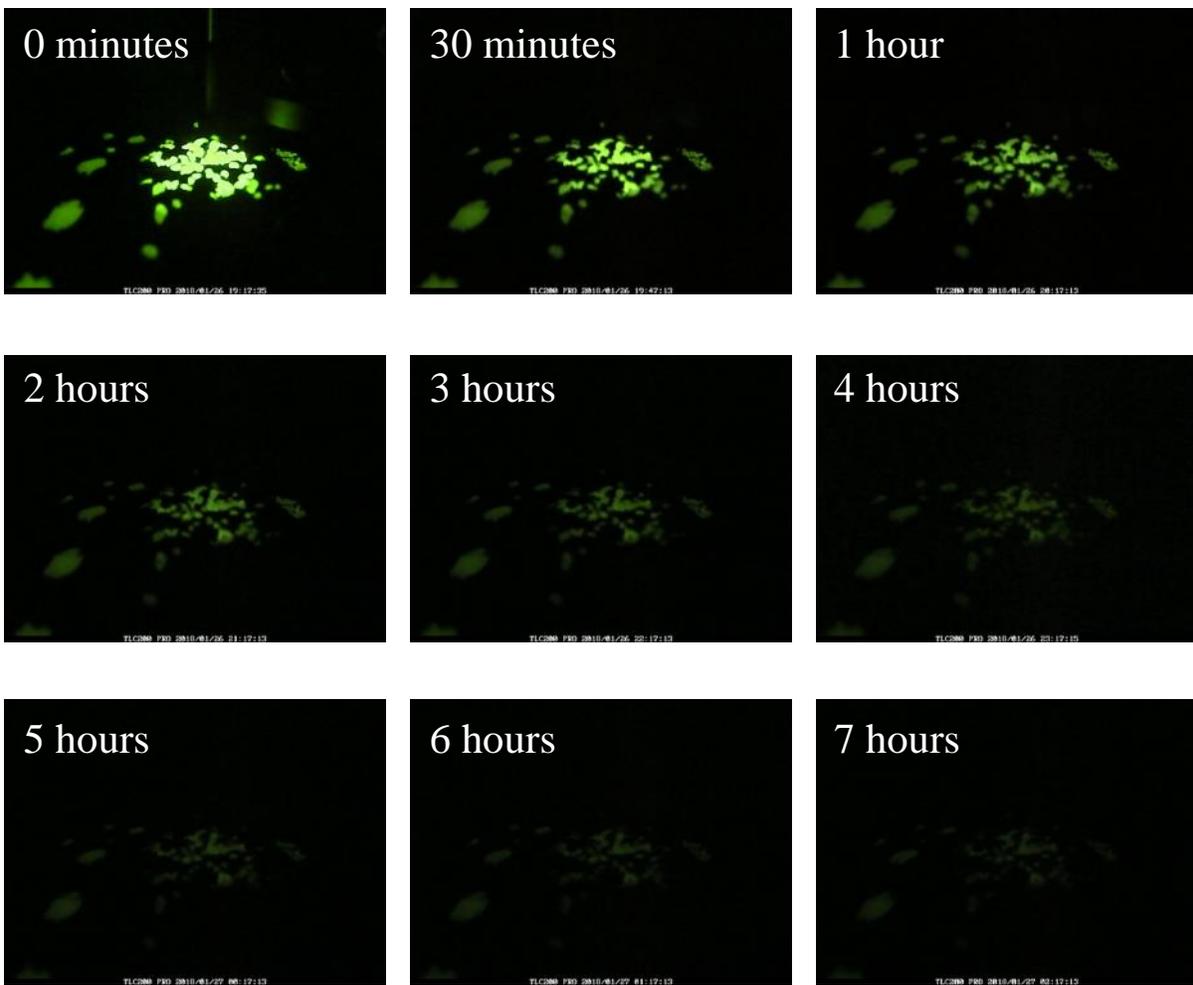
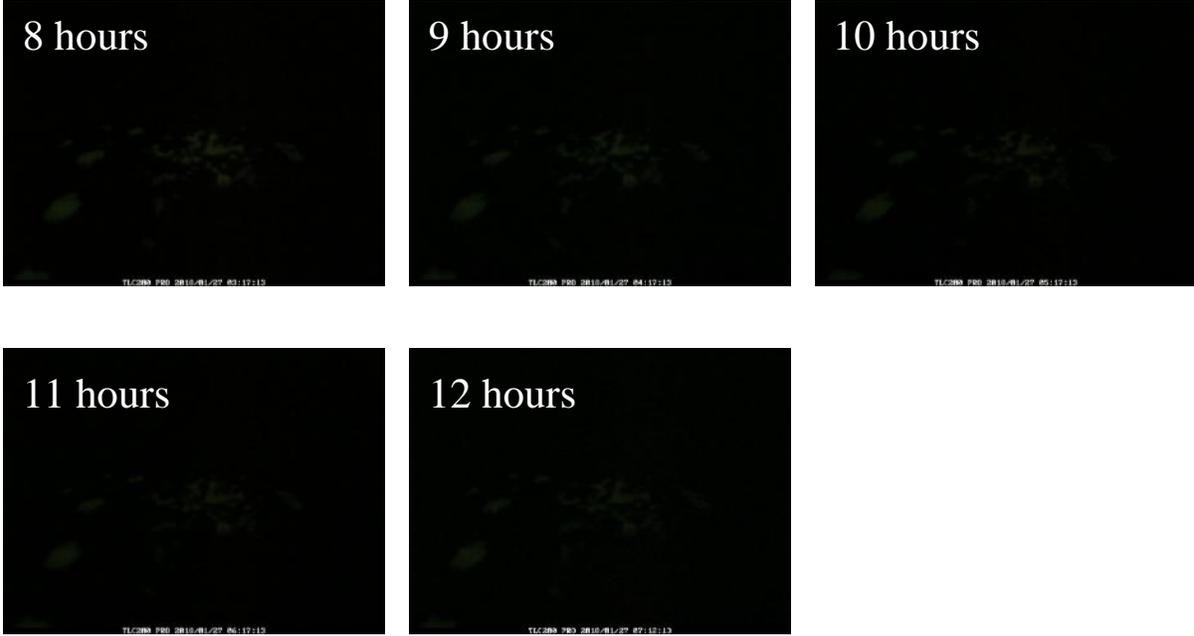
Figure 3-21. Afterglow pictures for asphalt. The pictures resemble a mini-walkway with the stones visible ahead at a distance. We can also see that these are fainter by the end of 12 hours as compared to the concrete samples.

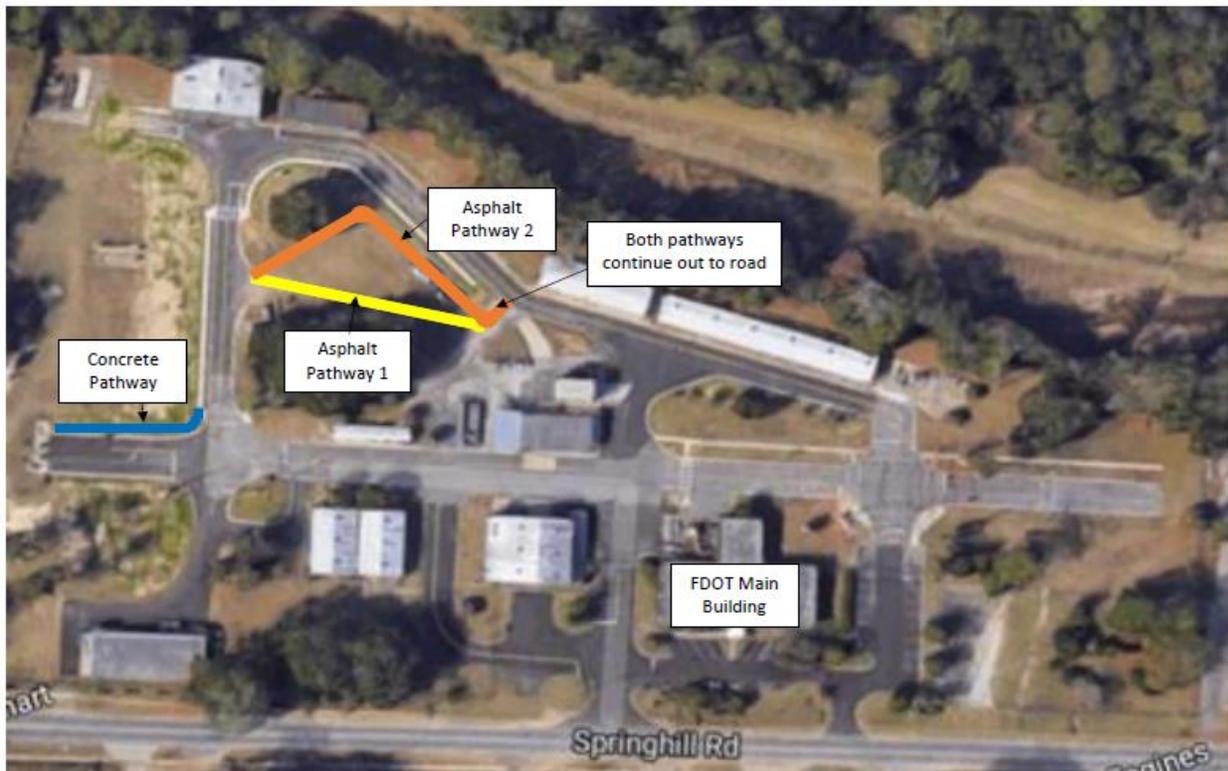
Figure 4-1. Satellite view of TERL facility with proposed pathways.

On March 2, 2018, the UF team visited the Florida Department of Transportation Traffic and Engineering Research Laboratory in Tallahassee to determine installation locations for the photoluminescent asphalt roadway and the concrete sidewalk. Pathway locations are depicted in Figure 4-1. The proposed concrete section (blue) would connect to an existing concrete pathway and would be 149-ft long by 5-ft wide. This section would curve along the roadway from the traffic signal to the barrier (see Figure 4-2). The pathway would be entirely in the sun with no shade.

across a field to be used as a road for buses that are currently parking in that location. There were two suggested pathways for the asphalt section: the first one was 247-ft long (yellow), and the second was 288-ft long (orange). Both pathways would start and end at the same location. The first proposed section would receive both road and pedestrian traffic and was in an area with sun and shade to provide a wide range of environmental conditions. The second proposed section would be entirely in the sun.

The final chosen path for the roadway was the 247-ft path (yellow) because it offered the most direct route across the field and would be simplest to pave. Images of the beginning and ending of the pathway are shown in Figure 4-3.

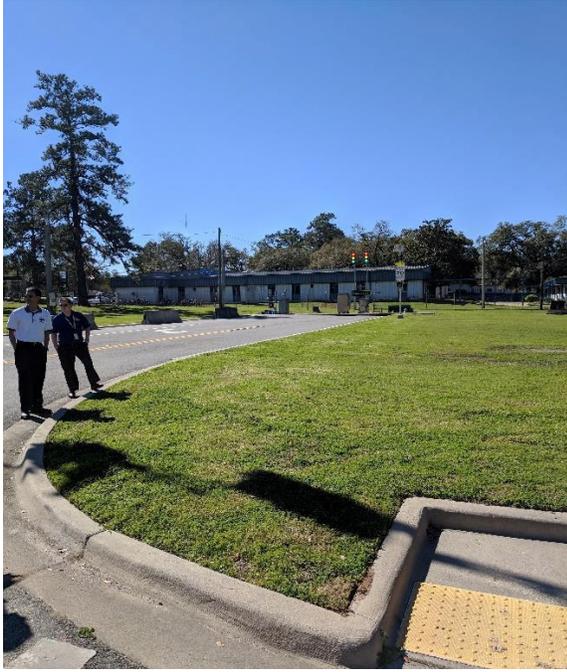
Figure 4-2. Concrete section will connect to existing sidewalk at lower right and extend to barrier at the end of the roadway.
