Design and Construction of an Integrated Solar Lighting Pedestrian Crosswalk(s) and Sidewalks with Enhanced Visibility

Master Agreement #: BDV31-977-78

Final Report

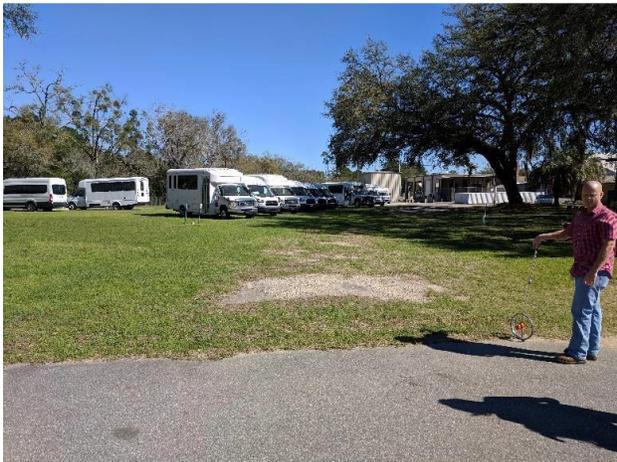
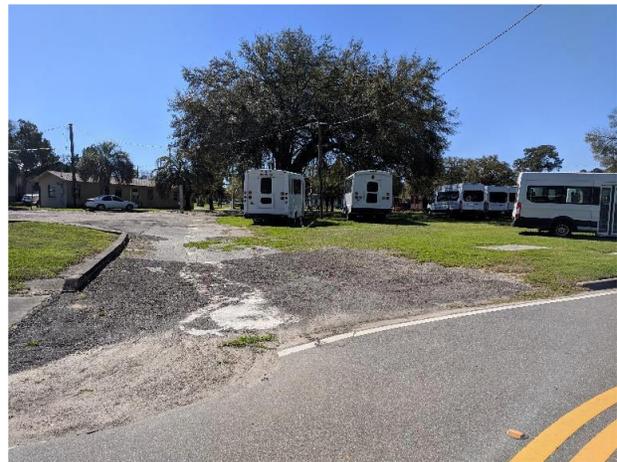
Figure 4-3. Beginning of both proposed asphalt sections (left) and end of both proposed asphalt sections (right).

The final chosen path for the roadway was the 247-ft path (yellow) because it offered the most direct route across the field and would be simplest to pave. Images of the beginning and ending of the pathway are shown in Figure 4-3.

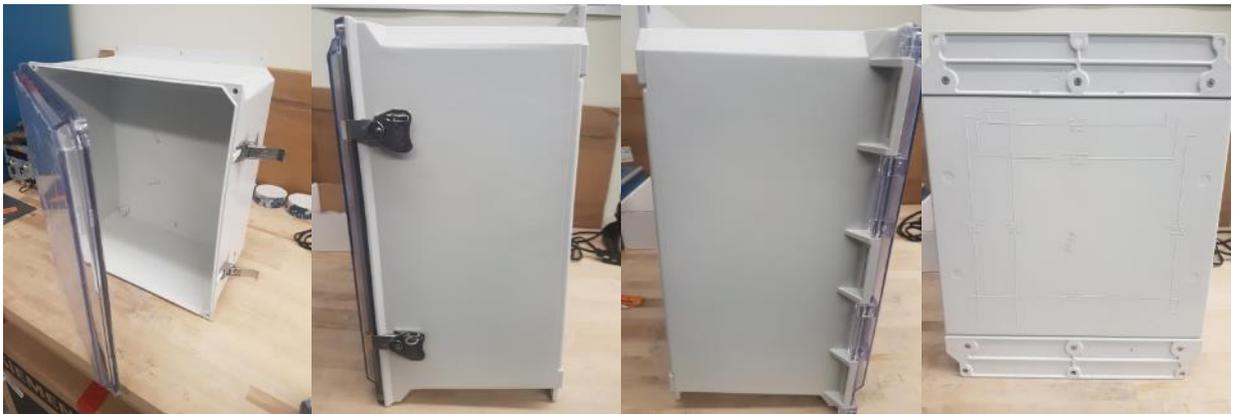
Figure 4-4. Fiberglass instrument enclosure without modifications.

The instrument enclosures we used to house all the sensors and hardware was provided by Omega Engineering. We used a non-metallic fiber glass with a transparent polycarbonate cover, as shown in Figure 4-4. The enclosure type guaranteed that the equipment inside will be protected against solids, liquids, and the formation of ice, if needed. We acquired three

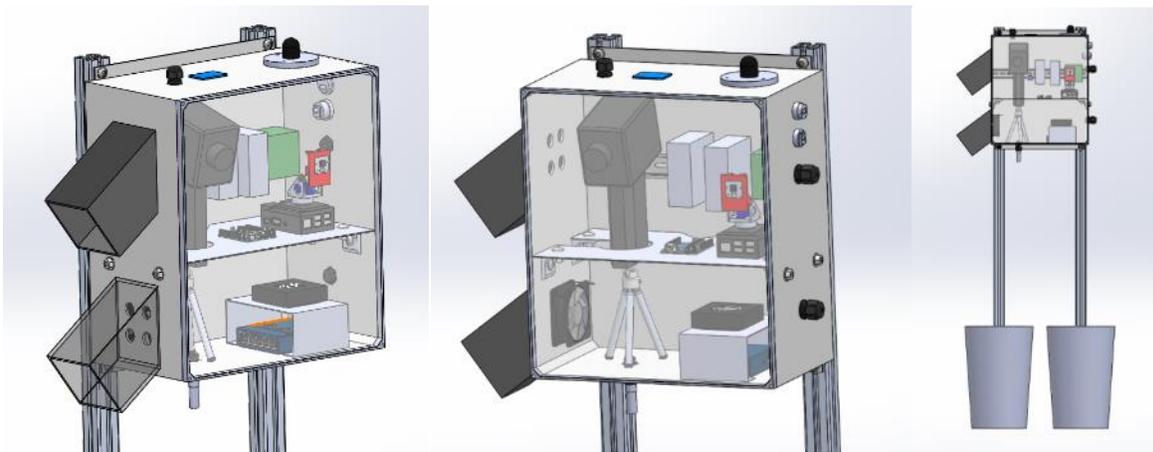
Figure 4-5. 3D model of the enclosure created in SolidWorks.

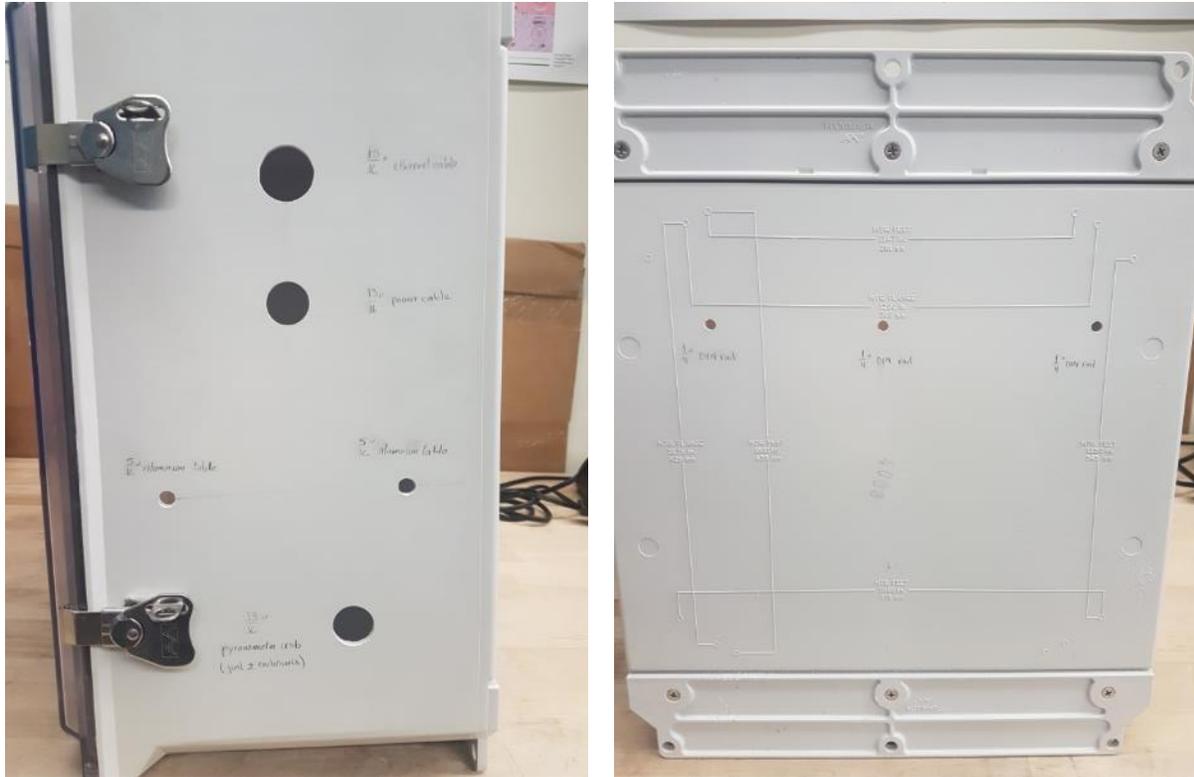
Figure 4-6. Holes drilled on the right side of the enclosure (left) and holes drilled on the back side of the enclosure (right).

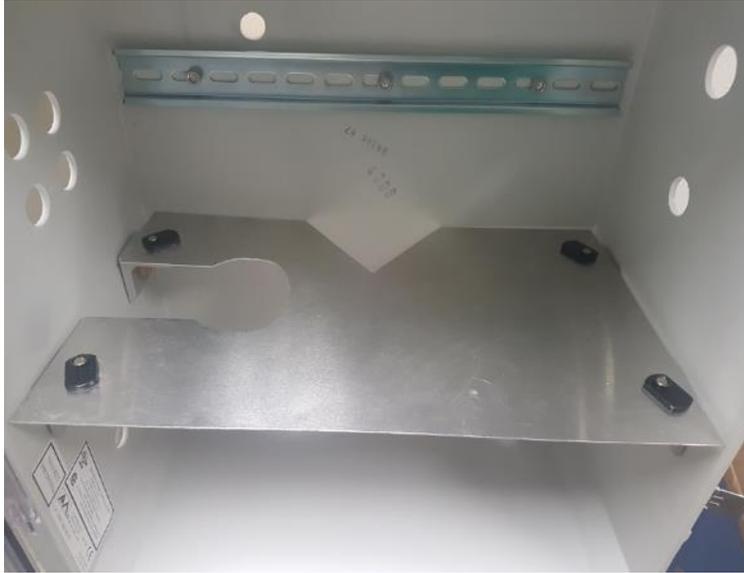
Figure 4-7. 18-gauge aluminum table.

A picture of the side and back of the enclosures is shown in Figure 4-6. The side holes are primarily for data and power access and the back for mounting purposes. An 18 gauge aluminum mounting table was installed to provide an additional platform to set equipment inside of the enclosure (Figure 4-7). The height at which the mounting table was placed was approximately 6” from the bottom surface. Four 5/16” holes had to be drilled to secure the table in position. A triangular cut was made on the back to allow cable connection in between upper and lower level of the enclosure. Finally, an elliptical cut was made on the left side of it to allow the installation of the luminance meter, which will be described later.

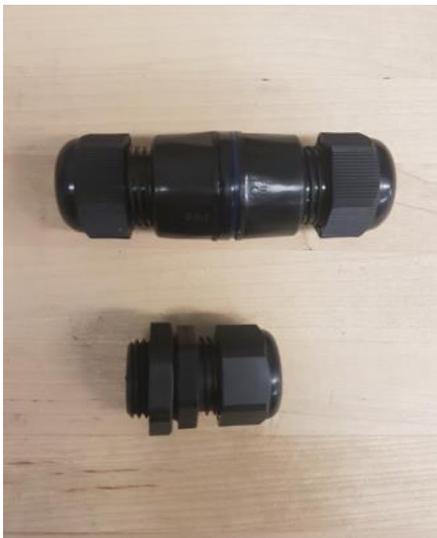
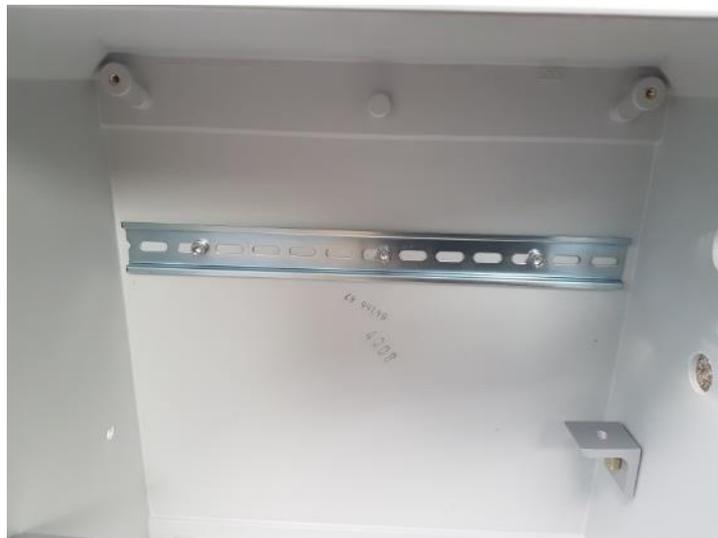
Figure 4-8. Strain relief liquid-tight connectors (left) and DIN rail mounted on the back side of the enclosure (right).

We acquired strain relief liquid-tight connectors for cables entering and leaving the enclosure. The two holes needed for these connectors were a 13/16" hole for the power cable and a 15/16" hole for the Ethernet cable. These modifications were made to guarantee that the 4X safety standard of the enclosure won't be compromised. In addition to the aluminum mounting table, an aluminum DIN rail was installed in the top back portion of the enclosure for quick installation of different instruments. Three 1/4" holes were made, equally spaced, to support the DIN rail on the back. The height at which it was placed was

approximately 5" from the top surface. The strain relief liquid-tight connectors and DIN mounting installation is shown in Figure 4-8. A 1/2" hole filled with rubber plug in the back was installed in order to perform luminance meter alignment.

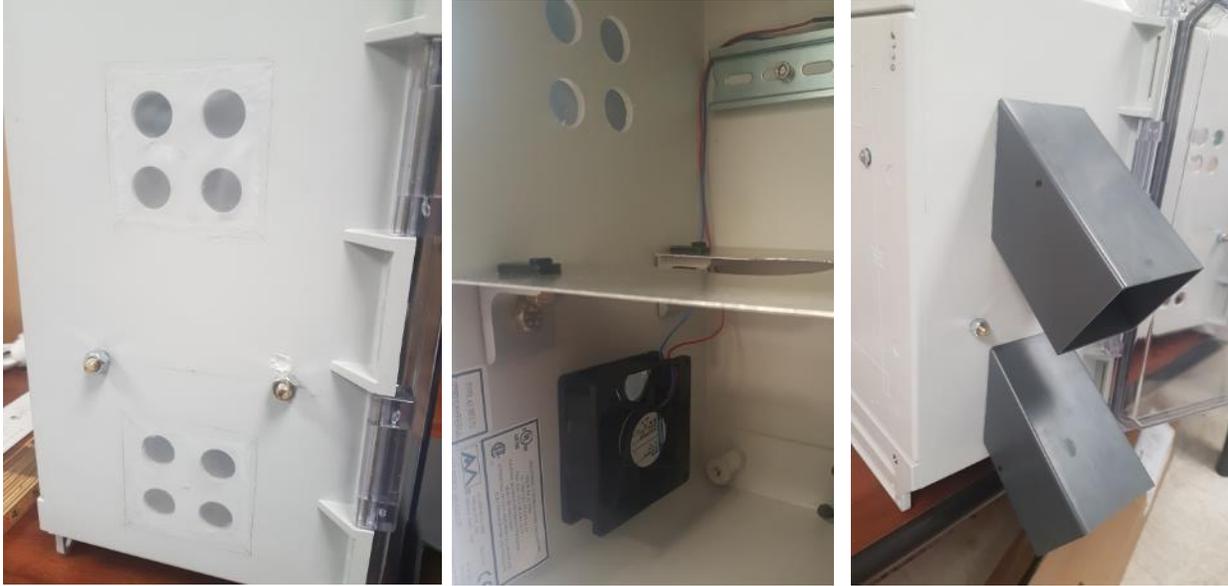
Figure 4-9. Ventilation system. Intake and exhaust with filter paper and powered by a computer fan. PVC pipe placed diagonally on the outside of the enclosure.

For the ventilation system, four holes were drilled in a square pattern, and were placed in the top and bottom side to guarantee an air flow across the whole enclosure as seen in Figure 4-9. The air flow was powered by a 4" x 4" computer fan installed on the intake side of the ventilation. To guarantee weather-proof protection of the enclosure, filter paper was installed on the intake and outtake, and PVC pipe was placed diagonally on the outside.

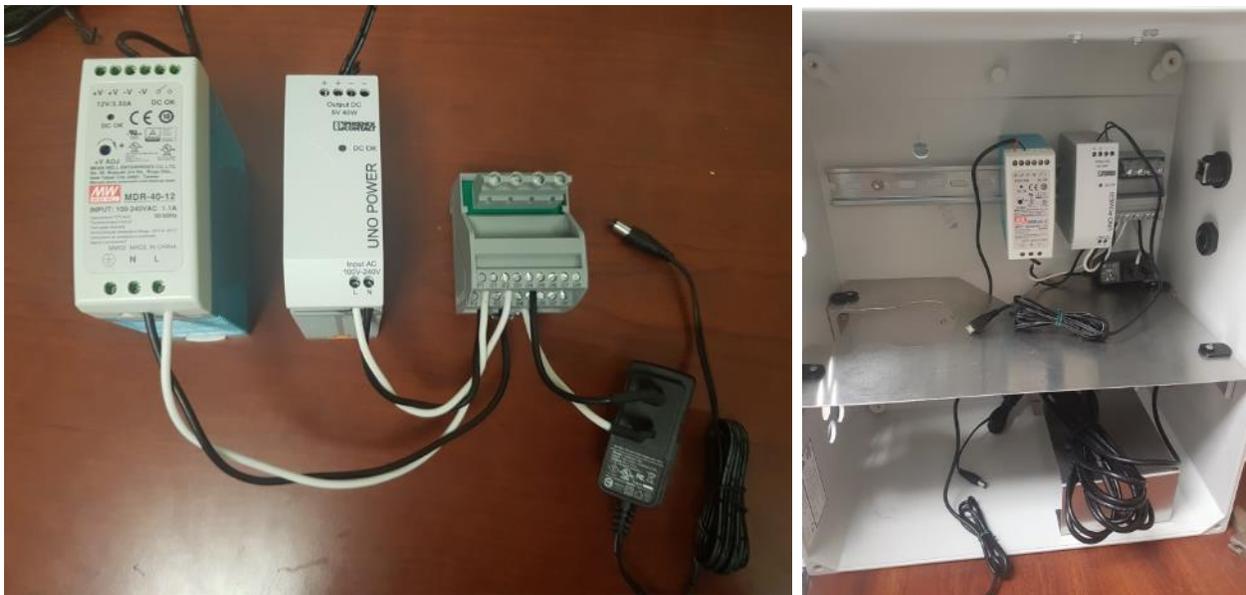
Figure 4-10. Power distribution block connected with power modules and converter (left). Connections mounted on DIN rail (right).

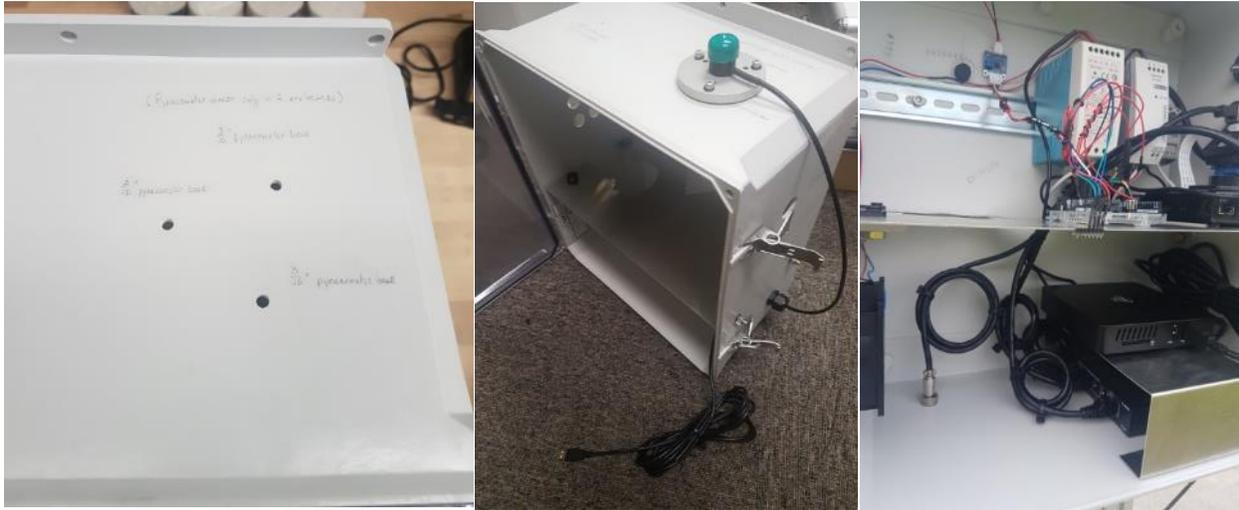
Figure 4-11. Three 3/16” holes for pyranometer attachment (left). Pyranometer locked in place and connected to Mini PC via USB cable (center). Raindrop sensor and outdoor temperature and humidity sensor connected to Arduino (right).

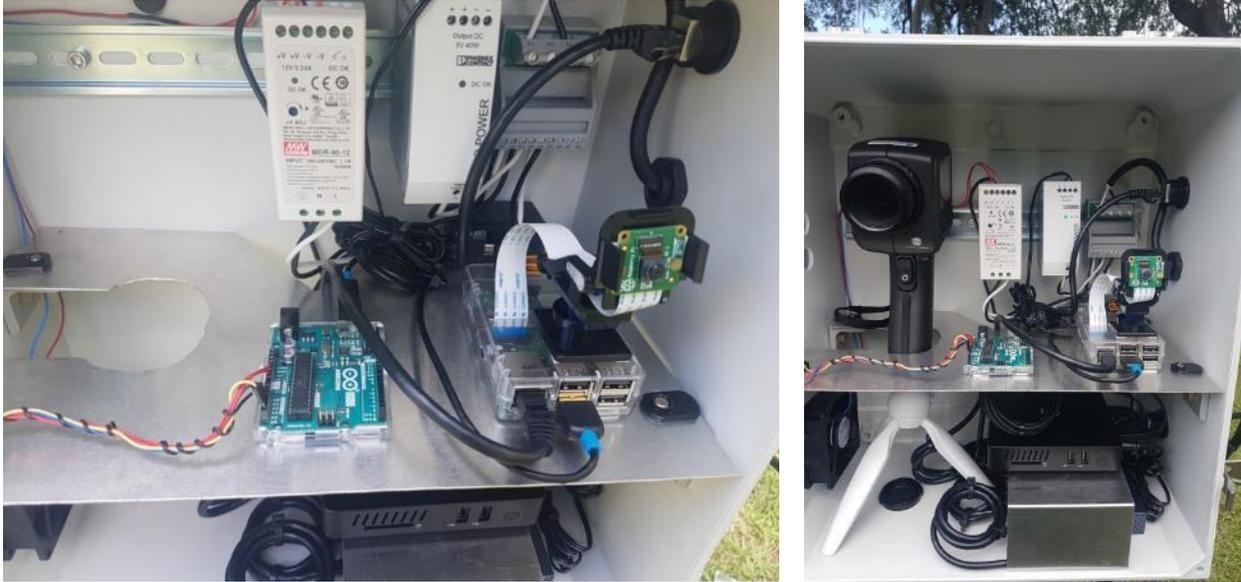
Figure 4-12. Final design on site without (left) and with luminance meter (right)

Once on site, all of the final connections were made. The Raspberry Pi, its camera, the Arduino with its sensors, and the mini PC with the switch were fixed in place with double-sided tape. The luminance meter was screwed into the camera tripod; it was aligned, and fixed in place (Figure 4-12). To guarantee that the enclosure will stay fixed in place, it was attached to two 80/20 aluminum extrusions on the back, which were secured in two buckets filled with concrete. For

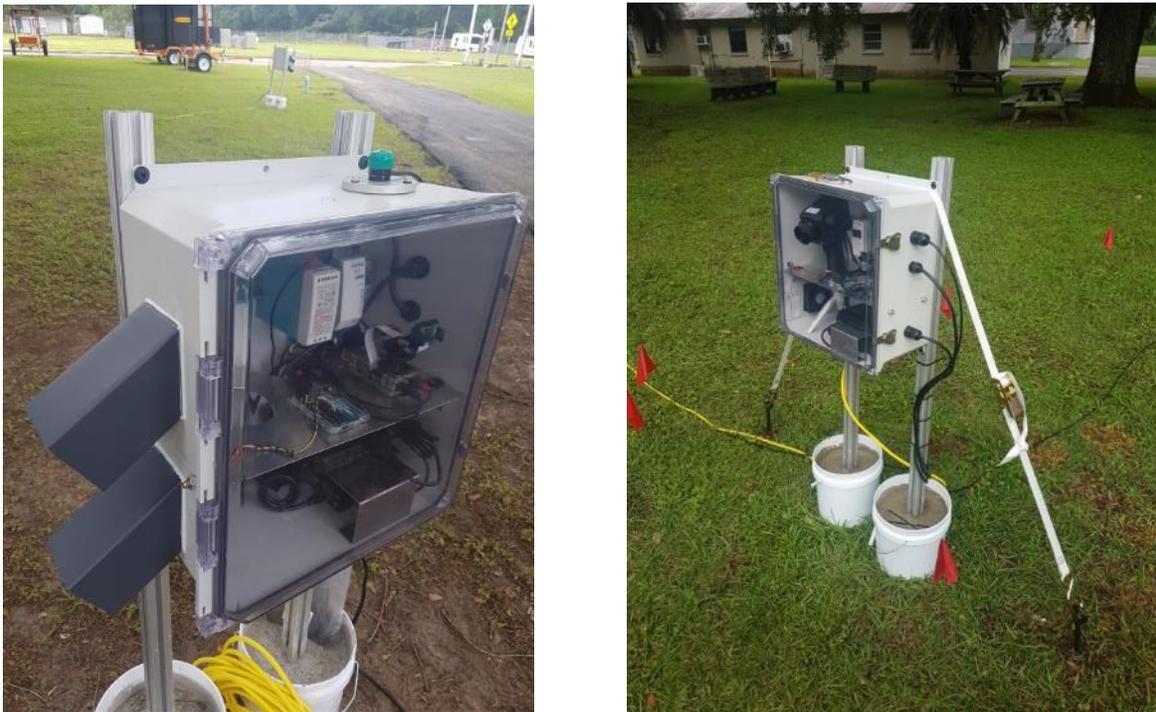
Figure 4-13. Enclosure set up with 80/20 extrusions and secured to the ground.

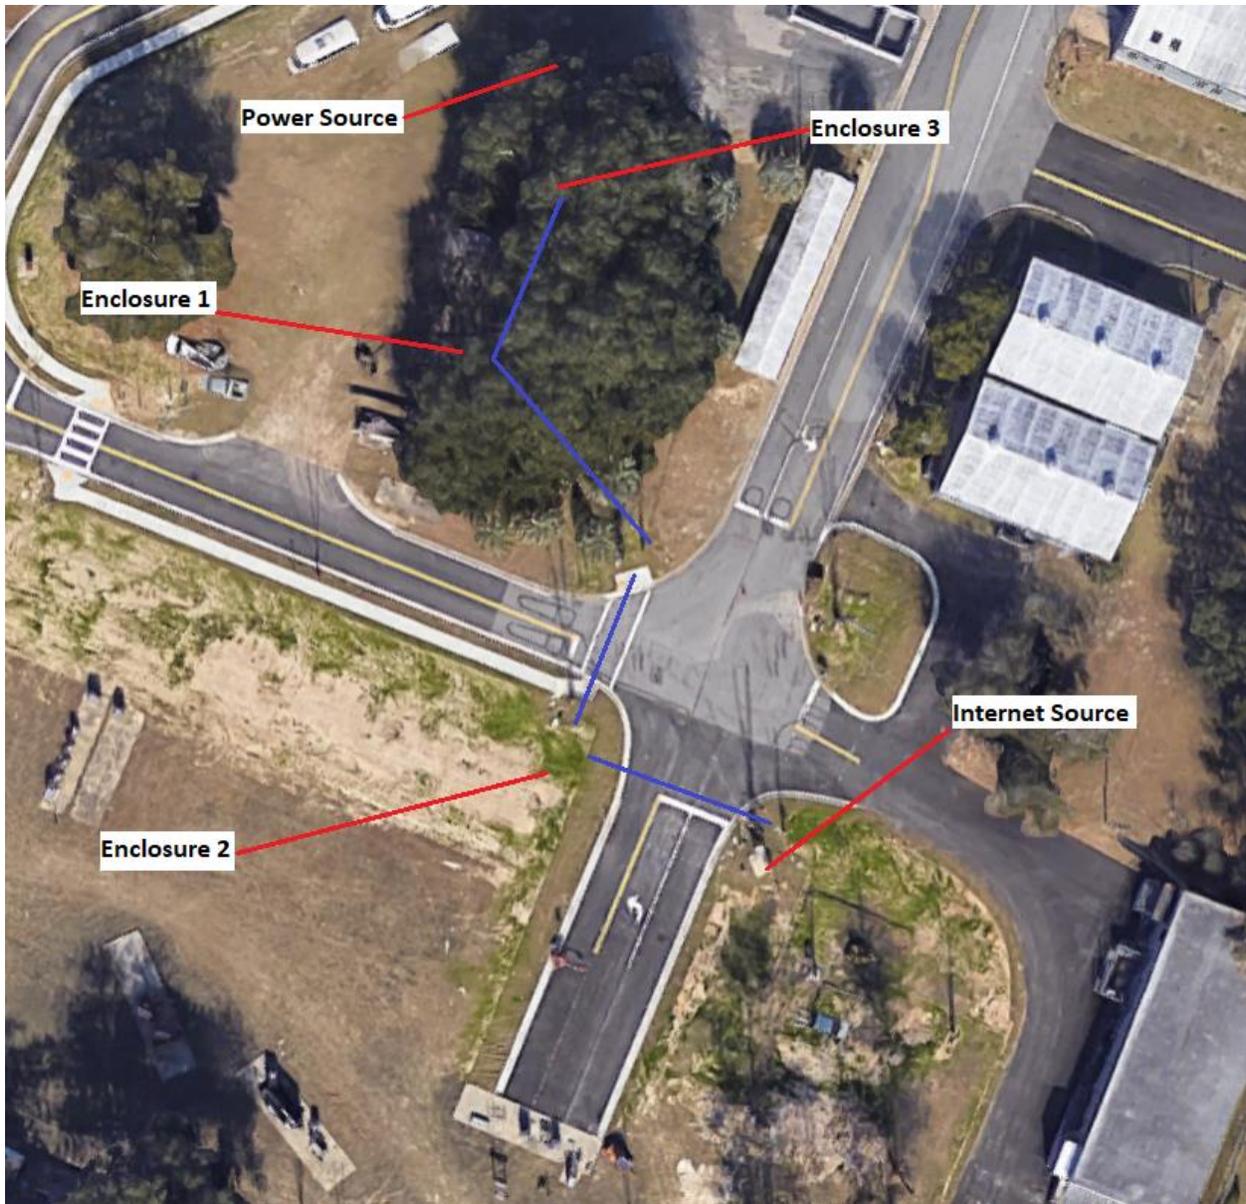
Figure 4-14. Location of enclosures on map. Blue lines denote Ethernet cables.

additional safety, all the cables coming in and out of the enclosure were attached with a strain relief loop to the 80/20 extrusion. Finally, a 10' strap secured each enclosure to the ground while attach to two 1' ground anchors (Figure 4-13). The final locations of the enclosures installed on sight can be seen in Figure 4-14 below.

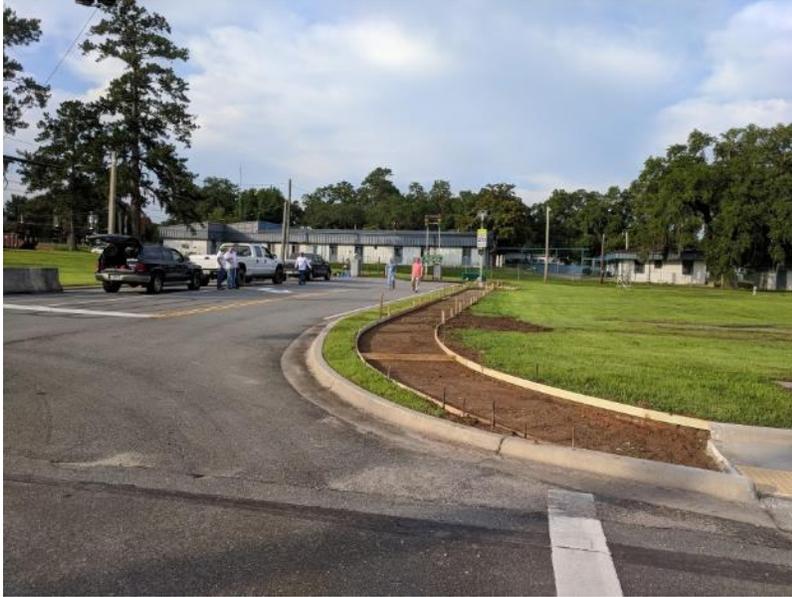
Figure 4-15. Site leveling and preparation for concrete installation

The site was first prepared and leveled as shown in Figure 4-15 below.

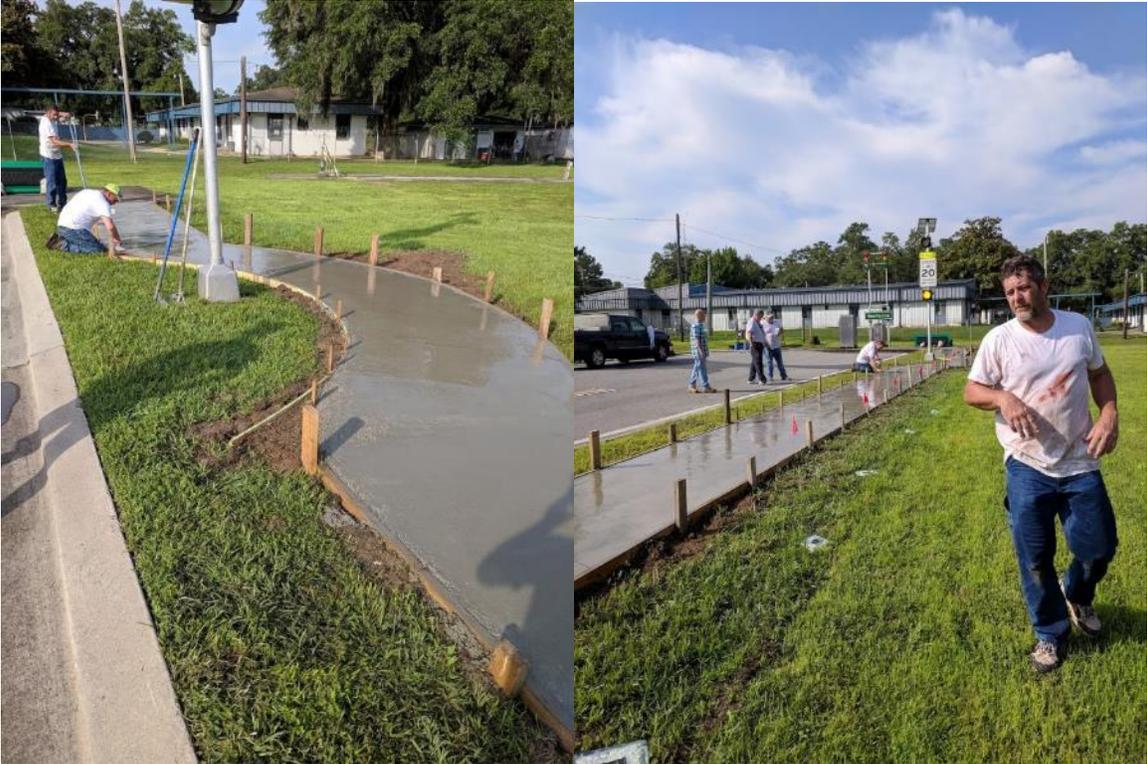
Figure 4-16. Concrete installation immediately following concrete pour and smoothing

Following that, on the morning of June 8th, the concrete was poured and then leveled as seen in Figure 4-16.

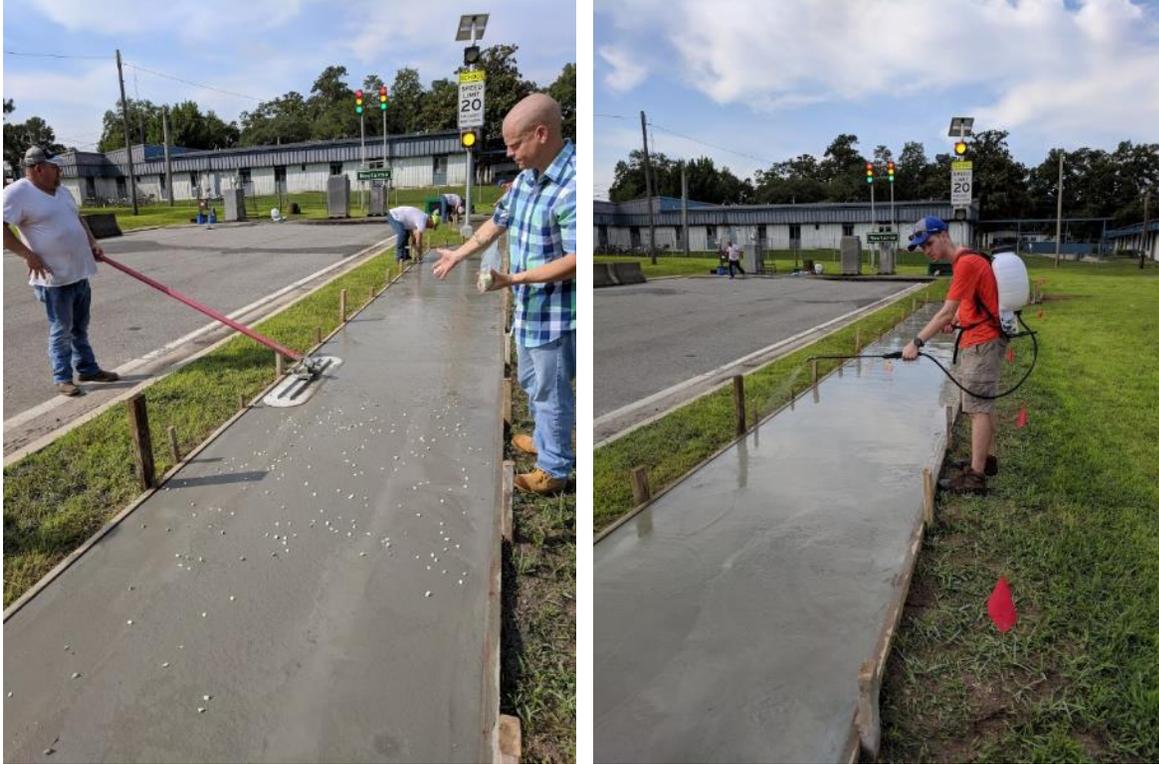
Figure 4-17. Sprinkling stones, followed by smoothing with a trowel (left) and spraying a retardant solution on the top, smoothed surface (right).

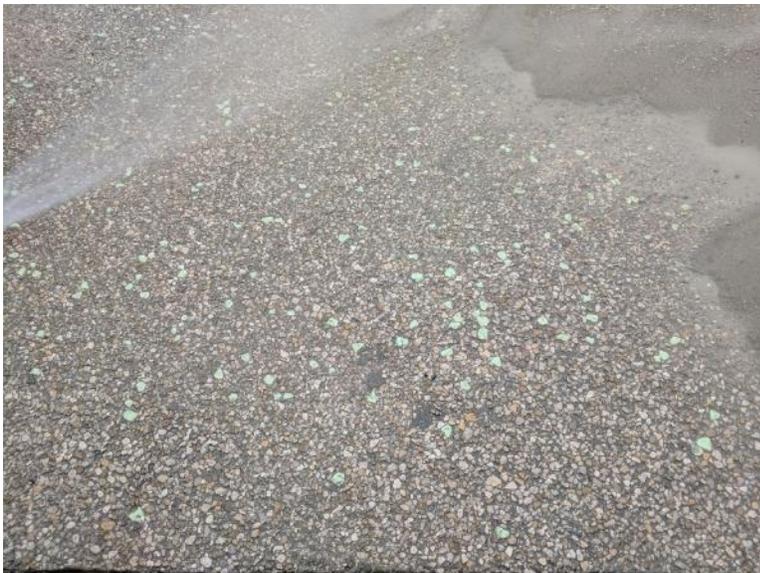
Figure 4-18. Top surface is washed away after 5 hours, revealing the exposed surface and glowing stones.

For the concrete, stones were dispersed about 15 minutes after it was poured and smoothed, and then the contractor smoothed the surface with a trowel. A retardant sugar based solution was then sprayed over the concrete surface to prevent curing, and about 5 hours later the contractor washed away the uncured surface to reveal the stones. A pictorial summary of the process is shown below.

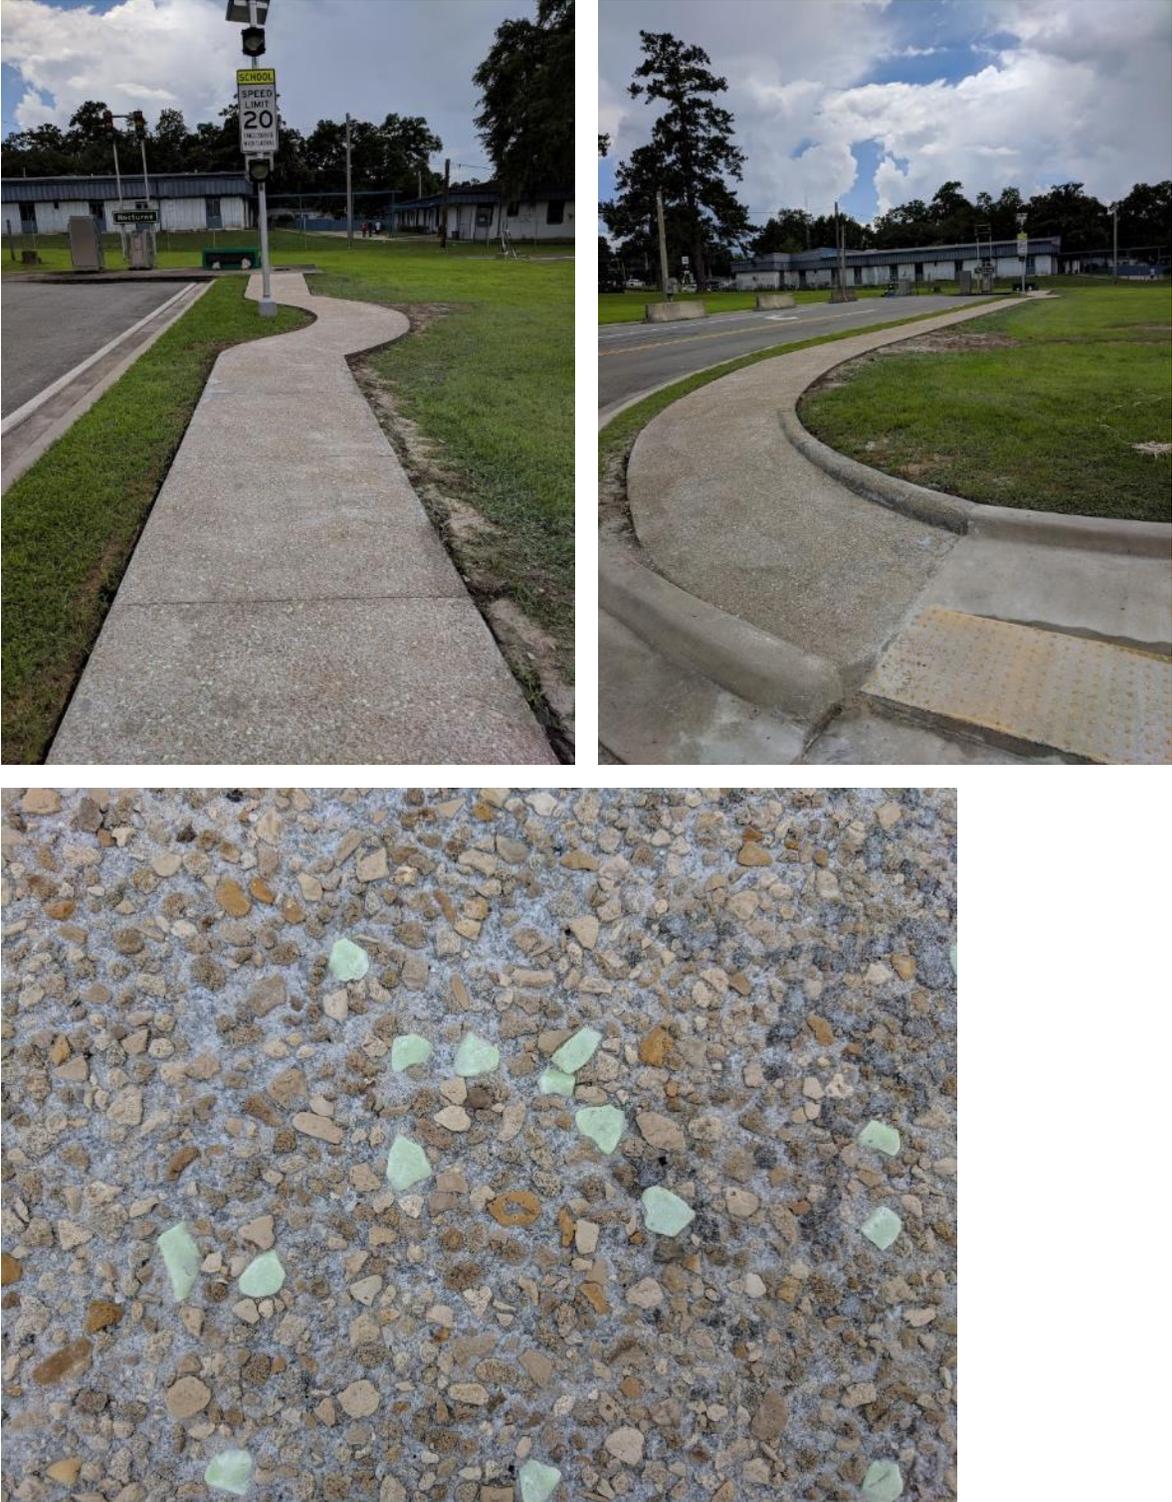
Figure 4-19. Pictures of the final concrete installation (top) and a zoomed-in image showing the exposed surface with glowing stones well integrated (bottom).

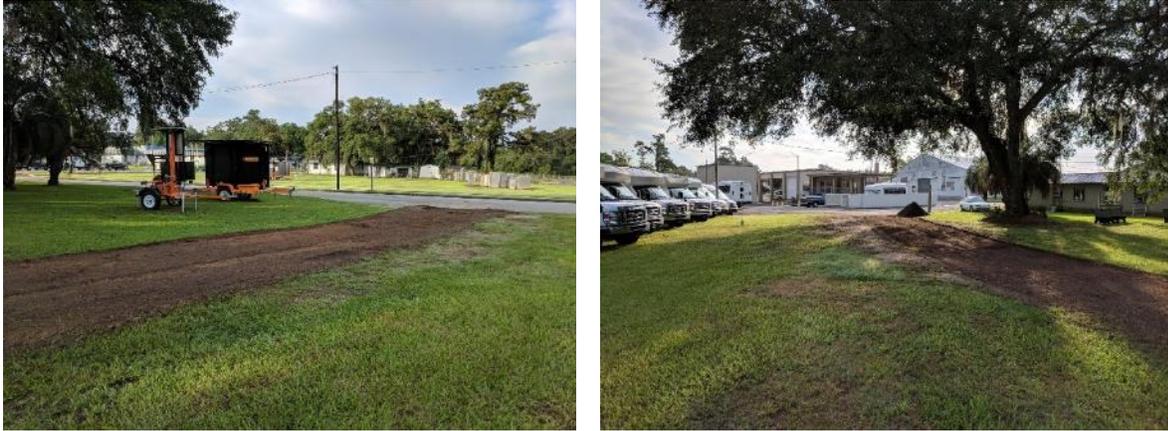
Figure 4-20. Prepped and leveled asphalt site, prior to application.

The prepared and leveled sight is shown below in Figure 4-20.

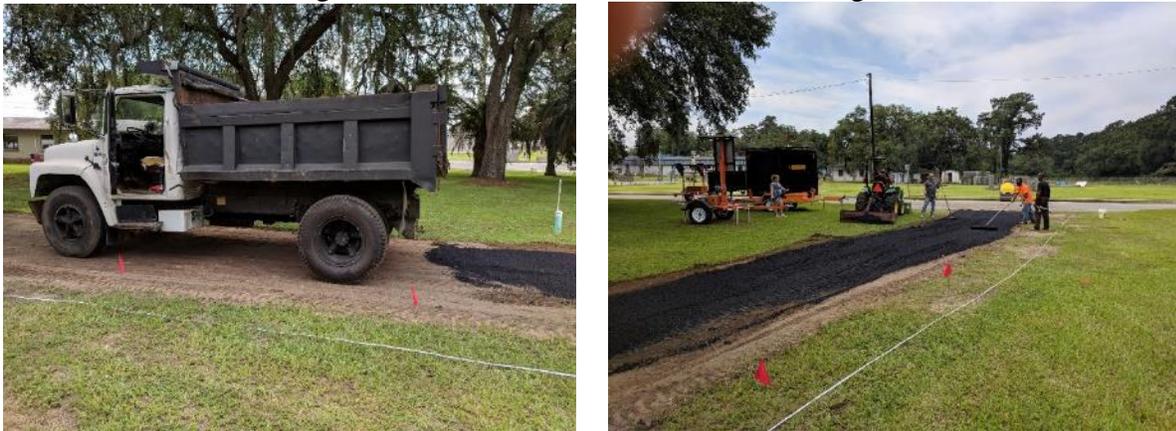
Figure 4-21. Truck used to transport and unload asphalt (left) and smoothing of asphalt by hand after unloading from the truck (right).

Asphalt was delivered in multiple batches over the course of two days because of the limited size of the truck. Below in Figure 4-21 on the left is the first batch being unloaded from the truck and

on the right the preliminary smoothing prior to rolling with the roller.

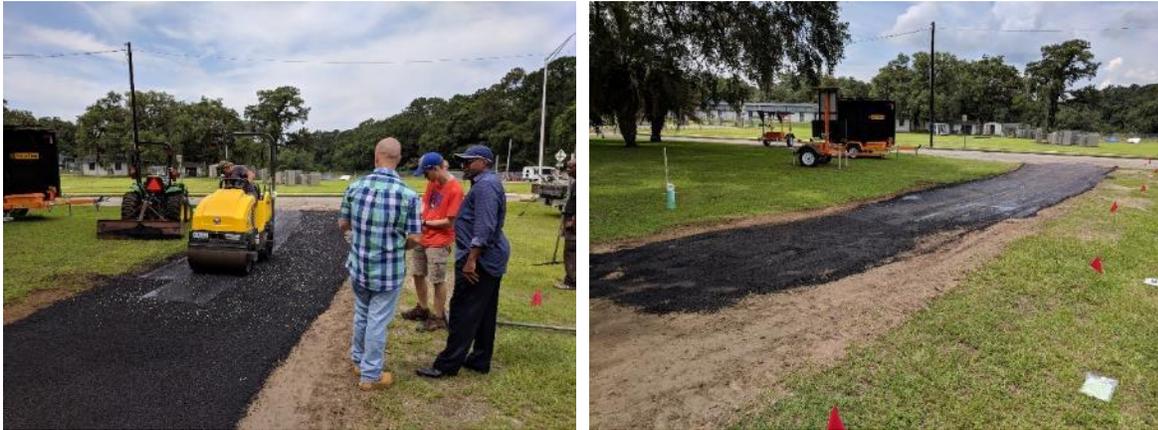
Figure 4-22. Roller smoothing asphalt with the stones integrated (left) and the asphalt after the first batch was unloaded and smoothed (right).

After manual smoothing, stones were dispersed by hand in the density mentioned prior and the results after the first rolling are shown below in Figure 4-22. As seen in the right figure, the end of the section was very thin. There were several miscommunications with the contractor about where to stop depositing stones. As a result, many were deposited in these thin layers that the contractors subsequently paved over to increase asphalt thickness, resulting in a smaller portion

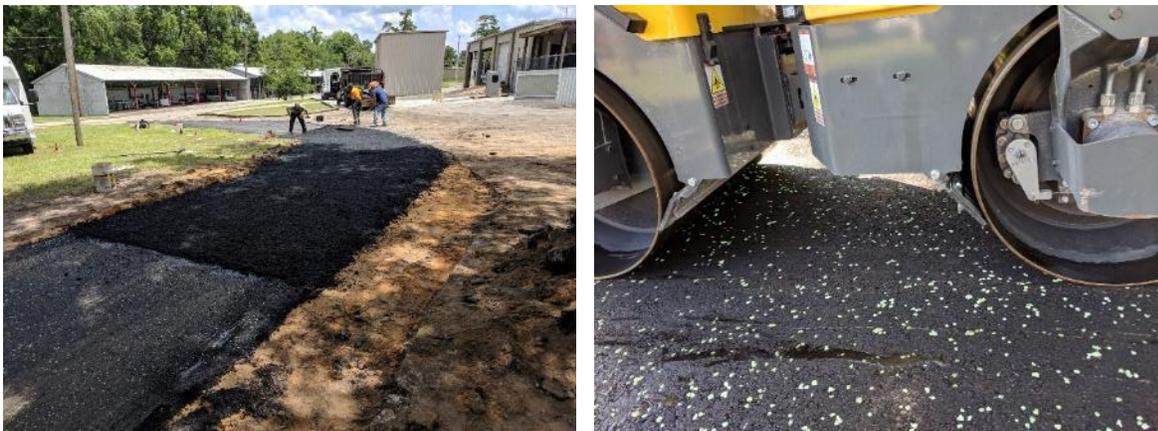
Figure 4-23. Contractors smoothing the last section of the installation (left) and a glimpse of the embedded stones underneath the smoother (right).

of asphalt being covered with stones than anticipated. In Figure 4-23, the last phases of the installation are shown and a glimpse of the stones under the roller where you can see a faint glow is shown.

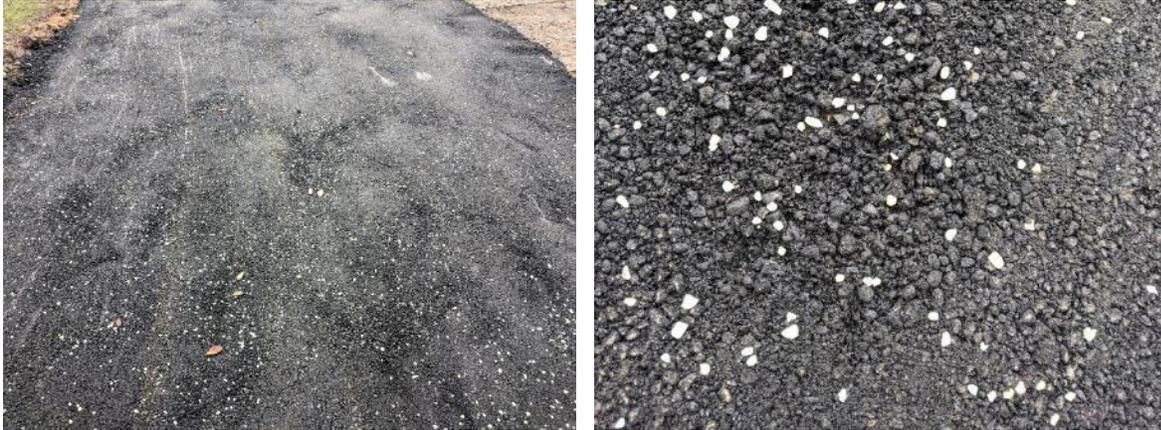
Figure 4-24. Zoomed-out images showing the “cold-rolled” areas that do not look homogeneous (left) and a zoomed-in image of one of these areas (right). In the “cold-rolled” sections the stones were not embedded well (right).

Overall, the stones were well embedded in the asphalt but there were several poorly paved areas where the asphalt is not homogeneous. We attribute this to inferior asphalt equipment and cold-asphalt which was rolled at an un-optimal temperature according to the contractor. These inconsistencies can be seen in both of the zoomed out and zoomed in images seen below in Figure 4-24.

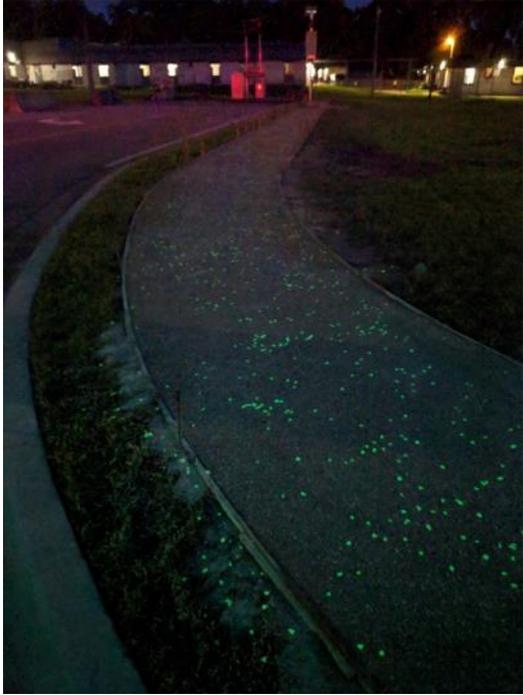
Figure 4-25. Glowing stones on the first night following installation. The surrounding ambient lighting severely hindered observation of the stones' performance.

Because of the high degree of ambient lighting at TERL, the glowing installations did not stand out as much as we anticipated based on our laboratory scale experiments in a perfectly dark enclosure. Results during the night of the concrete (Figure 4-25) and asphalt (Figure 4-26) installations can be seen below. It proved to be difficult to obtain nice images unless immediately next to the installations which could result in difficulties obtaining high quality time lapse images and relevant luminance data. We aim to work with TERL to try and schedule nights when lighting can be decreased or even turned off. Further, we may have to change the position of our cameras to be placed more immediately on top of the installations than they are. This may require new cameras that are stable outside of the electronic enclosures we designed.

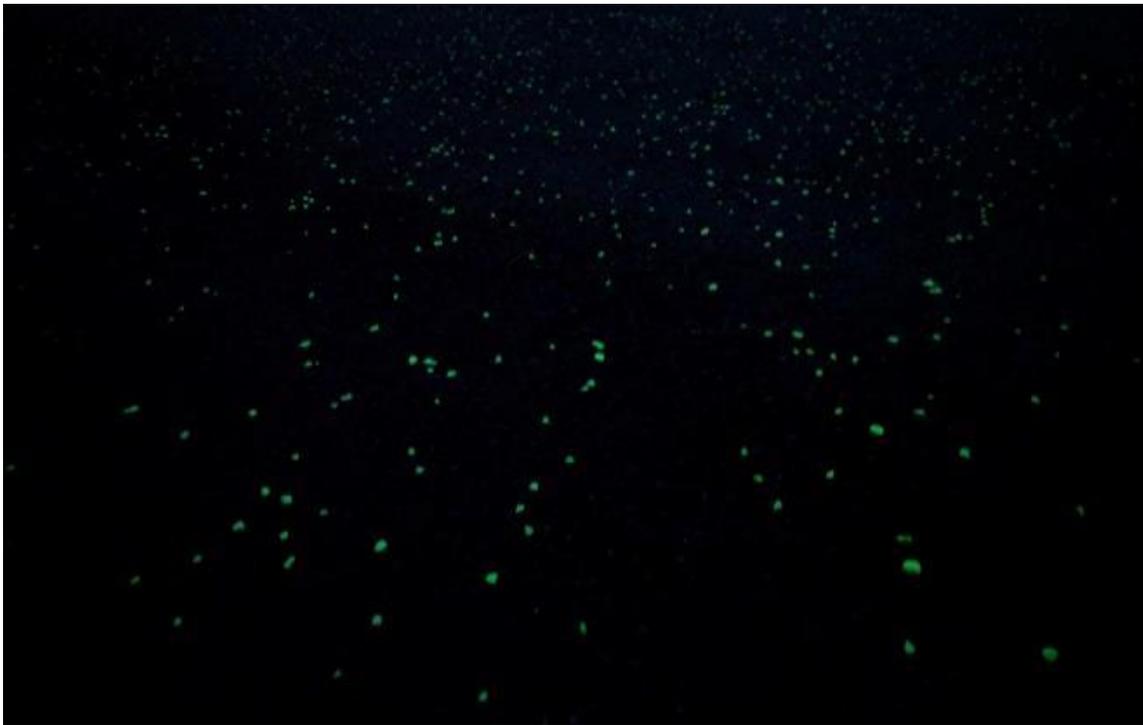
Figure 4-26. Glowing stones embedded in the asphalt. Like the concrete installation, these proved to be difficult to observe from afar because of the surrounding overhead lighting.

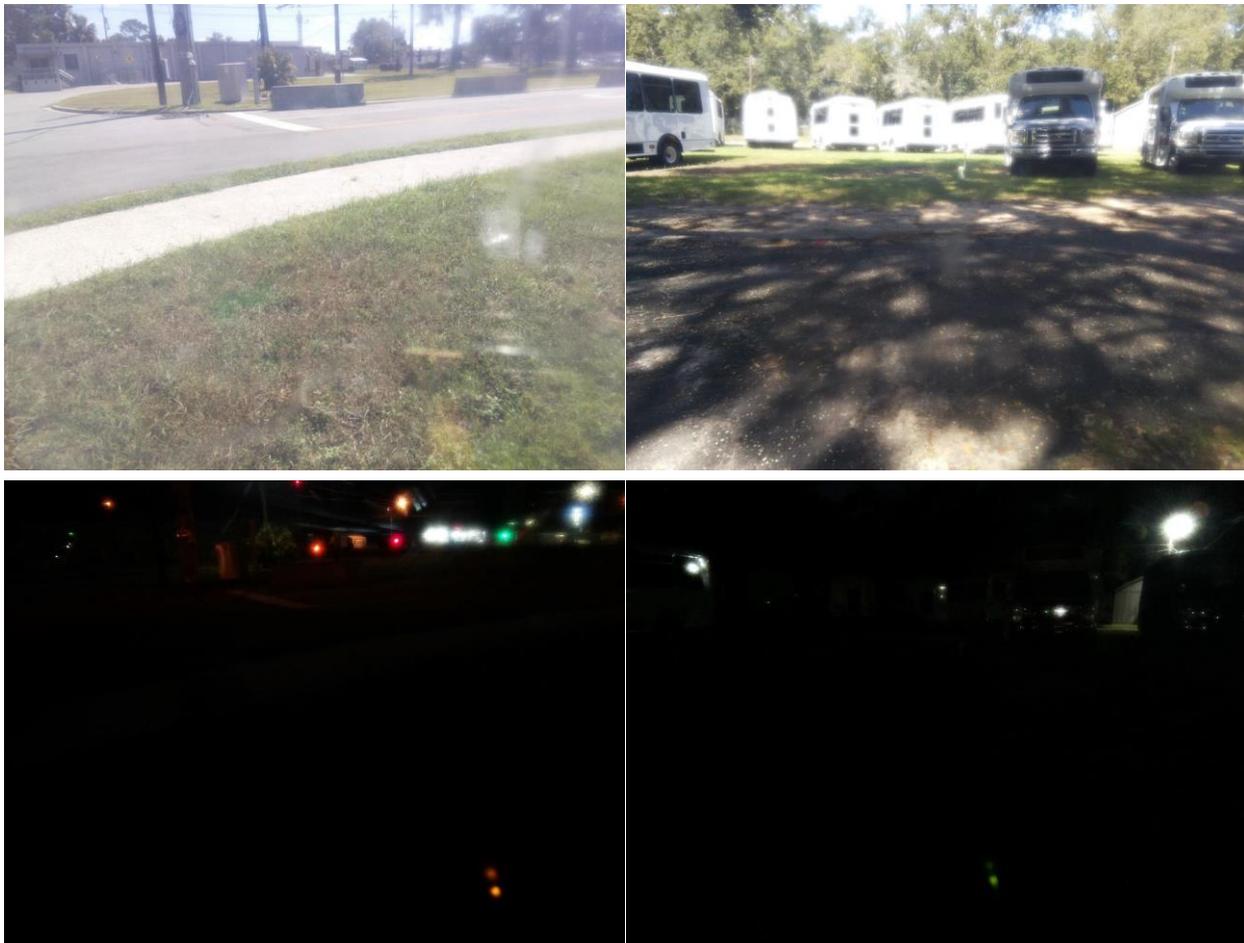
Figure 4-27. Raspberry Pi time-lapse photographs on 10/6/2018 at 12 pm (top images) and 7 pm (bottom images). Images on the left are of the concrete installation, and those on the right are of the asphalt.

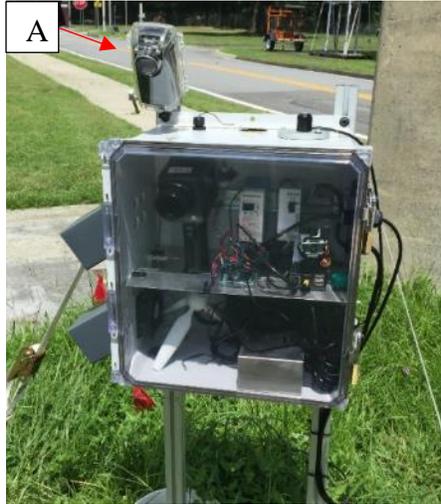
Figure 4-28. Electronic enclosure with Brinno time-lapse camera (A).

Photographs are uploaded to an SD card that must be manually uploaded to a computer by TERL staff onsite. Further, batteries need to be replaced intermittently, unlike the equipment (including Raspberry Pi Cameras) contained within the electronic enclosures. An image showing the original electronic enclosure with the Brinno time-lapse camera mounted on top (indicated with “A”) is shown in Figure 4-28.

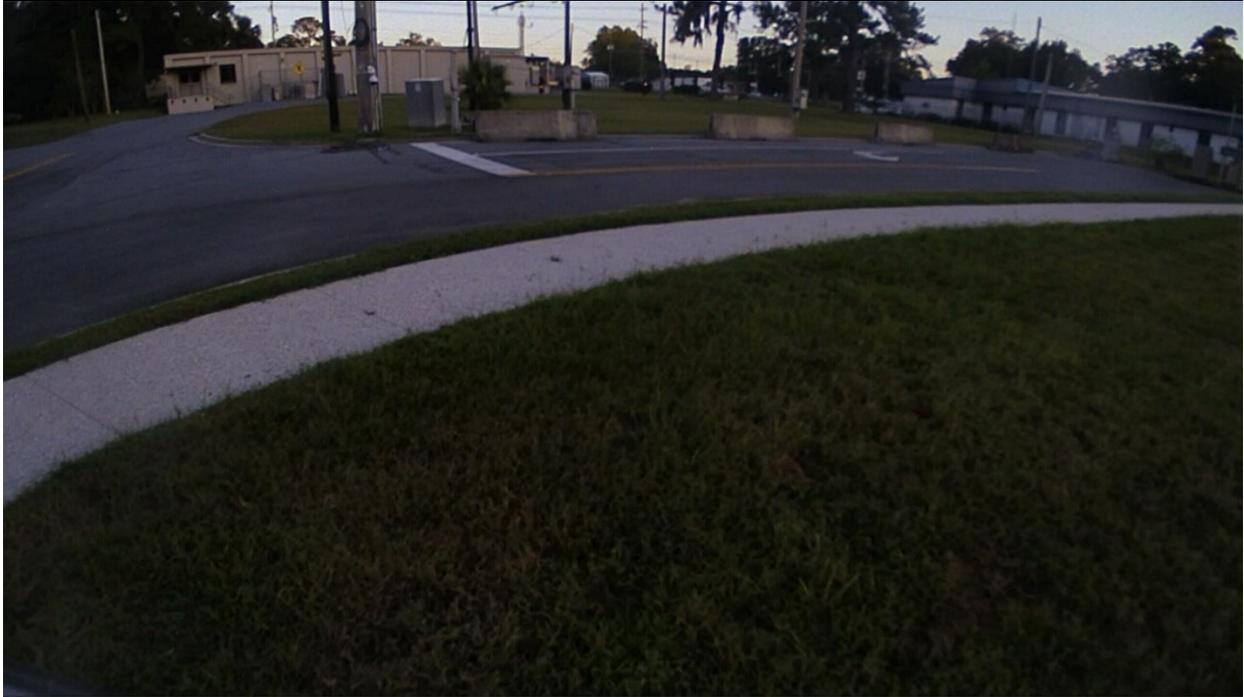
Figure 4-29. Brinno time-lapse photograph of the concrete installation at 7 pm on 10/6/2018.

These cameras proved to offer improvement over the Raspberry Pi cameras. Shown in Figure 4-29 and Figure 4-30 are images at 7 pm (near dusk) and 8:30 pm for the concrete installation on 10/6/18.

Immediately apparent is the difference between these and the Raspberry Pi photographs at 7pm where it appeared to be very dark – this is related to the exposure setting which was decreased to limit the surrounding light. At 8:30 pm where it is sufficiently dark and the stones are glowing strongly, it is still difficult to see them however except for the shaded portion on the far left side of the image in the shaded region. Images appear slightly better for the asphalt installation where the oak tree overhead provides more obstruction from the surrounding light sources; images at 7 pm (near dusk) and 8:30 pm on 10/6/18 are shown in Figure 4-31 and Figure 4-32. While these images are an improvement over the Raspberry Pi cameras, this has still not remedied the difficulties associated with measuring luminance with the meters contained within the electronic enclosures. We have
