Design and Construction of an Integrated Solar Lighting Pedestrian Crosswalk(s) and Sidewalks with Enhanced Visibility

Master Agreement #: BDV31-977-78

Final Report

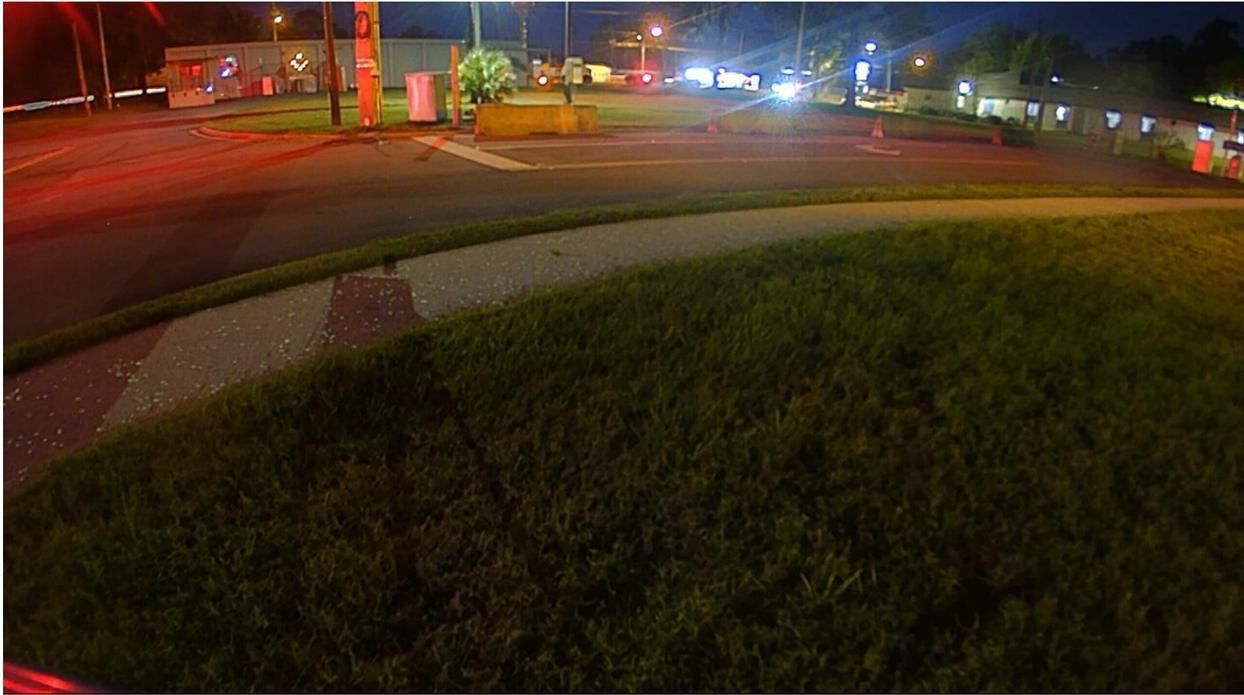
Figure 4-30. Brinno time-lapse photograph of the concrete installation at 8:30 pm on 10/6/2018.

These cameras proved to offer improvement over the Raspberry Pi cameras. Shown in Figure 4-29 and Figure 4-30 are images at 7 pm (near dusk) and 8:30 pm for the concrete installation on 10/6/18.

Immediately apparent is the difference between these and the Raspberry Pi photographs at 7pm where it appeared to be very dark – this is related to the exposure setting which was decreased to limit the surrounding light. At 8:30 pm where it is sufficiently dark and the stones are glowing strongly, it is still difficult to see them however except for the shaded portion on the far left side of the image in the shaded region. Images appear slightly better for the asphalt installation where the oak tree overhead provides more obstruction from the surrounding light sources; images at 7 pm (near dusk) and 8:30 pm on 10/6/18 are shown in Figure 4-31 and Figure 4-32. While these images are an improvement over the Raspberry Pi cameras, this has still not remedied the difficulties associated with measuring luminance with the meters contained within the electronic enclosures. We have

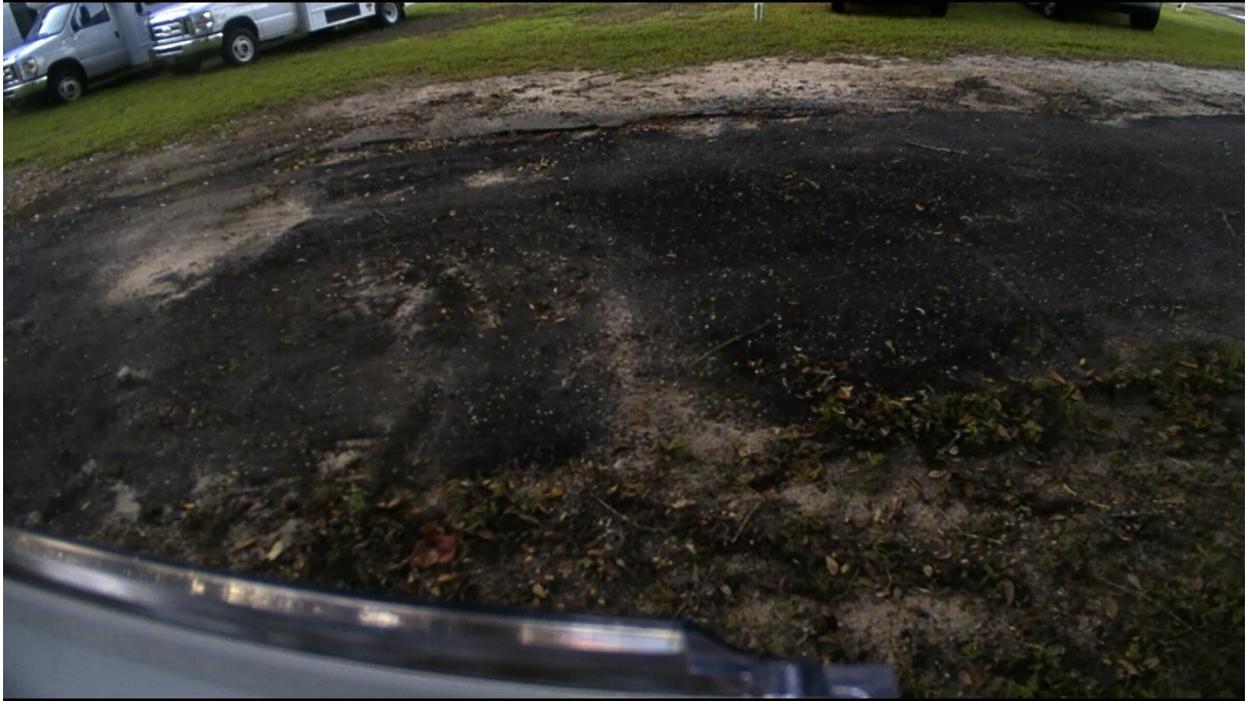
Figure 4-31. Brinno time-lapse photographs of the asphalt installation at 7:00 pm on 10/6/2018.

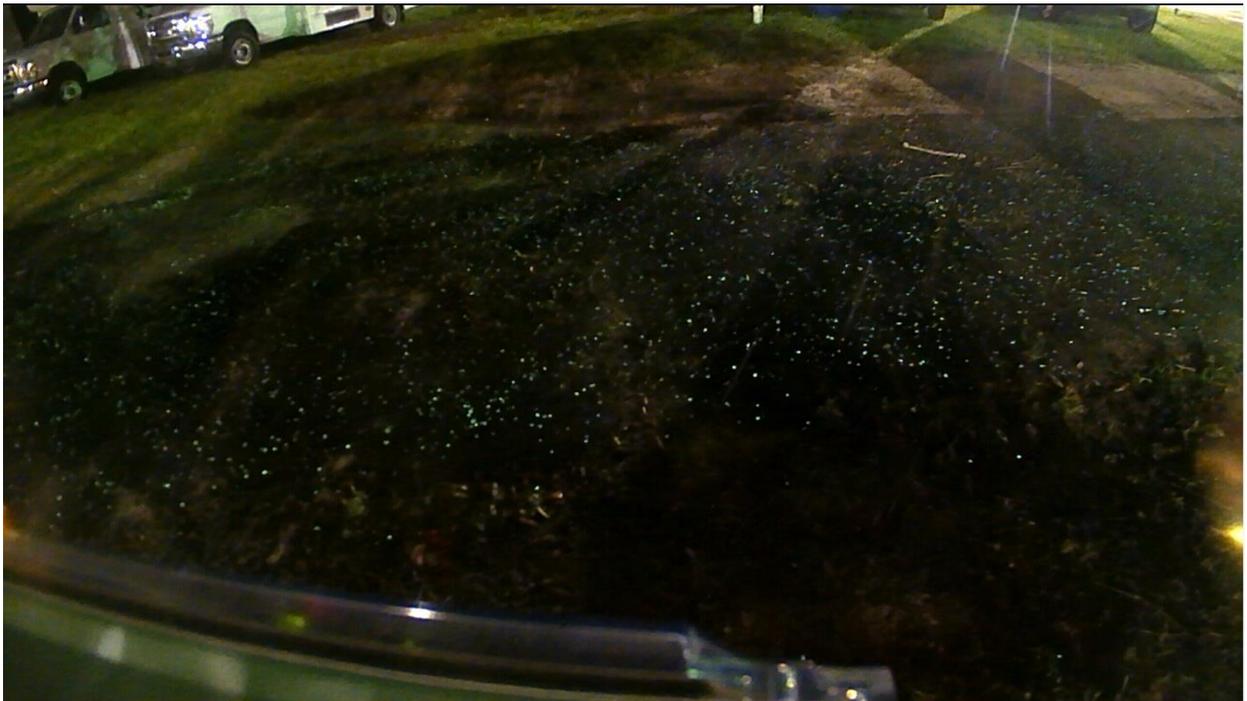
Figure 4-32. Brinno time-lapse photographs of the asphalt installation at 8:30 pm on 10/6/2018.

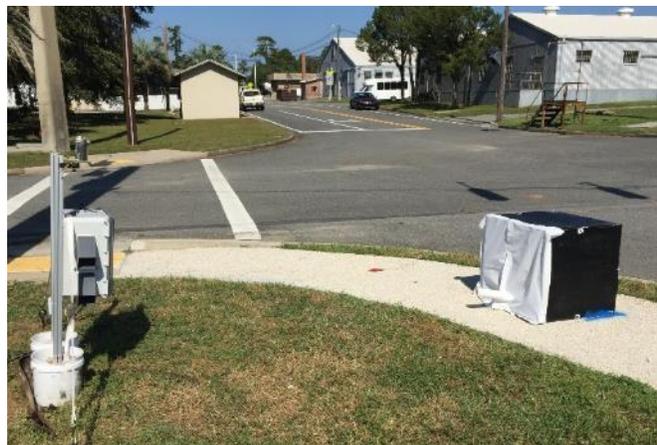
Figure 4-33. Left) Solidworks model of dark box enclosure. The only additional components to this model not shown are the blackout curtains covering the front opening that go around the PVC aperture and the time-lapse camera, which is mounted on the inside of the box looking straight down at the concrete. Right) Experimental setup at TERL facility in Tallahassee. The inner diameter of the PVC pipe is 2 inches. With a 1° acceptance angle for the luminance meter, the box can be up to 9.5 ft away and still look entirely through the PVC tube to the stones.

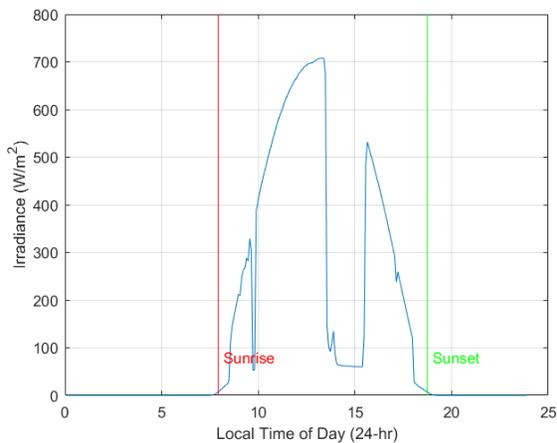
Figure 4-38. Pyranometer data captured from October 30th, 2018. It should be noted that there is a sharp decrease at around 1:30 pm and continues to around 3:30 pm due to cloud coverage.

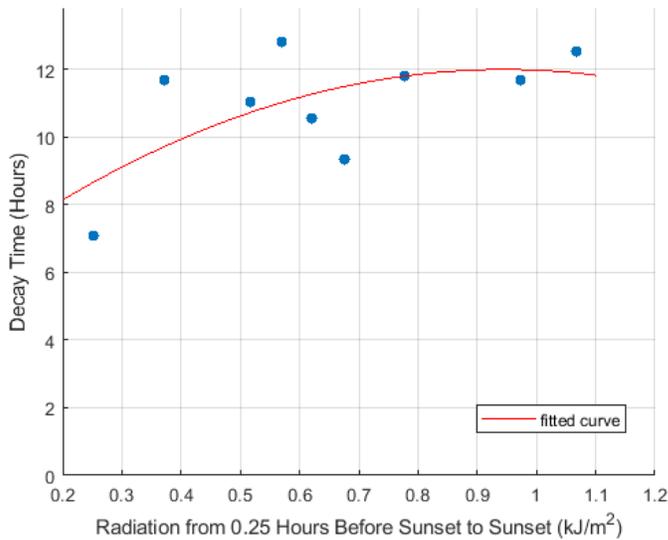
Figure 4-39. Decay time (hours) plotted against the amount of radiation received (kJ/m²) by the stones 15 minutes prior to sunset for the average pixel intensity.

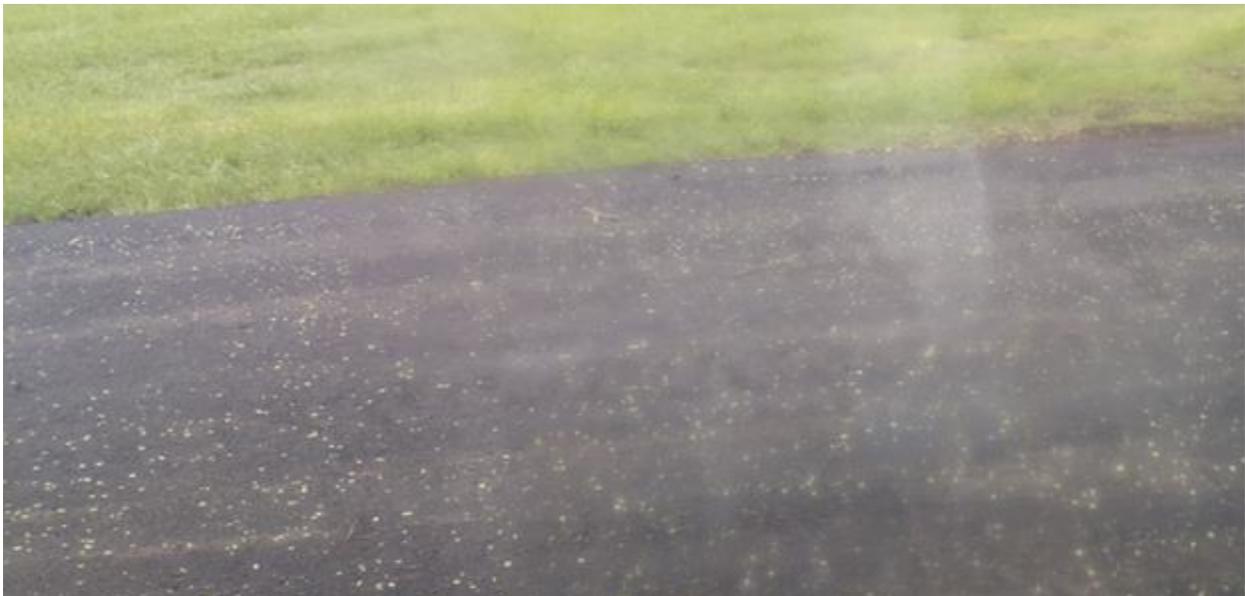
Figure 4-40. Image taken on June 15th, 2019 from within the weatherproof enclosure installed at the asphalt pathway.

Below in Figure 4-40 is a photograph from a time-lapse camera installed at the asphalt pathway taken on June 15th, near the date of construction. As seen, the stones are well distributed. Select photographs from later dates using the same time lapse camera (12/22/2018, 2/21/2019 and 4/03/2019) are shown in the following images in Figure 4-41 Overall, the images show no grossly apparent changes in the stone density. However, it is difficult to assess how well the stones are integrated into the pathway and the overall integrity of the installation because the images are taken from within a weather-proof enclosure at a distance fairly far from the pathway.

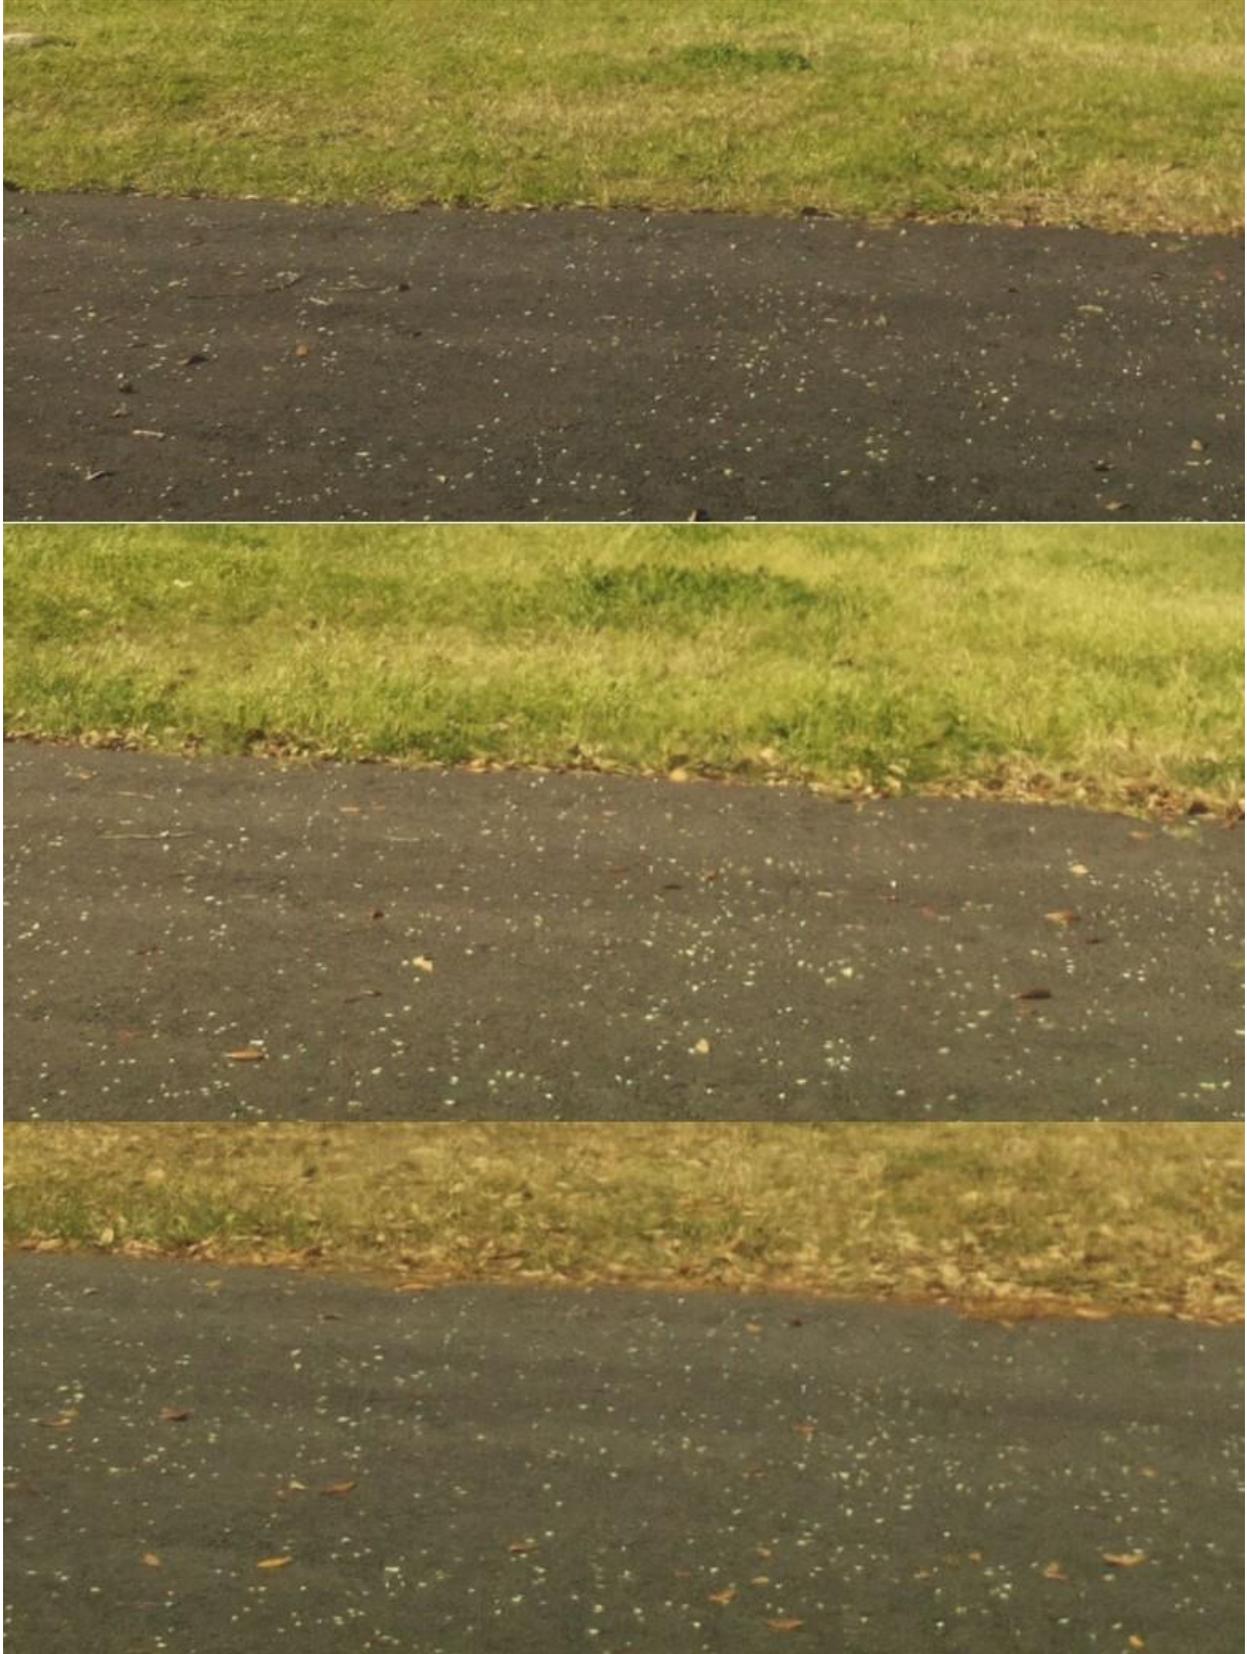
Figure 4-41. Images taken from within the weatherproof enclosure installed at the asphalt pathway on 12/22/2018, 2/21/2019, and 4/03/2019.

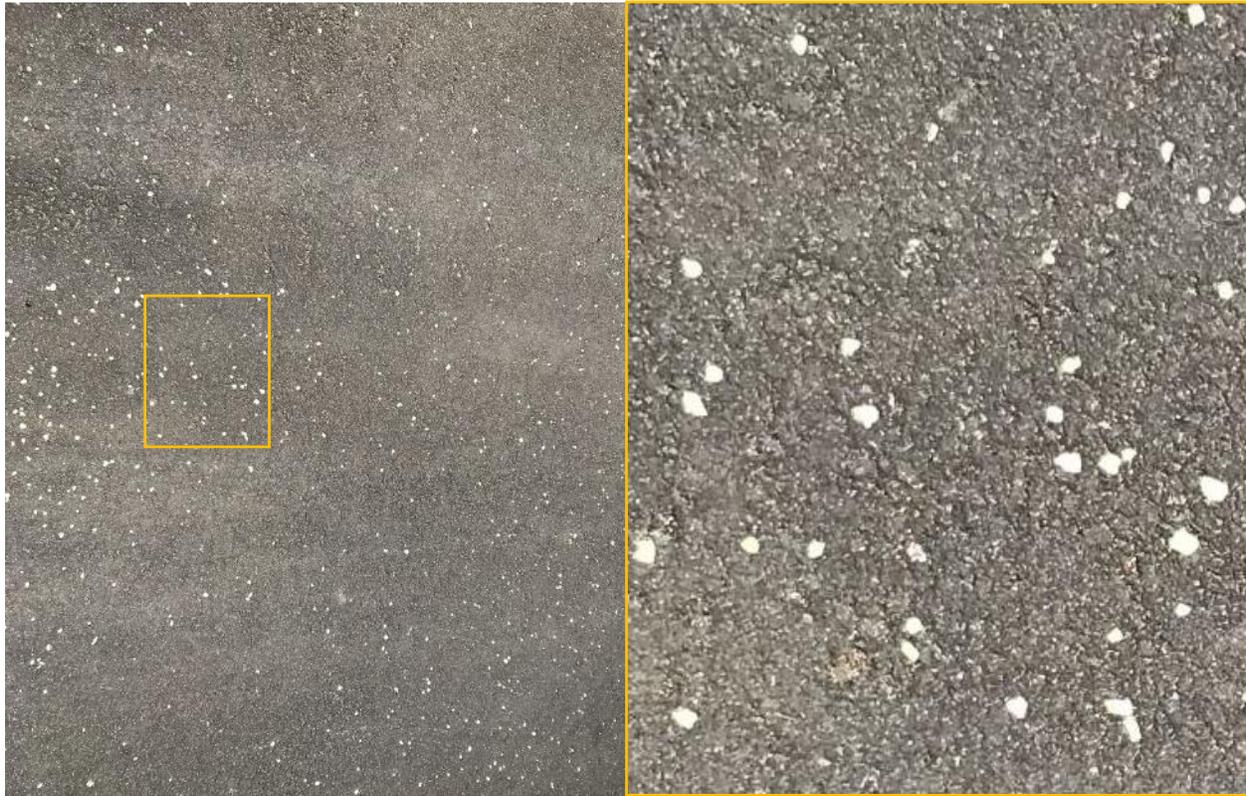
Figure 4-42. Top-down view of the asphalt installation (left). Zoomed-in image showing the integration of the stones in the asphalt (right).

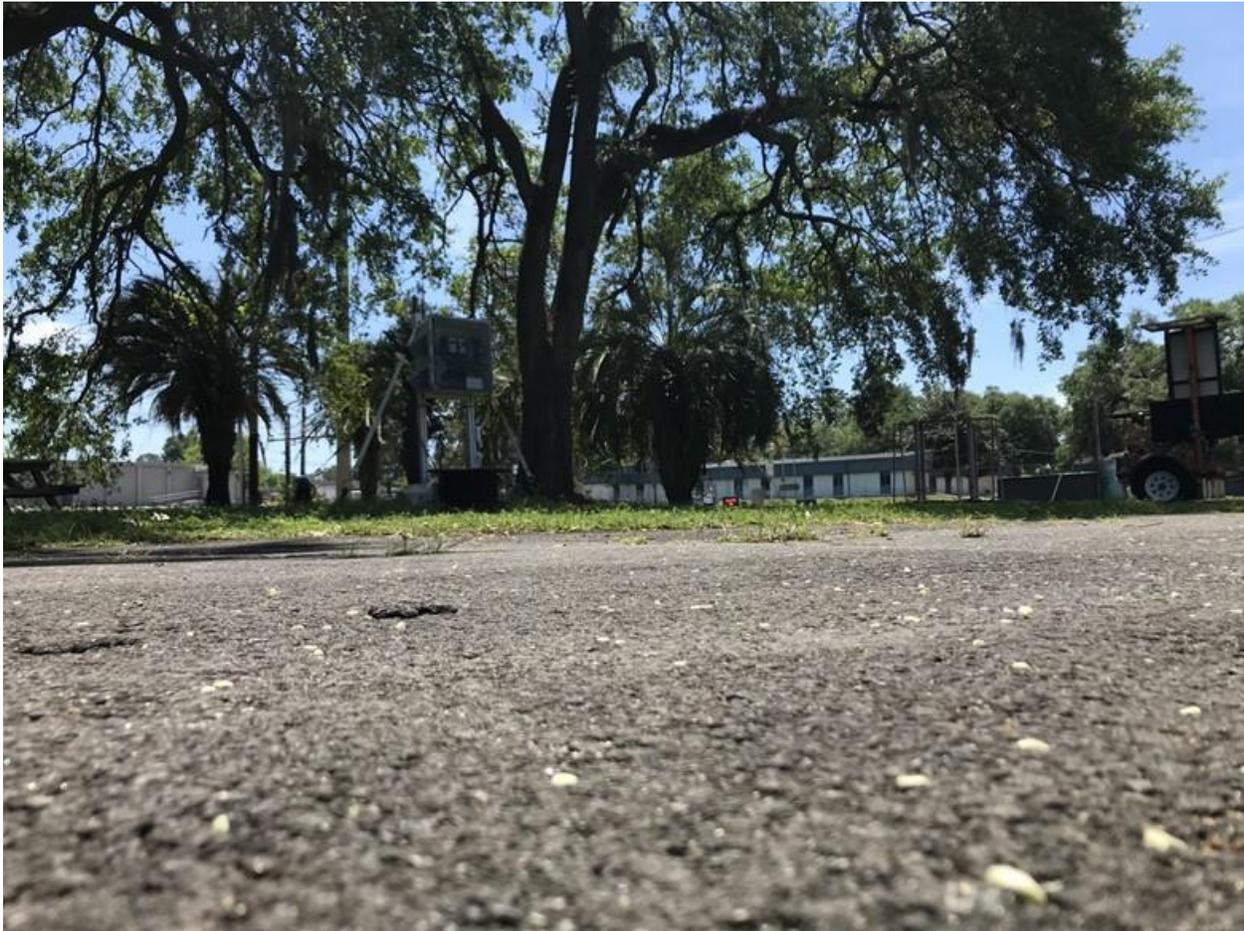
Figure 4-43. Horizontal image showing that the stone surface is level with surface of the asphalt.

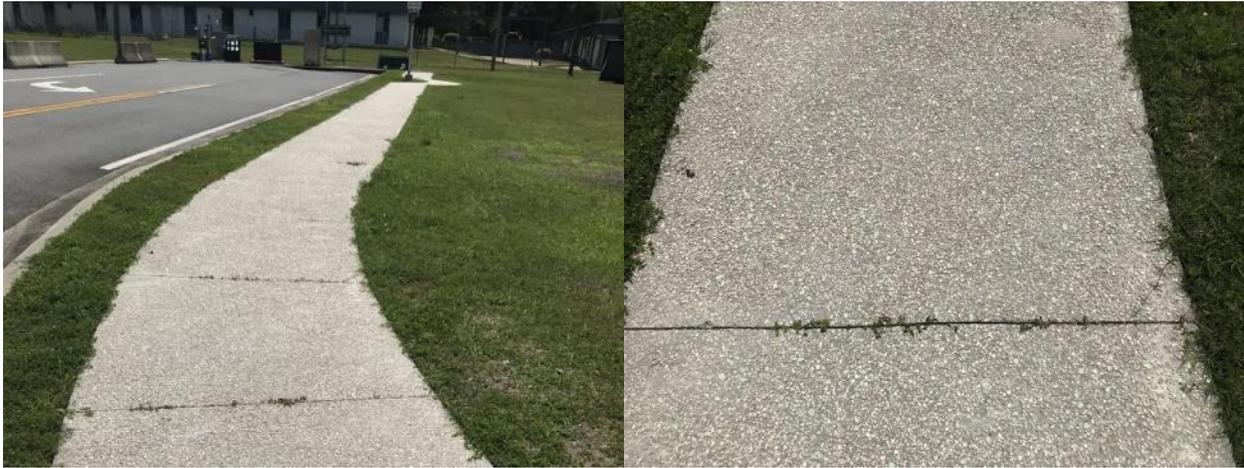
Figure 4-44. Zoomed-out images of the concrete walkway. At this scale, the stones are not easily discernable. Weeds have grown in along the edges of the concrete and within the saw cuts, but there is no noticeable deterioration of the installation.

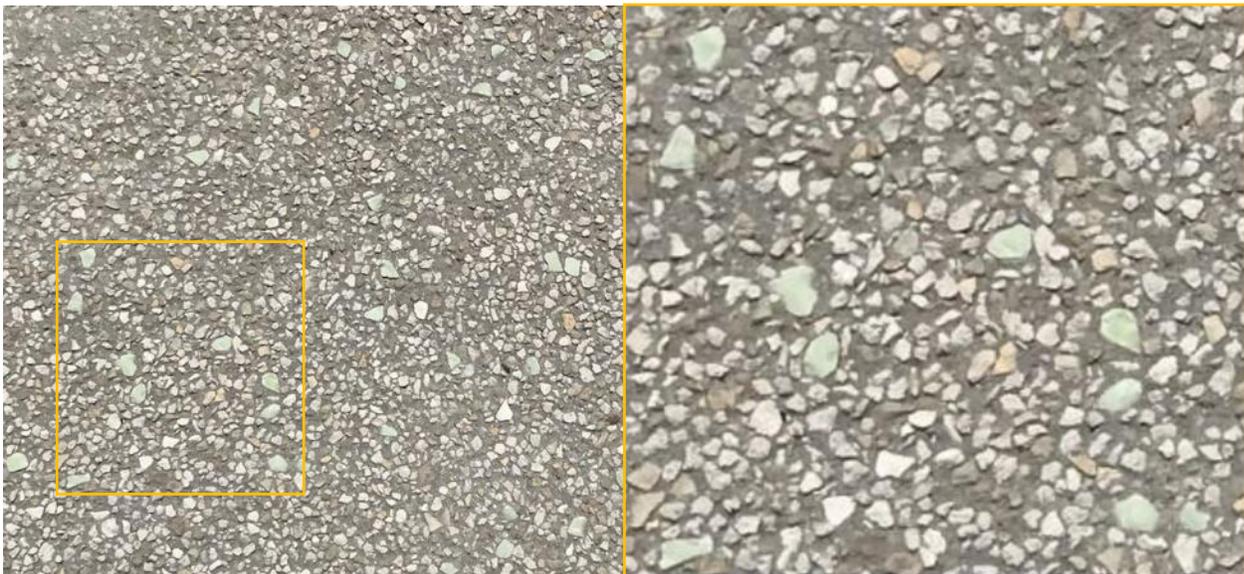
Figure 4-45. Top-down view and zoomed-in images of the concrete. Glowing stones can be recognized by their larger size, compared to the other exposed aggregate particles. Although only a single area is shown, this is representative of the entire installation. No attrition or raveling is observed, but the color of the stones has noticeably faded.

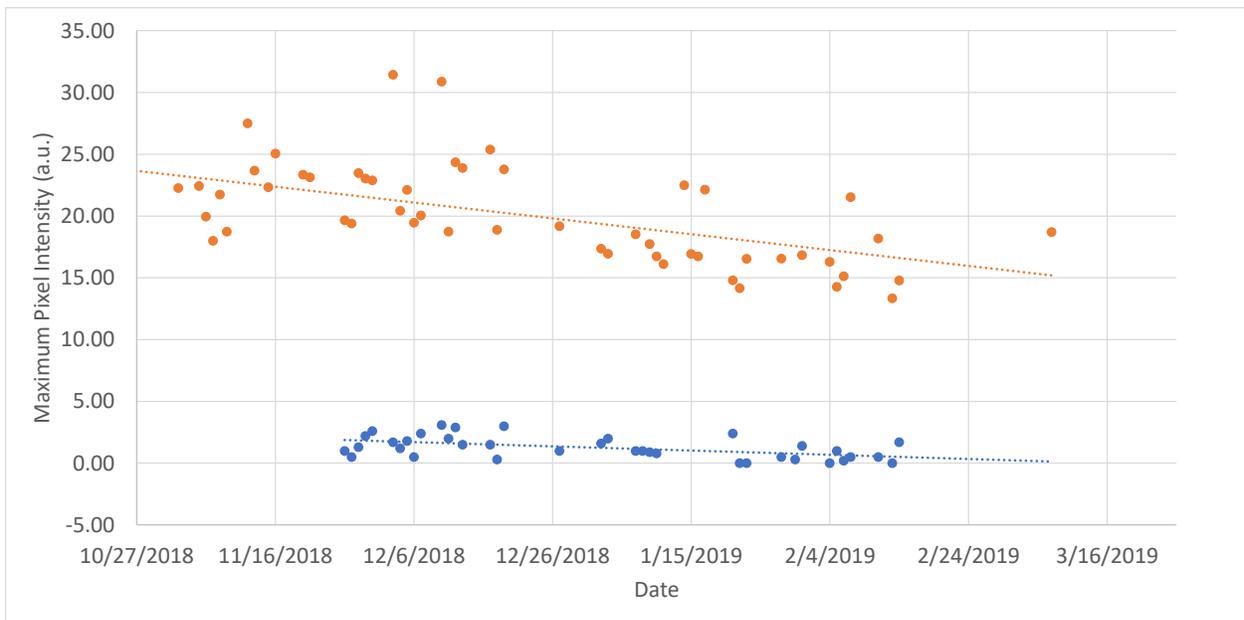
Figure 4-46. Maximum pixel intensity and pixel intensity recorded 8 hours after sunset for the stones on the concrete walkway. Orange dots represent maximum pixel intensity and blue the intensity, after 8 hours. Lines are linear trend lines for visual purposes only.

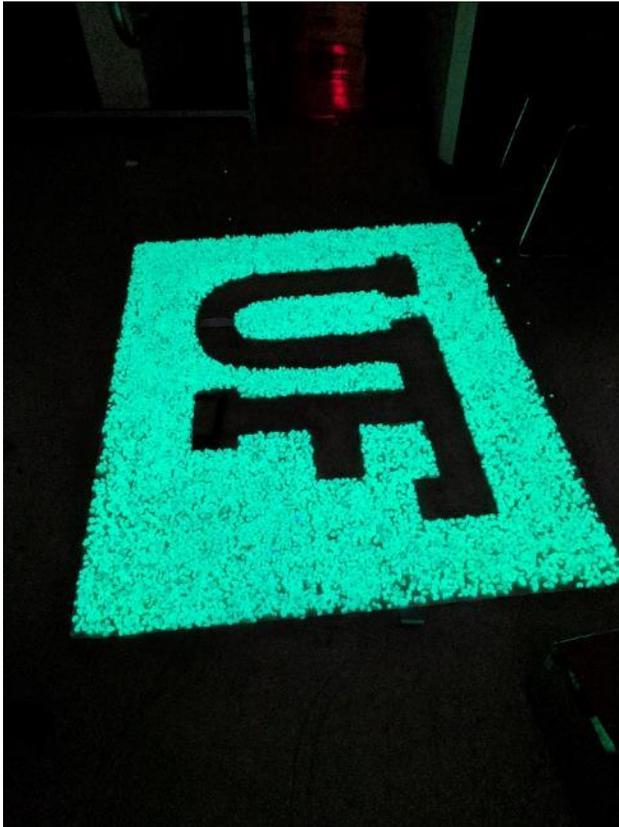
Figure 5-1. Glowing UF logo fabricated by placing Emerald Yellow glow stones on double-sided carpet tape.

logos, solid sections without logos and inverted logos over the length of the sidewalk. An exemplary pre-fabricated design of one section is shown in Figure 5-1.

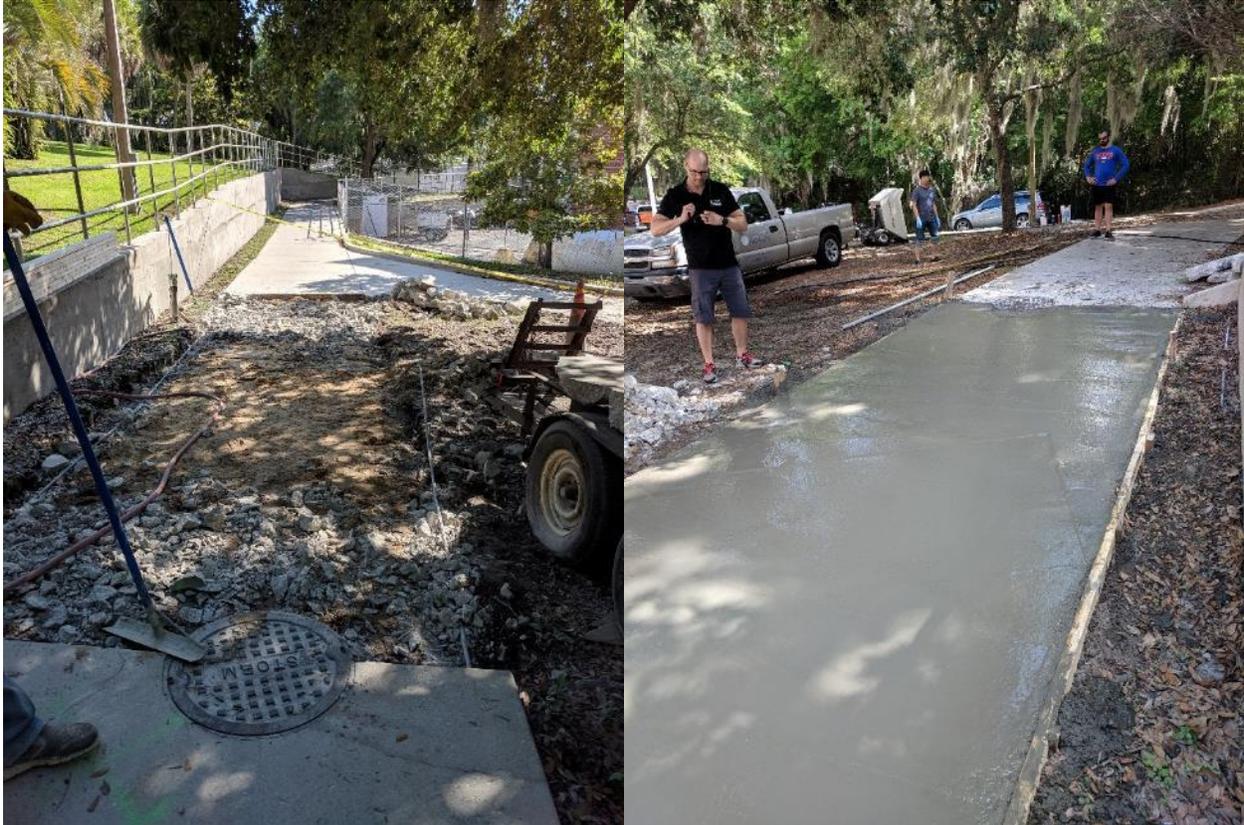
Figure 5-2. Sidewalk after removal of prior (left) and sidewalk after pouring concrete (right).

Initially on 5/5/2019 the existing sidewalk was removed in anticipation of installation the next day. Photographs after removal and after pouring of concrete are shown below in Figure 5-2. During installation the contractor determined that the large prefabricated sections were not being well integrated into the concrete. Therefore, a decision was made to flip solid sections upside down in order to ensure better adhesion of the stones with the concrete. In Figure 5-3 the contractor can be seen embedding one of the logos under the concrete and smoothing with a trowel, with alternating white sections where the carpet tape was flipped. These white sections were smoothed with the lumber to ensure good adhesion to the concrete.

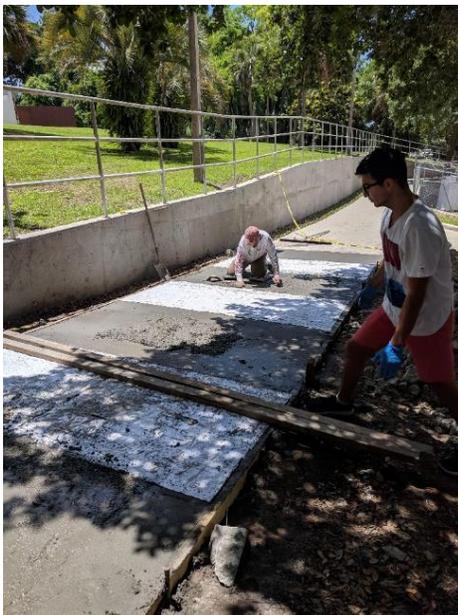
Figure 5-3. The pre-fabricated logos were placed under the concrete by the contractor. Solid sections of carpet tape were flipped, and the bottom, white side is shown. These sections were smoothed but not covered by concrete.

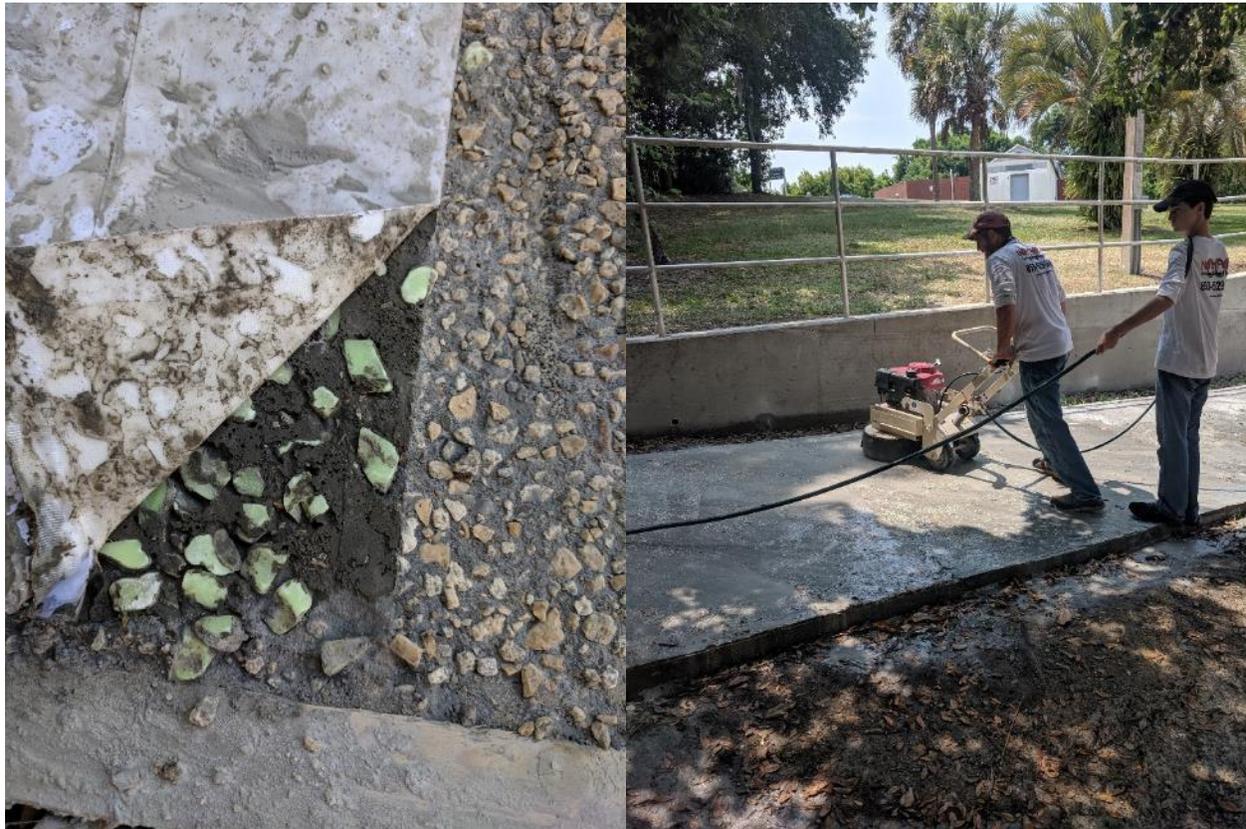
Figure 5-4. One week later, the tape backing was removed, and the stones were mostly well integrated but there were sections that did not adhere well to the concrete because it cured for too long (left). Contractor using polishing machine to smooth elevated and uneven sections (right).

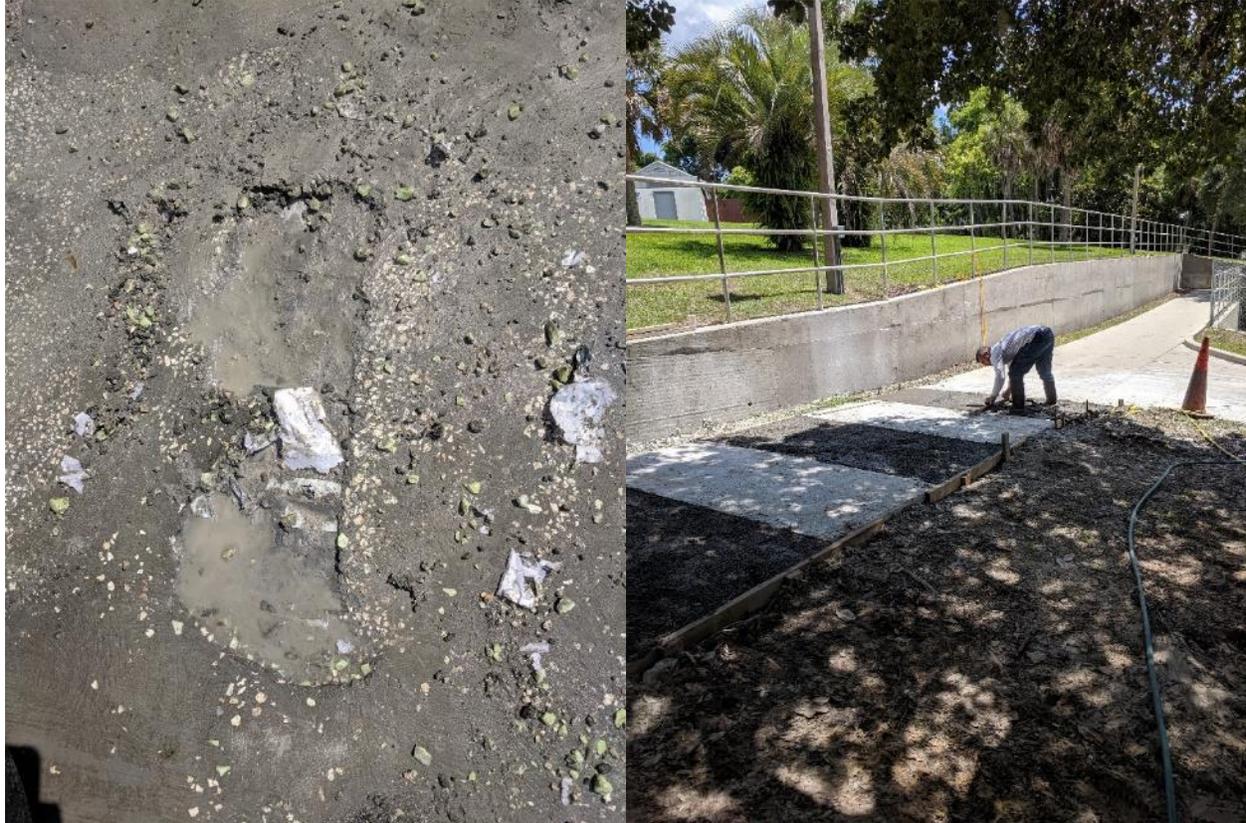
Figure 5-5. Representative image of the tape that was caught in the polishing machine (left) and freshly poured concrete in the sections with logos that were removed (right).

the contractor could fit us into his schedule. An exemplary image of the exposed tape that was caught in the polishing device is shown in Figure 5-5 on the left and the removed sections filled in with freshly poured concrete are shown in Figure 5-5 on the right.

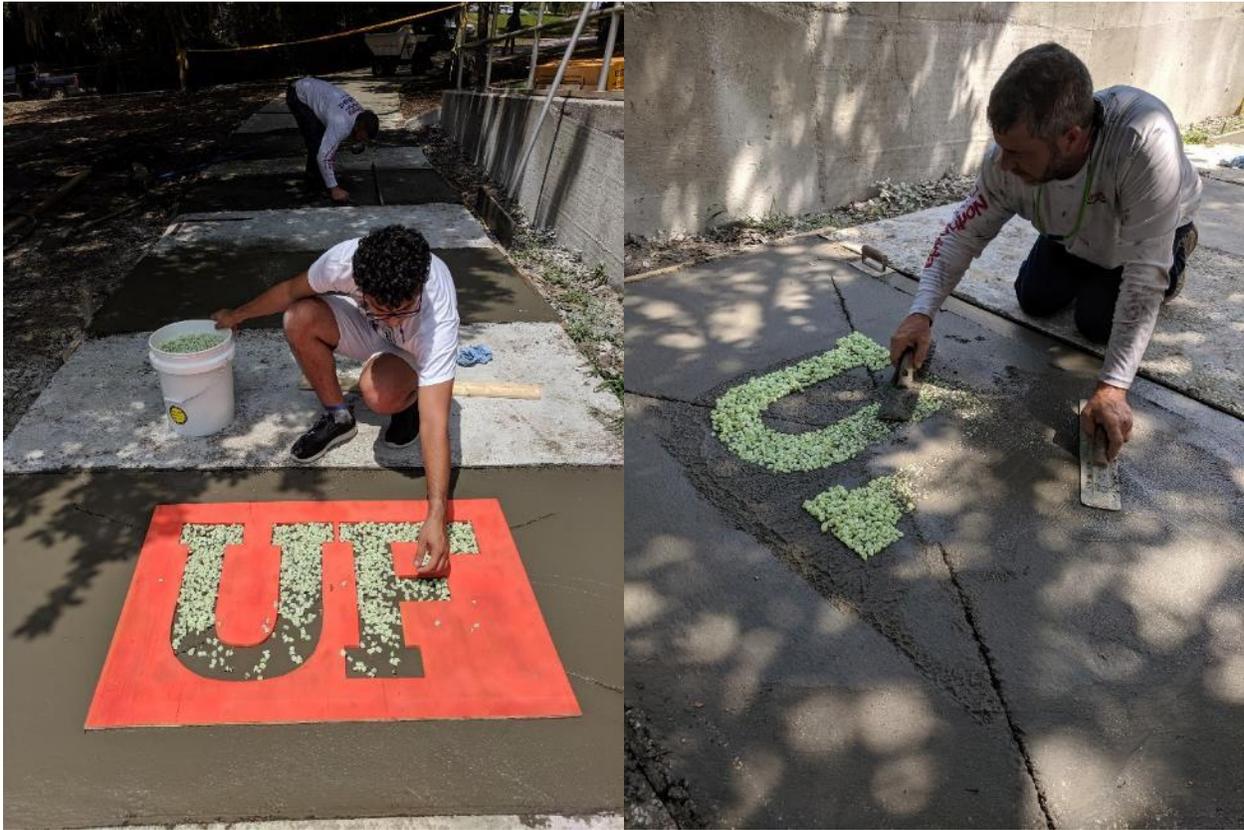
Figure 5-6. Stencil used to create the UF logo out of glowing stones (left). Contractor using a trowel to embed the stones in the concrete (right).

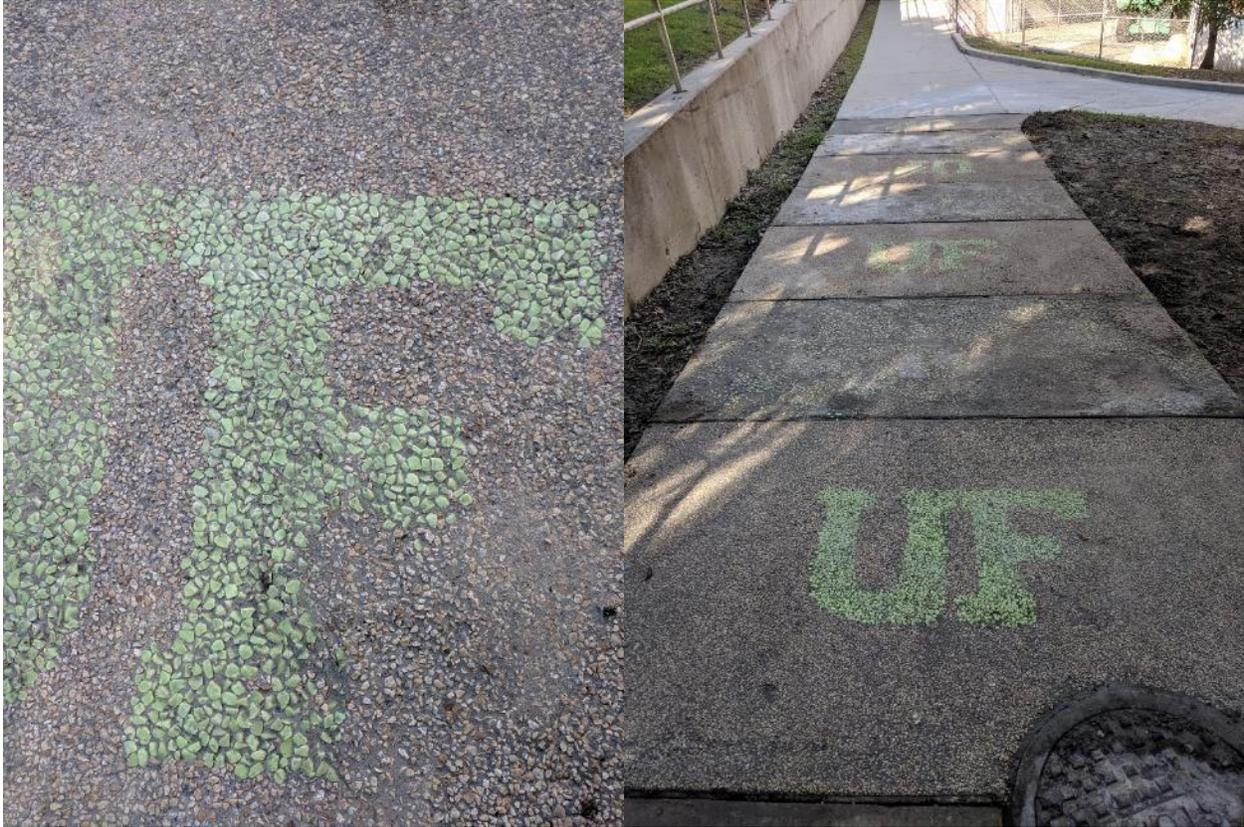
Figure 5-7. Left) Zoomed-in image of the logo after removing the top layer of concrete. Right) Image of the entire installation showing alternating logos and high density stones.

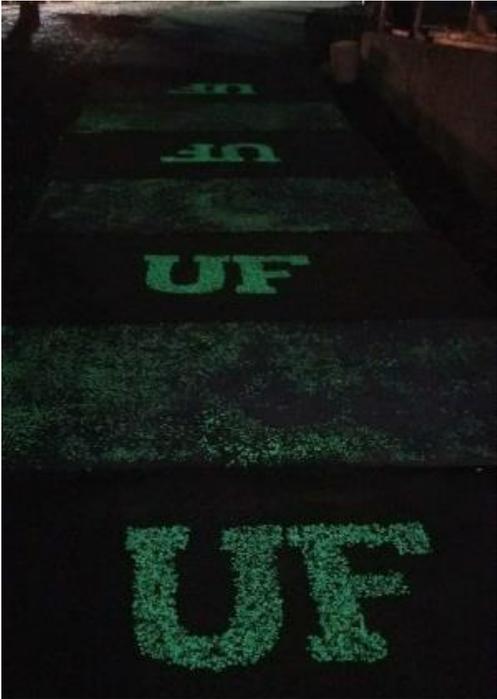
Figure 5-8. Snapshot from camera after sunset.

Time lapse images of the installation have been acquired throughout the nighttime. A snapshot of the installation soon after sunset (not edited) is shown in Figure 5-8. For anyone at FDOT who would like to see time lapse videos of the installation during the entire nighttime (sent to Ron Chin and Matt Dewitt prior), both zoomed on a logo and of the entire installation, please email me at jscheffe@ufl.edu and I will provide electronic credentials. Following this are a series of three time-lapse images of the installation near peak intensity after sunset, midnight and 3 am, respectively.

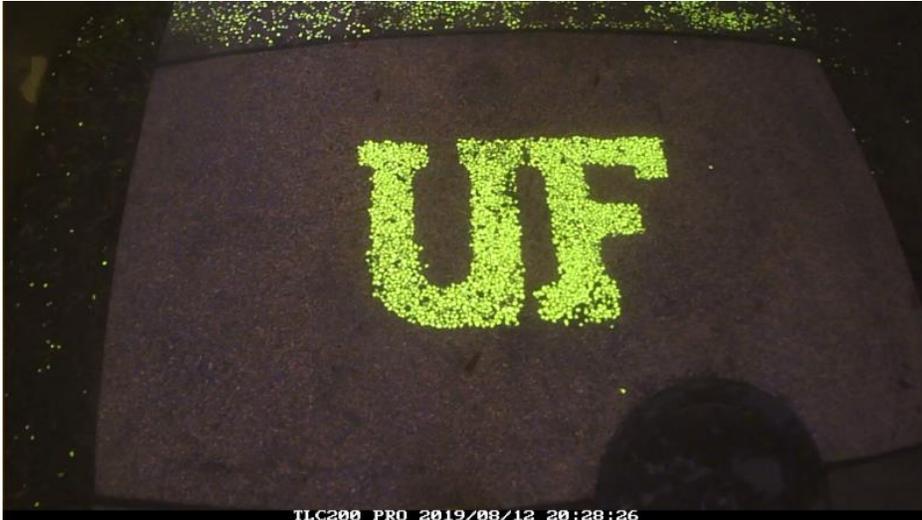
Figure 5-9. Photograph of the installation near peak intensity after sunset.

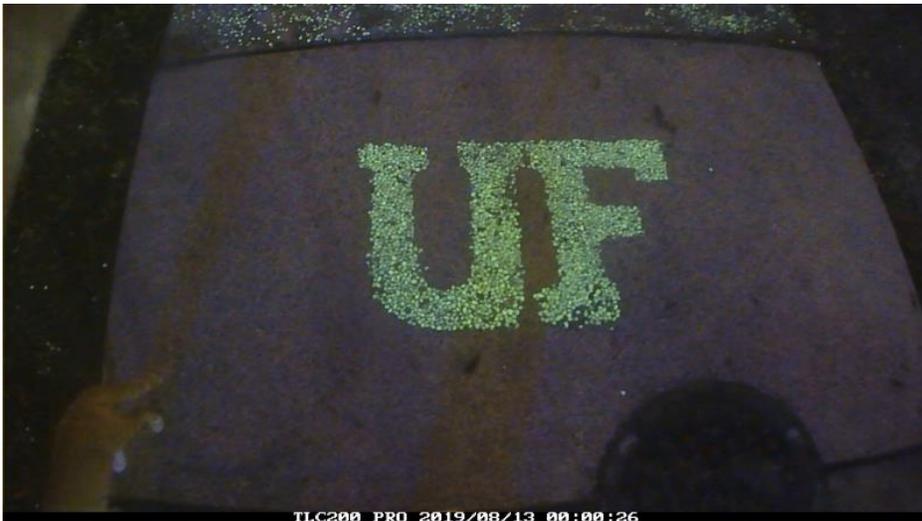
Figure 5-10. Photograph of the installation at midnight.

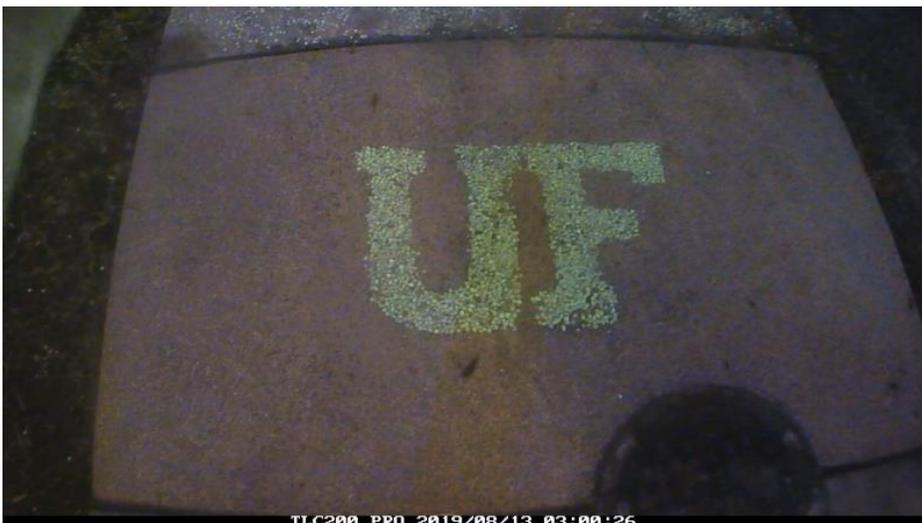
Figure 5-11. Photograph of the installation at 3 am.

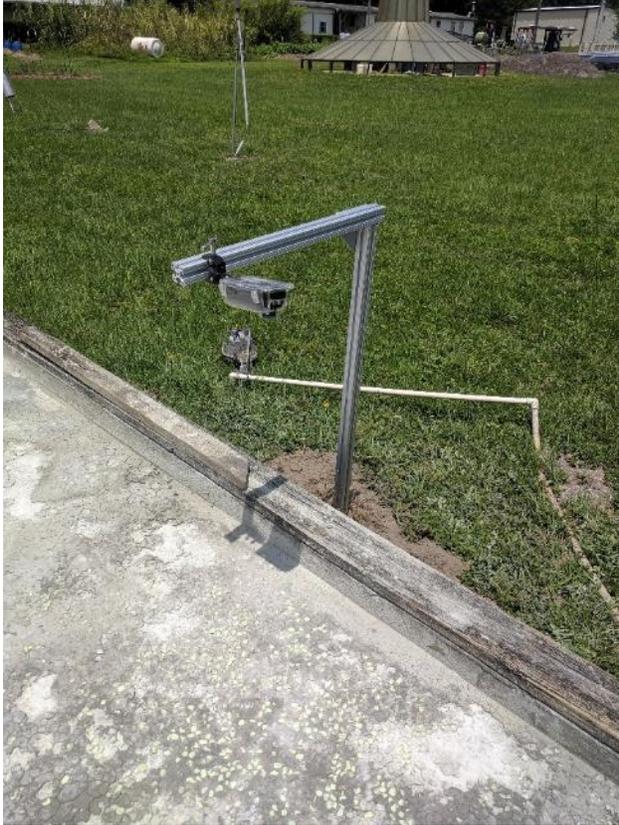
Figure 5-12. Time-lapse camera and concrete installation with Emerald Yellow glow stones embedded at UF's Energy Park.

In an effort to acquire more quantitative data, a second installation with randomly distributed stones was fabricated at UF's Energy Park where we have control over local lighting and keep it off during most evenings. Here we have a permanent time lapse camera installed directly overhead the installation and the same electronic enclosure that was installed at TERL with a pyranometer installed in order to acquire total horizontal solar irradiation. An image of the installation with the time-lapse camera installed directly overhead is shown in Figure 5-12.

After the photoluminescent stones were installed in the UF Energy Park, a time-lapse camera was set up above the installation. The camera takes pictures of the stones in one-minute intervals throughout the night. By running the photos of this decay process through a custom Matlab code, the intensity of light can then be classified through an arbitrary measurement of pixel intensity.

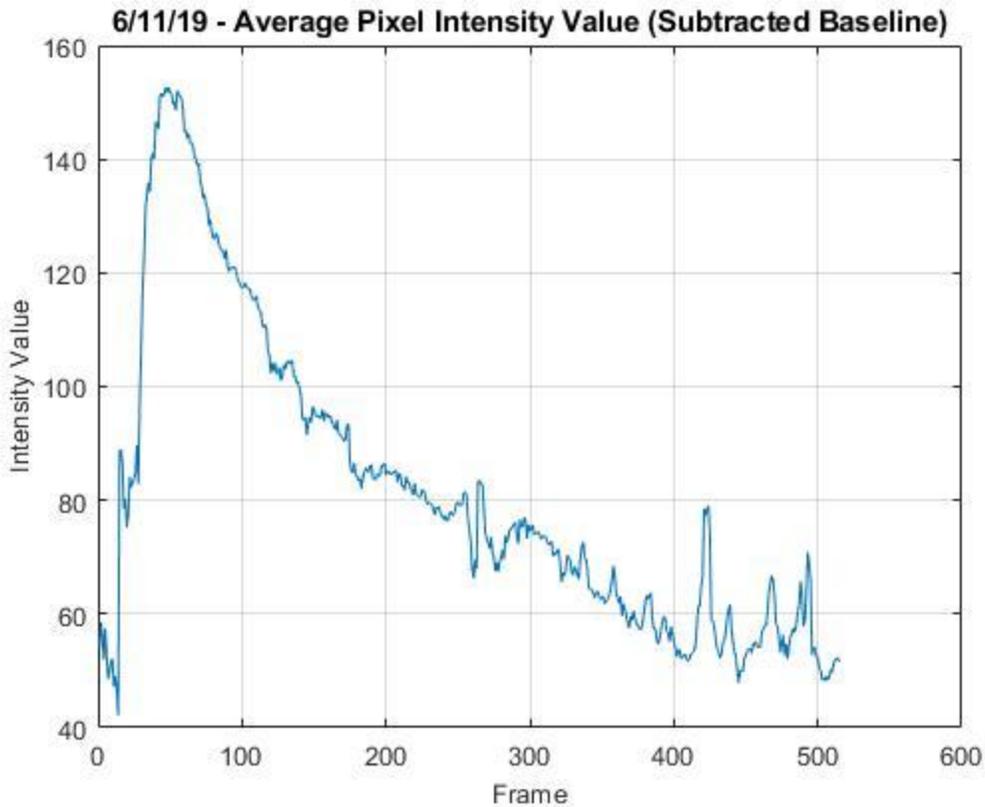
Figure 5-14. Pixel intensity shown vs. Frame (1 frame = 1 minute) for the images shown in Figure 5-13.

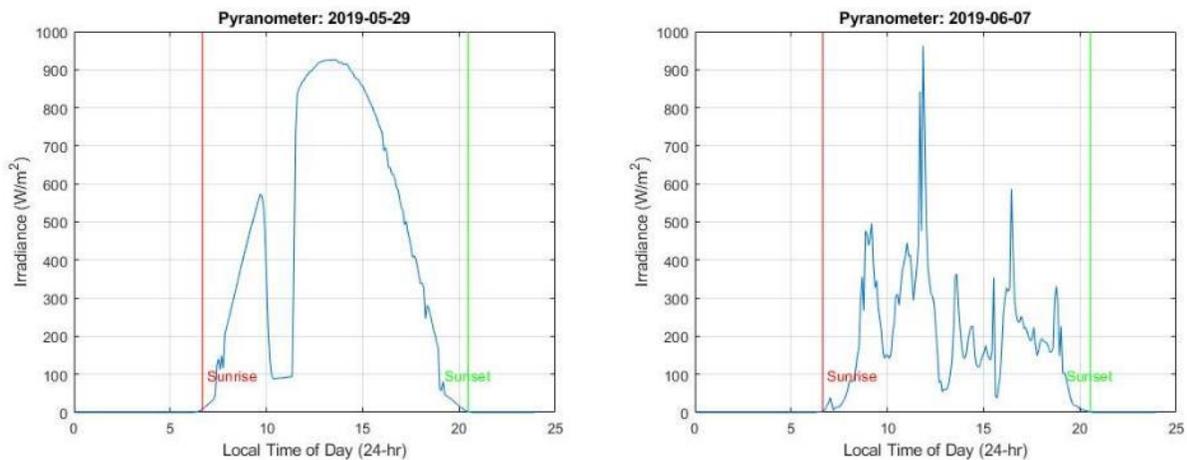
Figure 5-15. Solar irradiance on a sunny day (left) and cloudy day (right).
