Design and Construction of an Integrated Solar Lighting Pedestrian Crosswalk(s) and Sidewalks with Enhanced Visibility

Master Agreement #: BDV31-977-78

Final Report

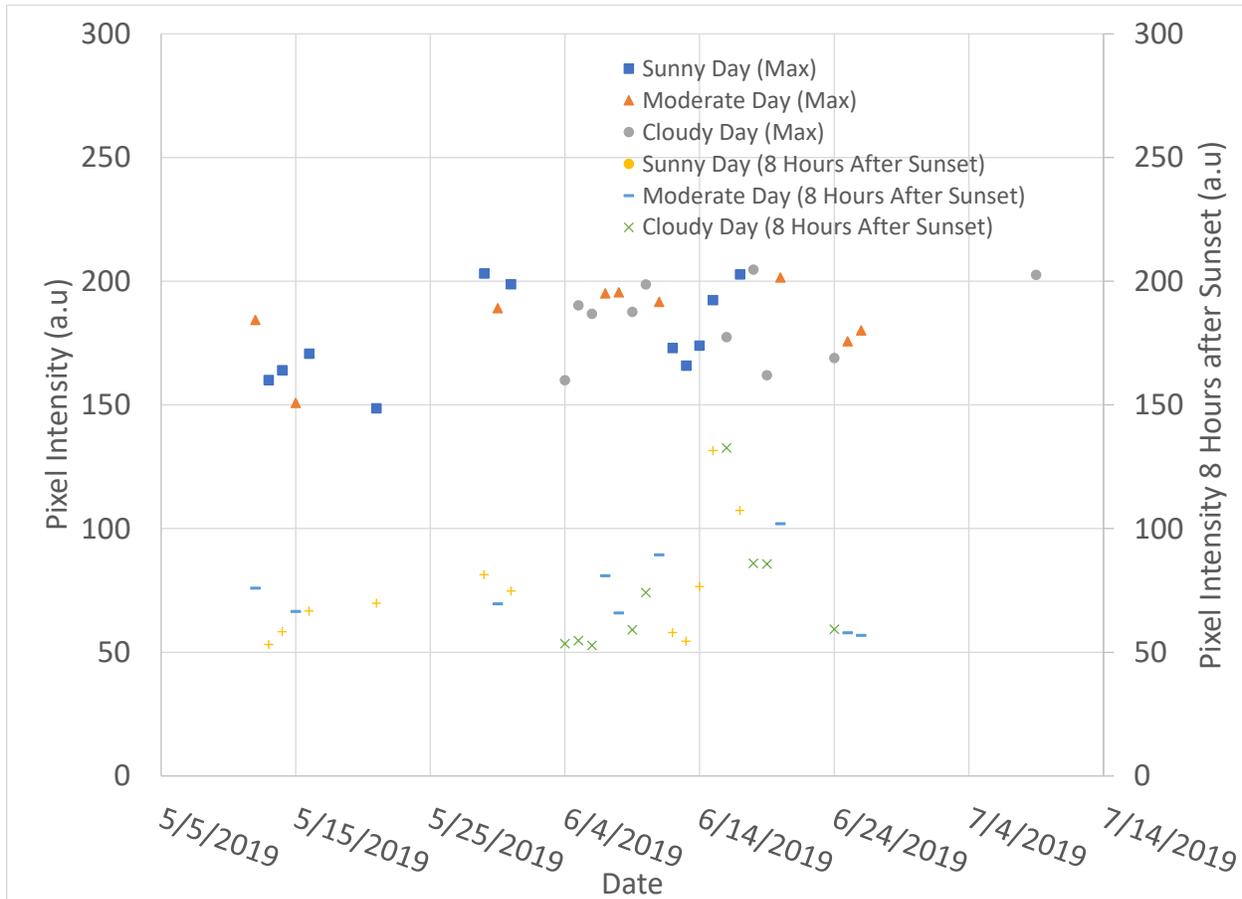
Figure 5-16. Pixel intensity as measured by the time-lapse camera, divided by sunny, moderately sunny and cloudy days. On the left axis is the maximum pixel intensity recorded, and on the right, the intensity measured 8 hours after sunset.

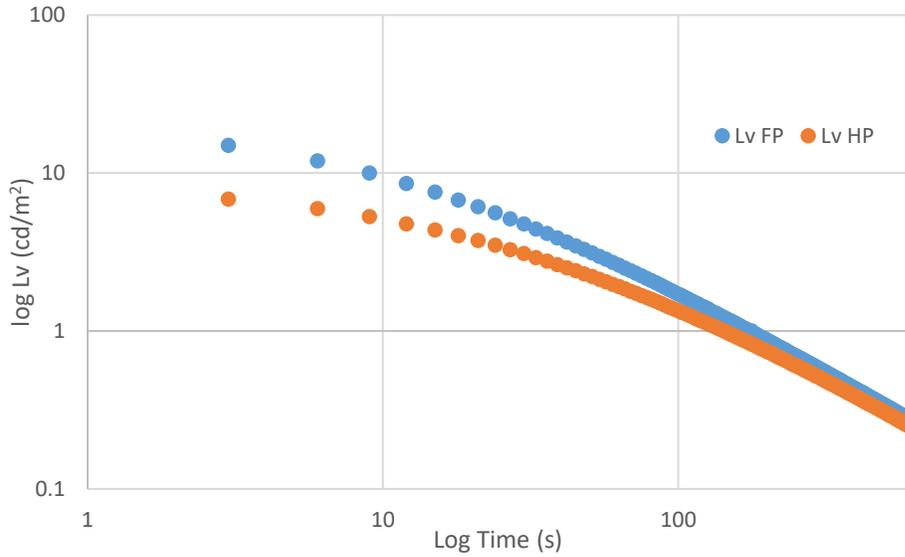
Figure 5-19. Log(L_v) vs. log(t) for the first 10 minutes.

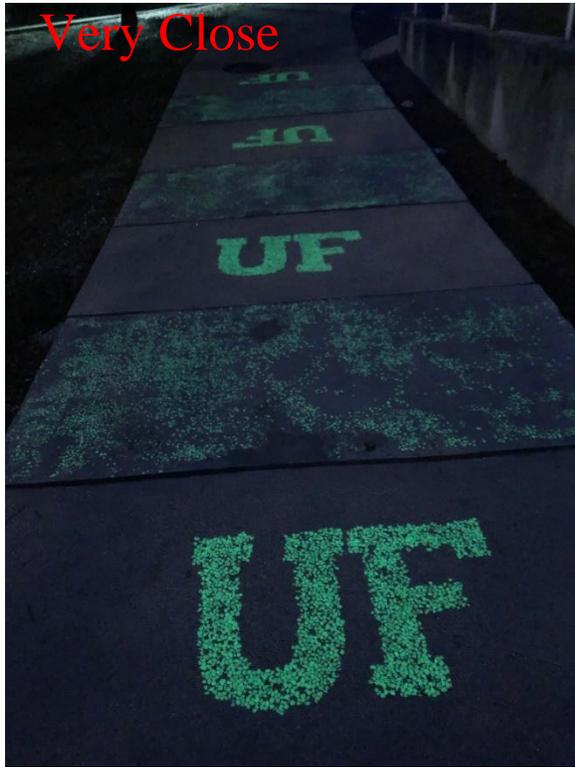
Figure 5-21. Installation viewed from the southwest from close proximity 30 minutes after sunset.

As documented through time-lapse data collected overnight, the intensity of the light produced by the stones reaches peak values around 30 minutes after sunset. In order to visually qualify the brightness of the stones at night from the vantage-point of a possible driver, pictures were taken of the stones at this time from various perspectives and distances. Photographs of the sidewalk installation were taken at 6:03 pm on a day when the sun set at 5:33 pm. There are five photographs that display the installation from a south-west facing view (Figure 5-21 through Figure 5-25) and five photographs that display the installation from a north-east facing view (Figure 5-26 through Figure 5-30). These sets of photographs are taken from points of reference up close to the installation, approximately 10 feet away, 20 feet away, 30 feet away, and 40 feet away in each respective orientation. Once the reference point was moved further than 40 feet away the light being emitted by the stones was visible but the design of the stones themselves became less visible due to the geometry of the sidewalk. In addition to these two main lines of orientation, Figure 5-33 displays the brightness of the stones from three more frames of reference. Overall, it is clear that the emitted light is easily detected by the human eye at night. This would lead to the conclusion that the application of aggregate similar spread would be beneficial to increase driver visibility at pedestrian/bicyclist pathways at night. The stones, however, do not appear to illuminate people or other objects that are near them.

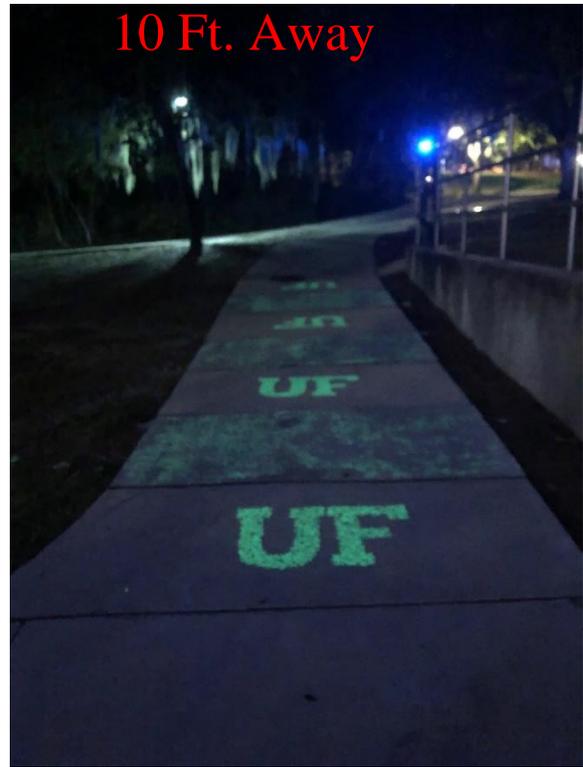
Figure 5-22. Installation viewed from the southwest from 10 ft. 30 minutes after sunset.

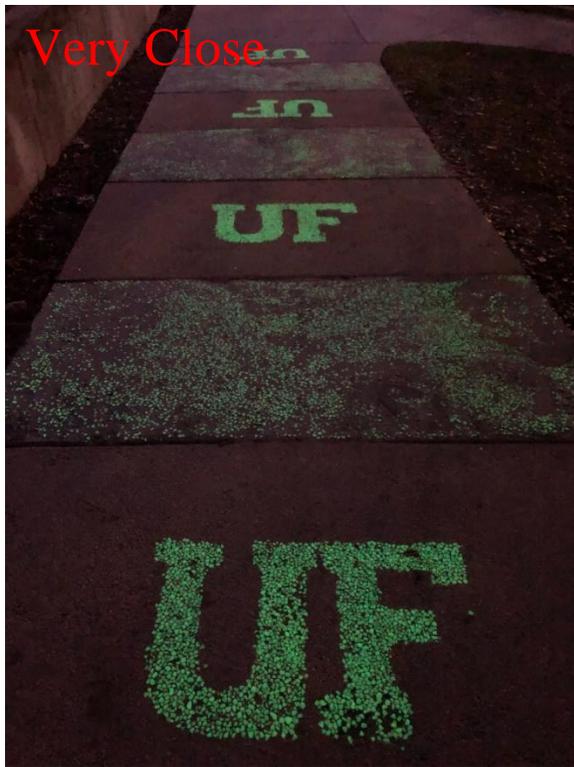
Figure 5-26. Installation viewed from the northeast at close proximity 30 minutes after sunset.

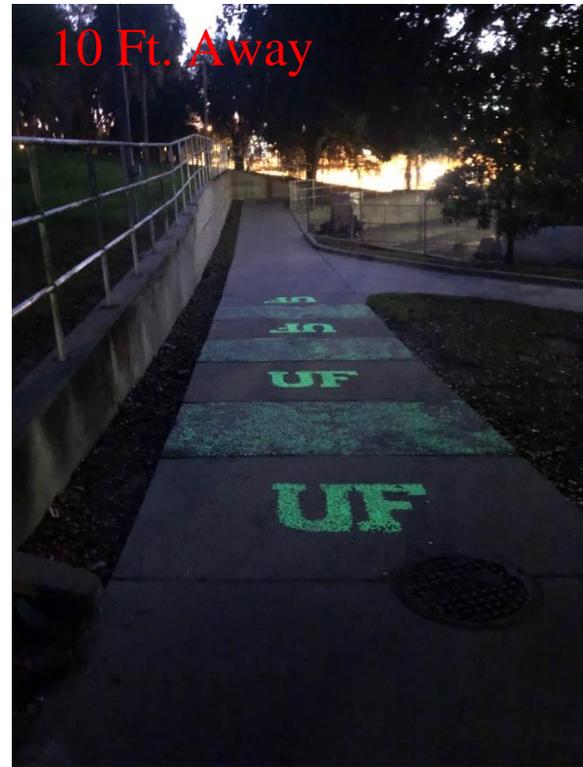
Figure 5-27. Installation viewed from northeast 10 ft. away 30 minutes after sunset.

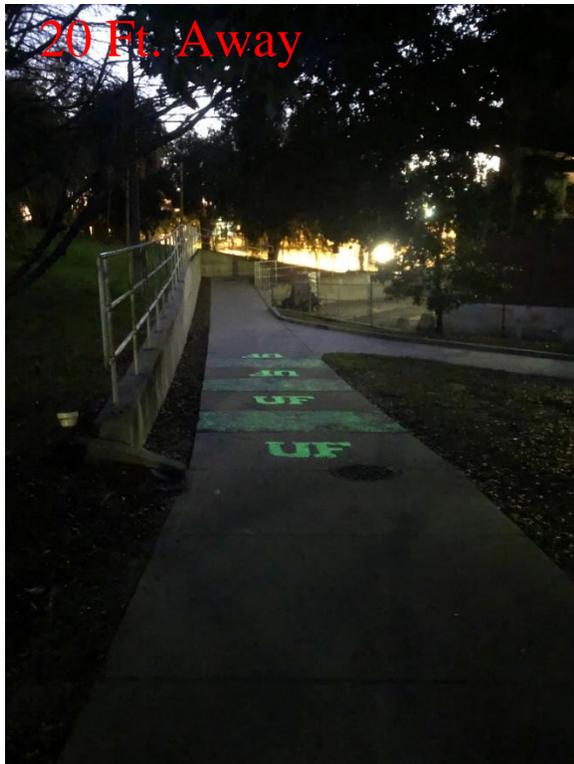
Figure 5-28. Installation viewed from northeast 20 ft. away 30 minutes after sunset.

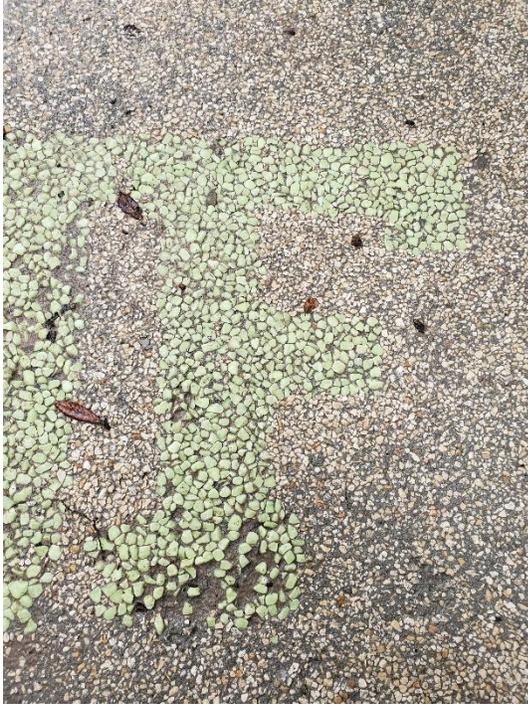
Figure 5-34. The last logo was placed after the concrete started to set, and some of the stones are coming loose.

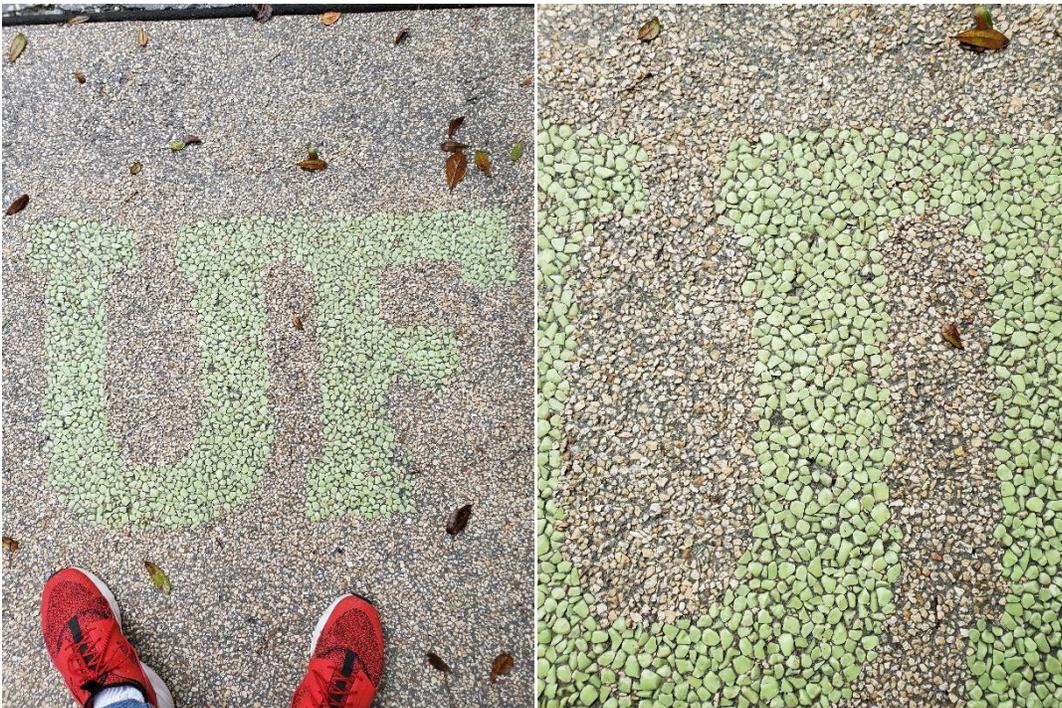
Figure 5-35. Stones that were placed while the concrete was still wet are showing no sign of attrition.

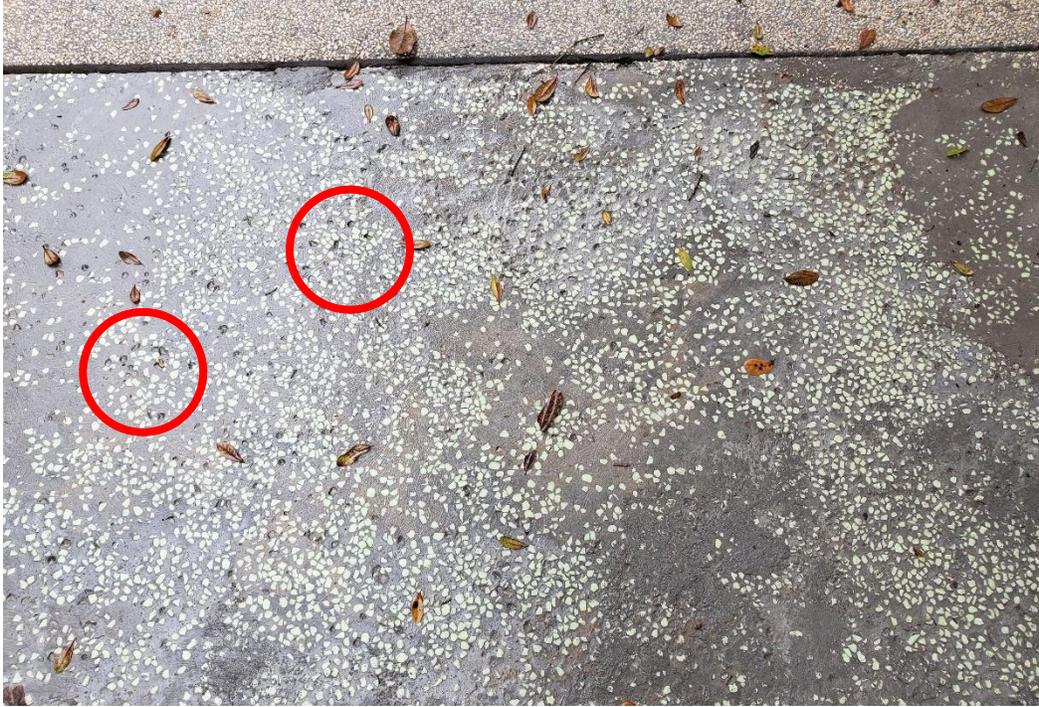
Figure 5-36. In this section of the installation, prefabricated sheets were used and then everything was sanded and ground down to make the surface smooth. In general, the glowing stones are all well integrated, but some were removed after the back covering was peeled away. Selected sections where stones are removed are indicated with the red circles.

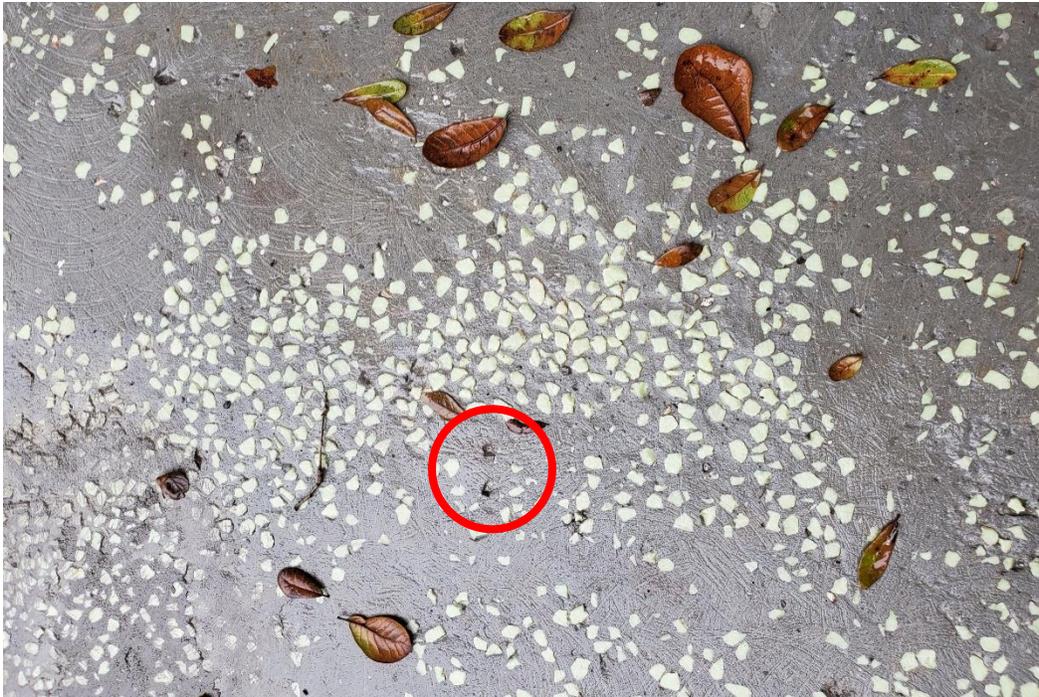
Figure 5-37. A zoomed in look at one of the areas where stones were not well integrated.
