Materials Research Report
Final Report

April 2019

Degradation Mechanisms and Service Life Estimation of Fiber Reinforced Polymer (FRP) Concrete Reinforcements

**School of Engineering
College of Computing, Engineering, and Construction
University of North Florida
Jacksonville, Florida 32224**

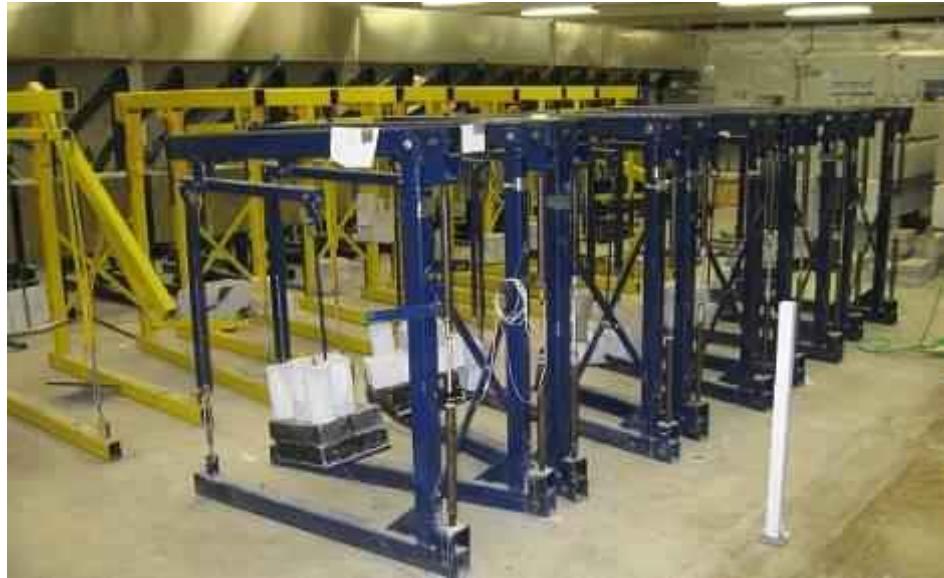
Figure 2.9: MTS 810 hydraulic machine for creep rupture test

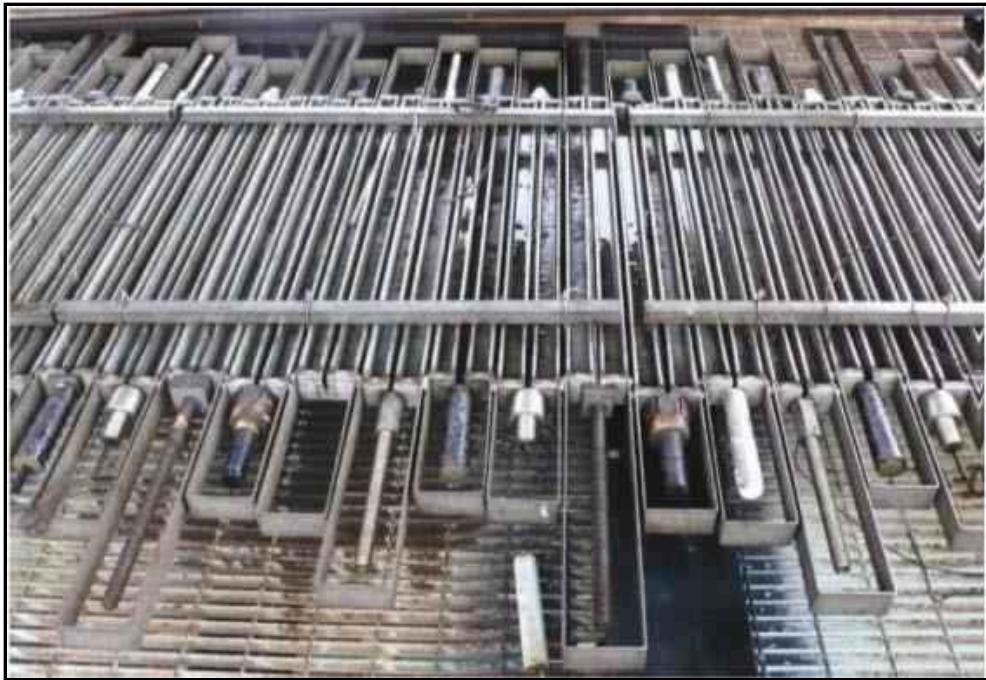
Figure 2.18: FRP cables pre-stressed in SUS flames (Sasaki and Nishizaki 2015)

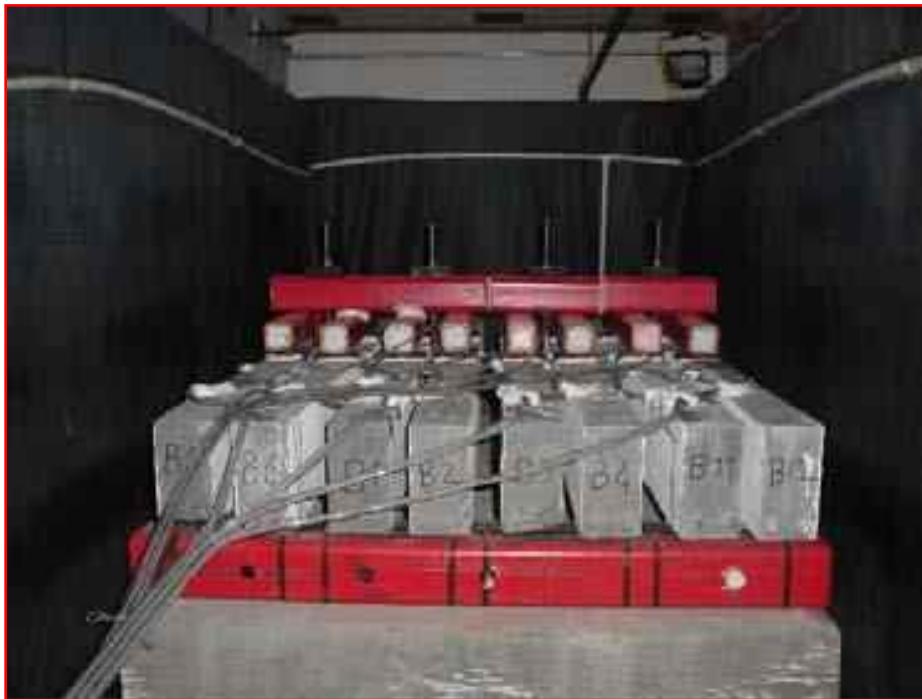
Figure 2.20: Test set-up for sustained loading (environmental exposure) (Mertol et al. 2007).

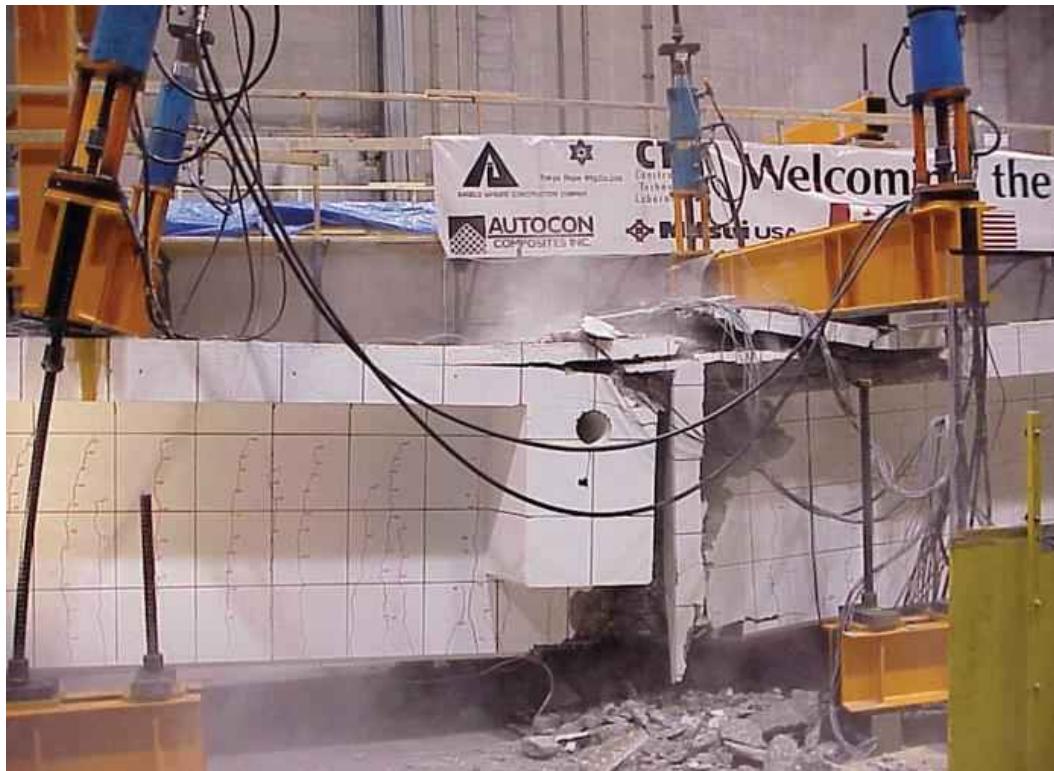
Figure 2.23: Failure of DT girder due to separation of concrete topping and crushing of concrete (Grace et al. 2003).

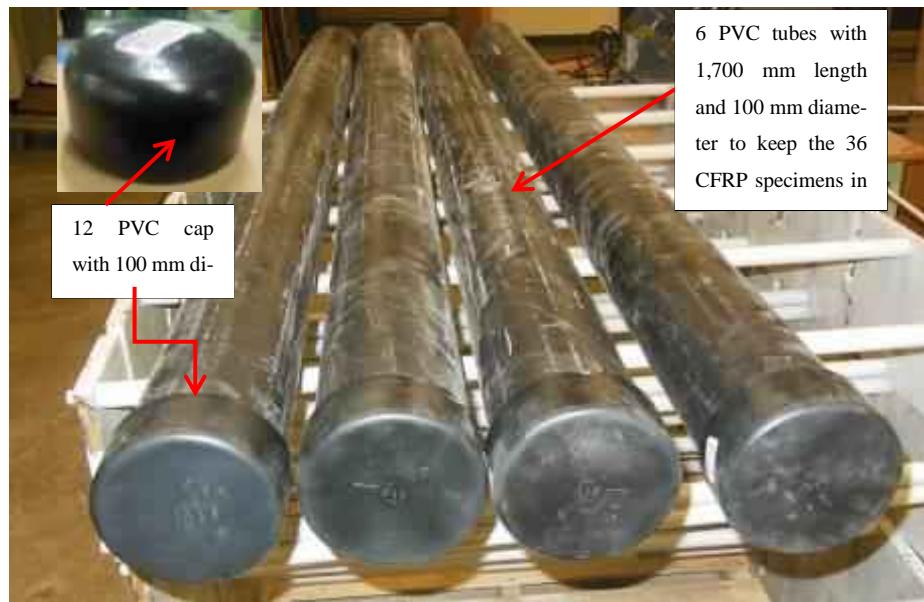
Figure 3.12: The CFRP specimens exposed to alkaline solution inside PVC tubes

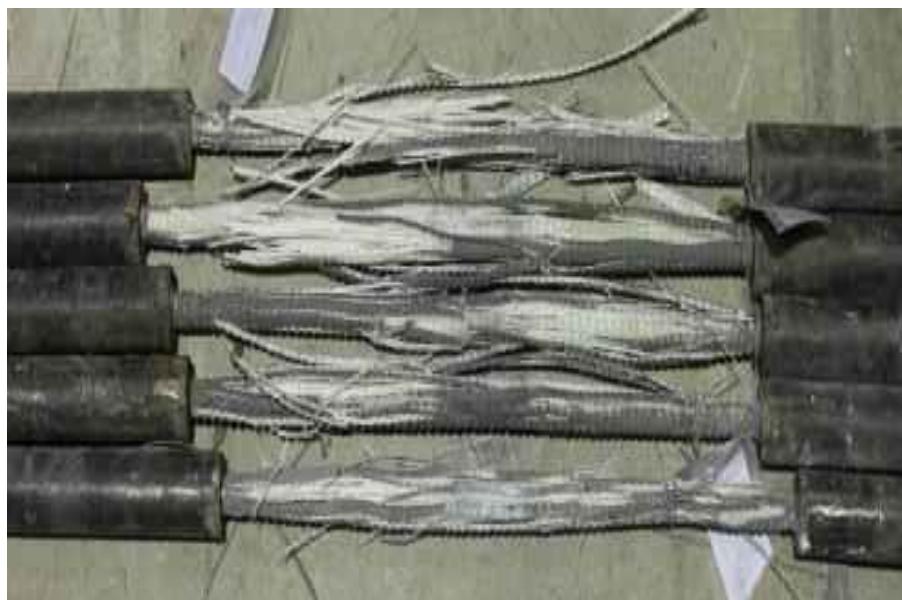
Figure 4.26: Typical mode of failure of vinyl ester GFRP bars

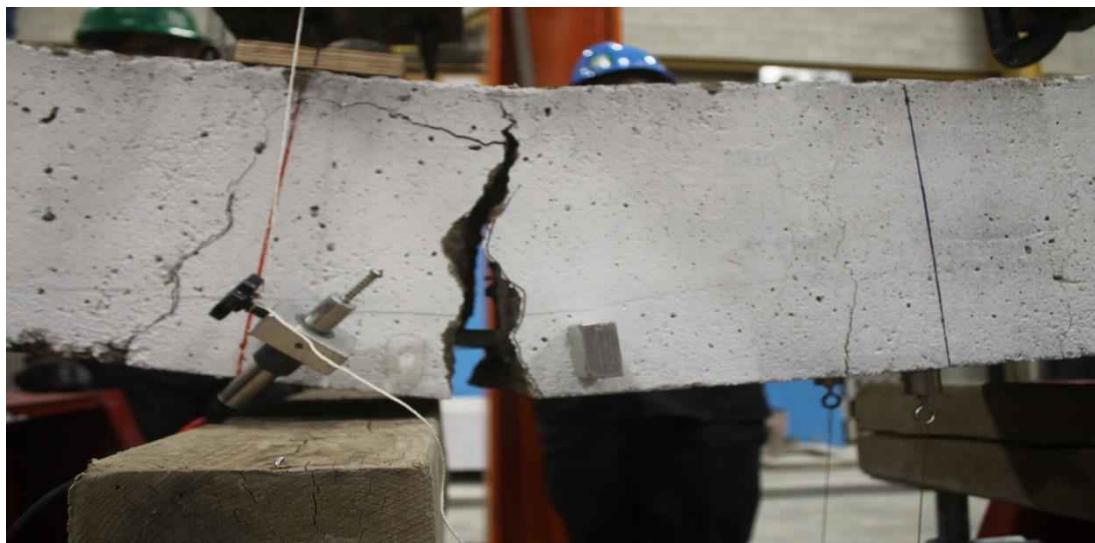
Figure 4.52: Flexural tension failure mode observed in all of the control and conditioned specimens

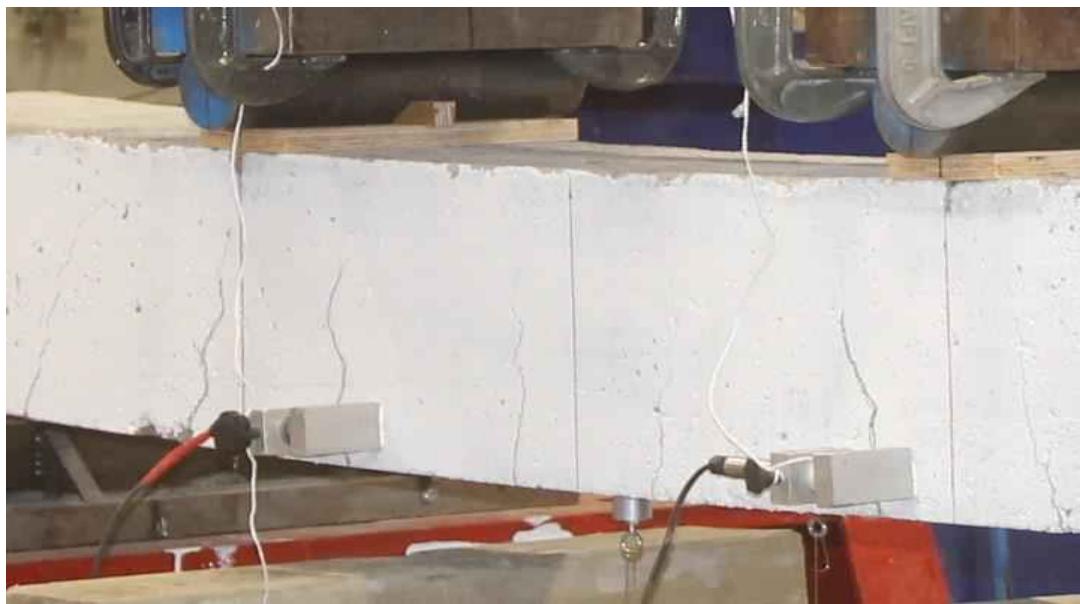
Figure 4.54: Crack pattern of the conditioned beam specimens

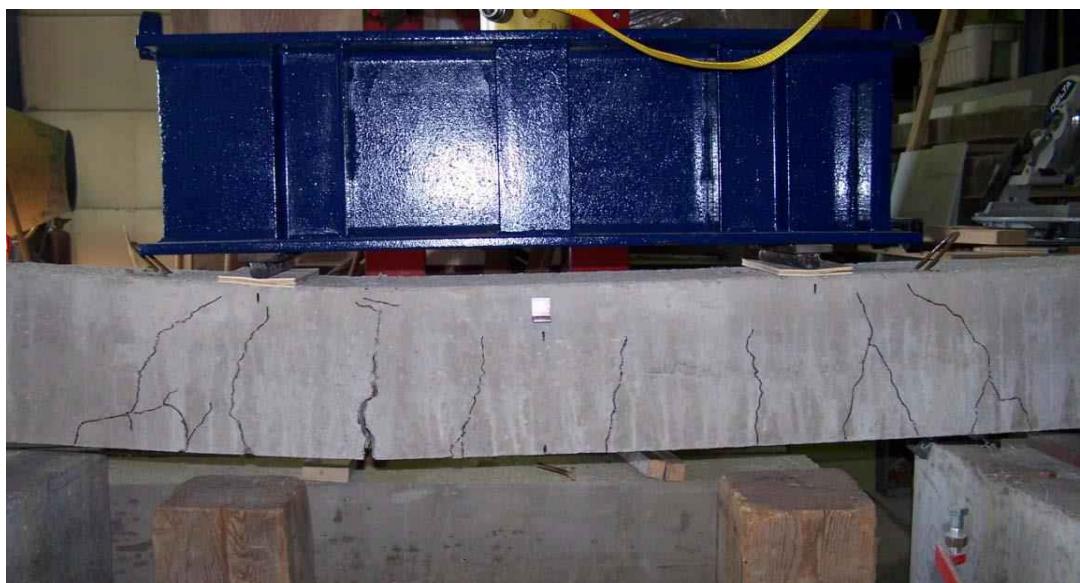
Figure 4.55: Crack pattern of the control beam specimens

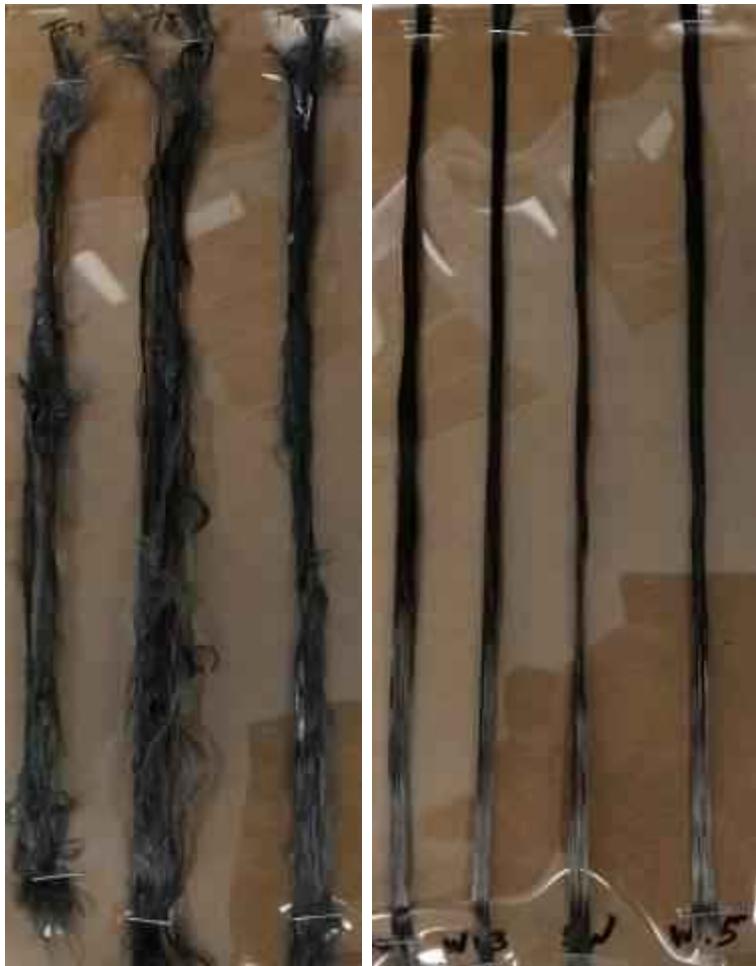
Figure 5.8: Comparison between specimens exposed to alkaline solution (left) and water (right).

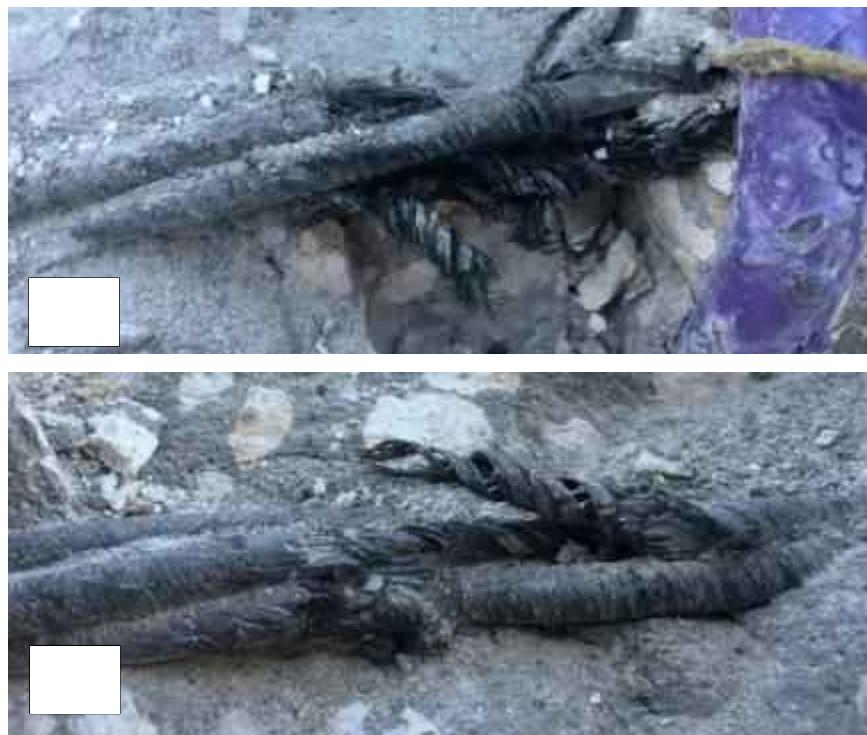
Figure 6.21: A close up view of the strand rupture after 3 months exposure (a) top beam (b) bottom beam.

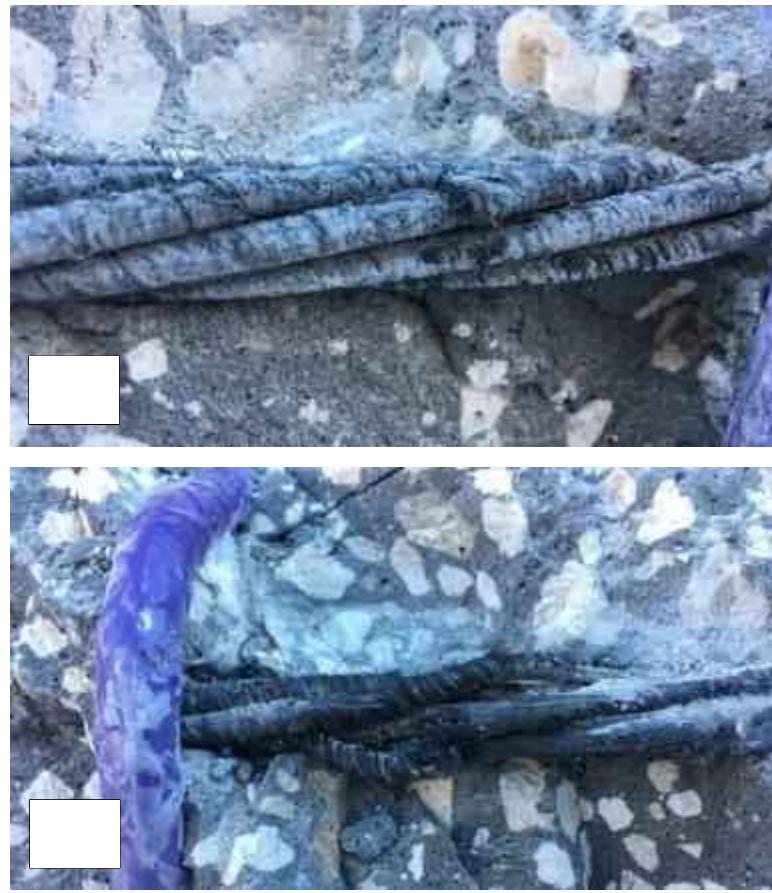
Figure 6.25: A close up view of the strand rupture after 6 months exposure (a) top beam (b) bottom beam.

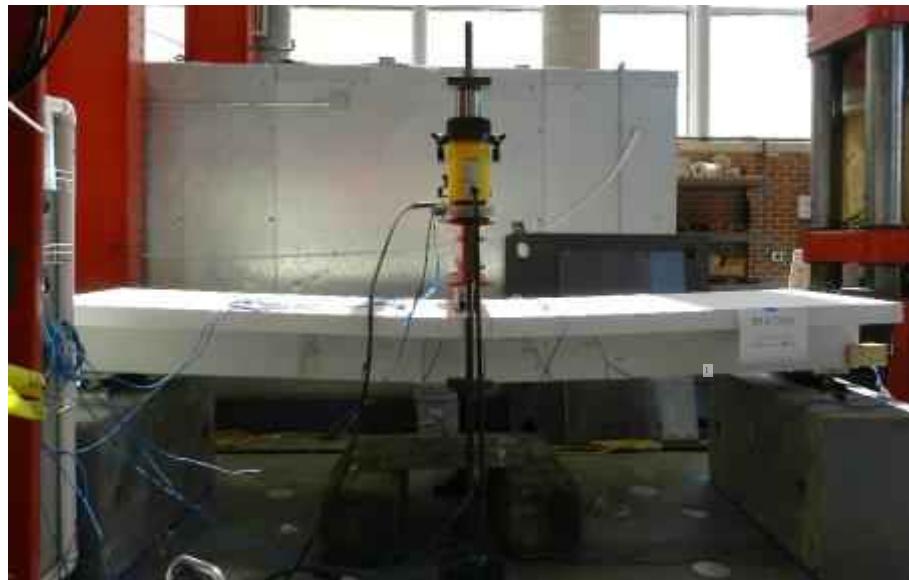
Figure 6.27: Failure of beam#7 after 12 months of exposure (Top Beam).

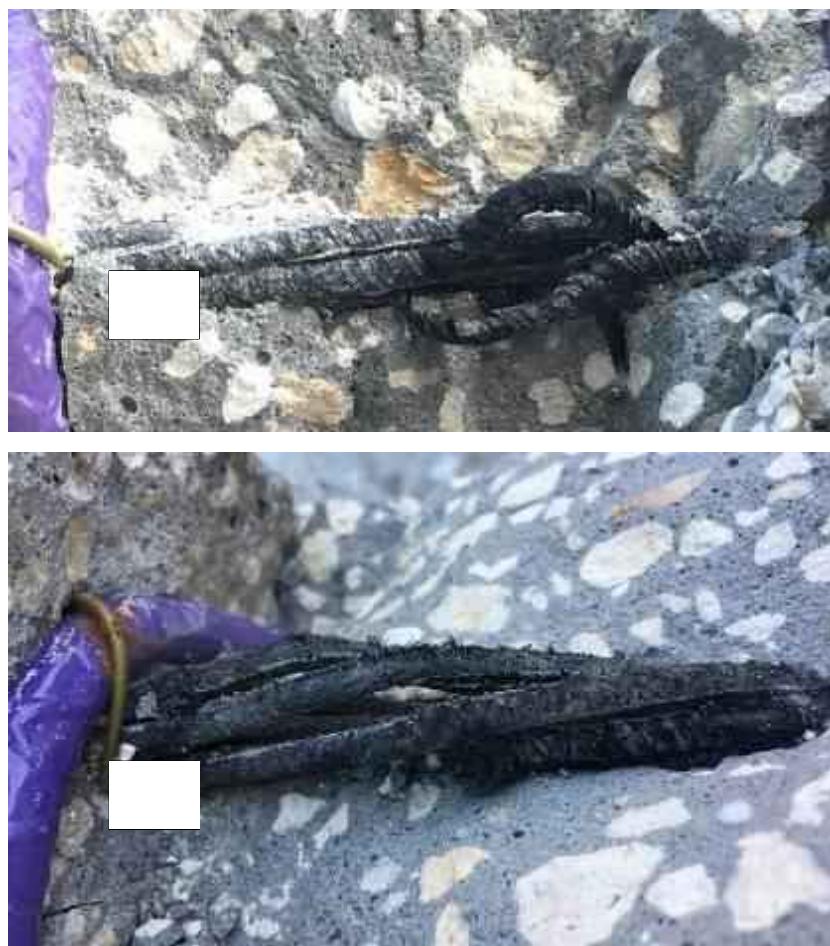
Figure 6.29: A close up view of the strand rupture after 12 months exposure (a) top beam (b) bottom beam

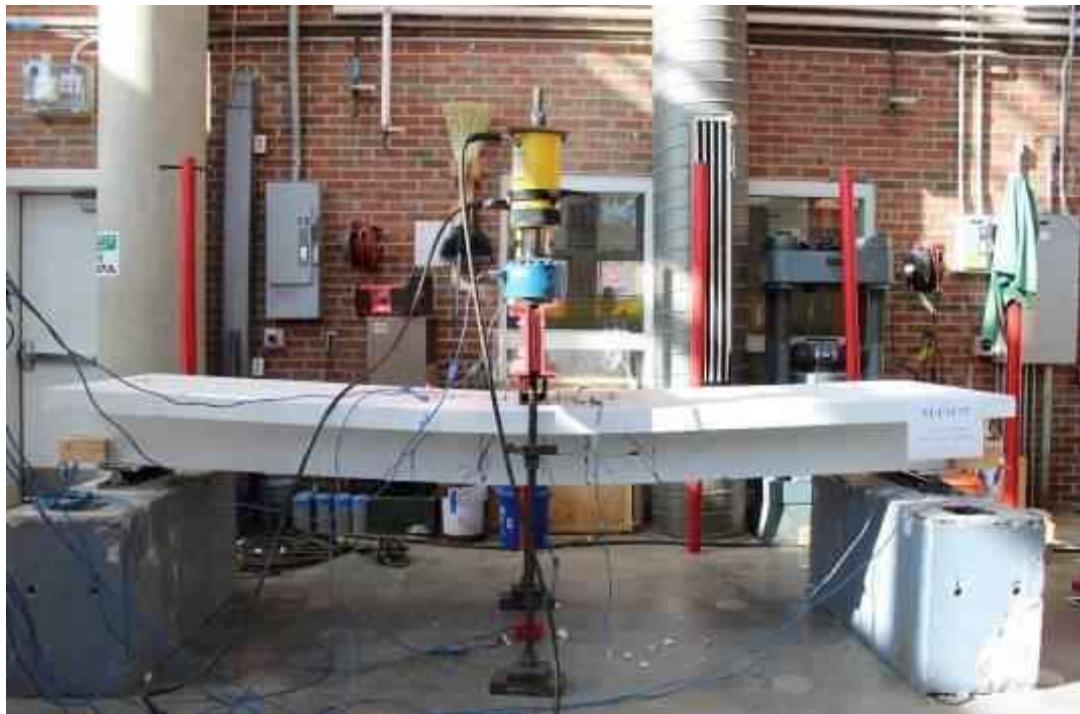
Figure 6.30: Failure of beam#9 after 18 months of exposure (Top Beam).

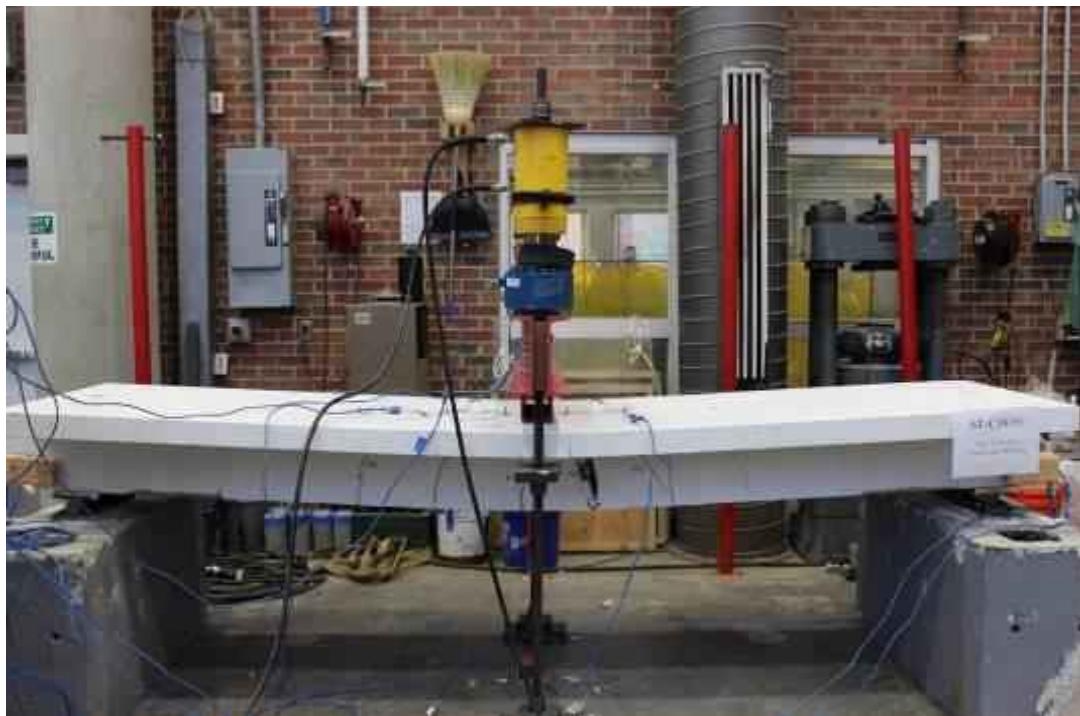
Figure 6.31: Failure of beam#10 after 18 months of exposure (Bottom Beam).

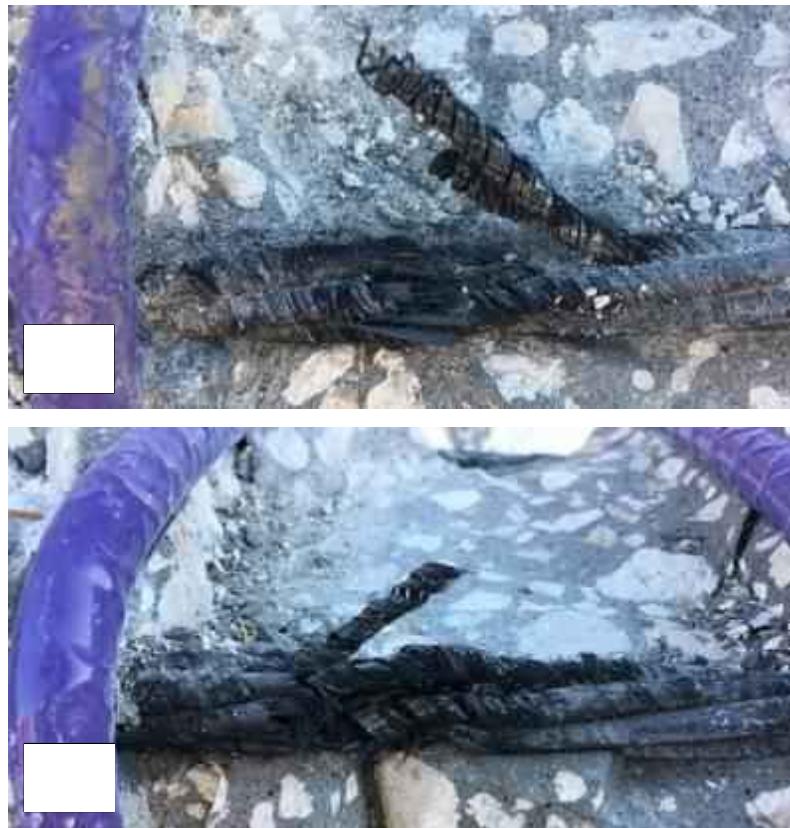
Figure 6.32: A close up view of the strand rupture after 18 months exposure (a) top beam (b) bottom beam.

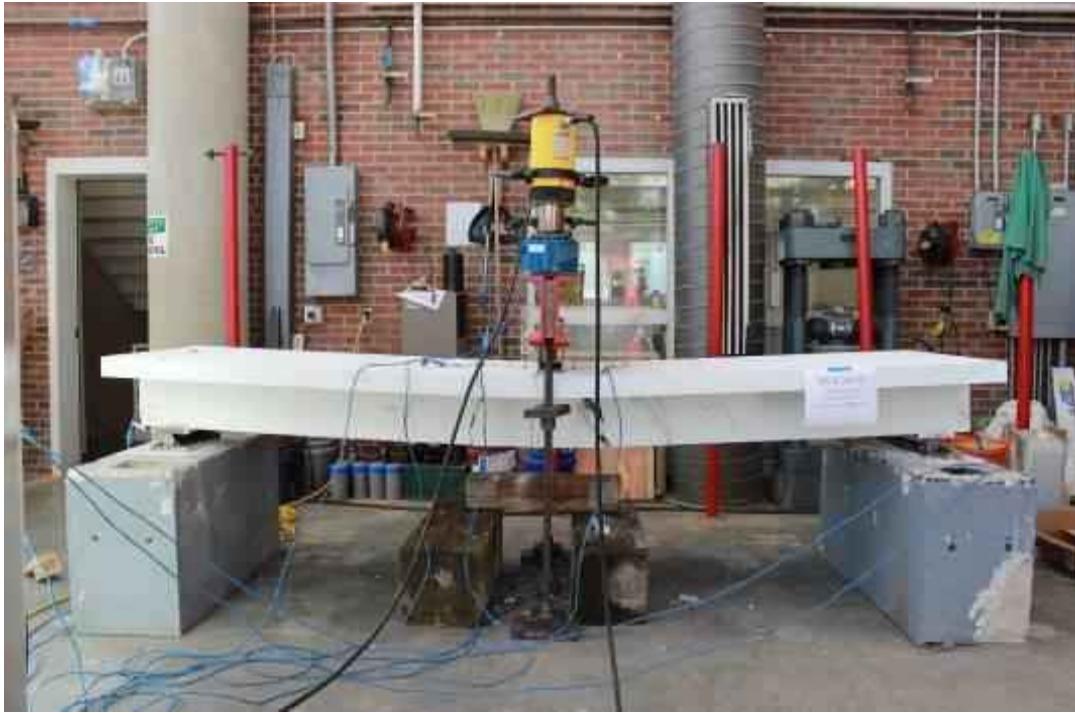
Figure 6.34: Failure of Beam#11 after exposure to sustained load for 18 months (Top Beam)

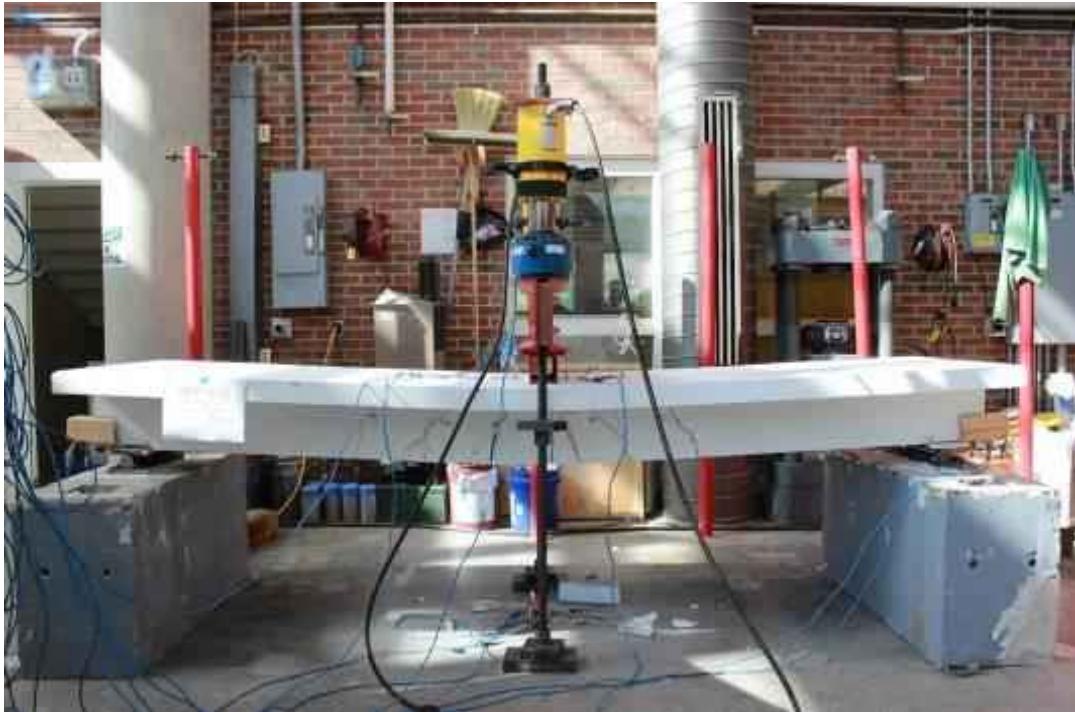
Figure 6.35: Failure of Beam#12 after exposure to sustained load for 18 months (Bottom Beam)

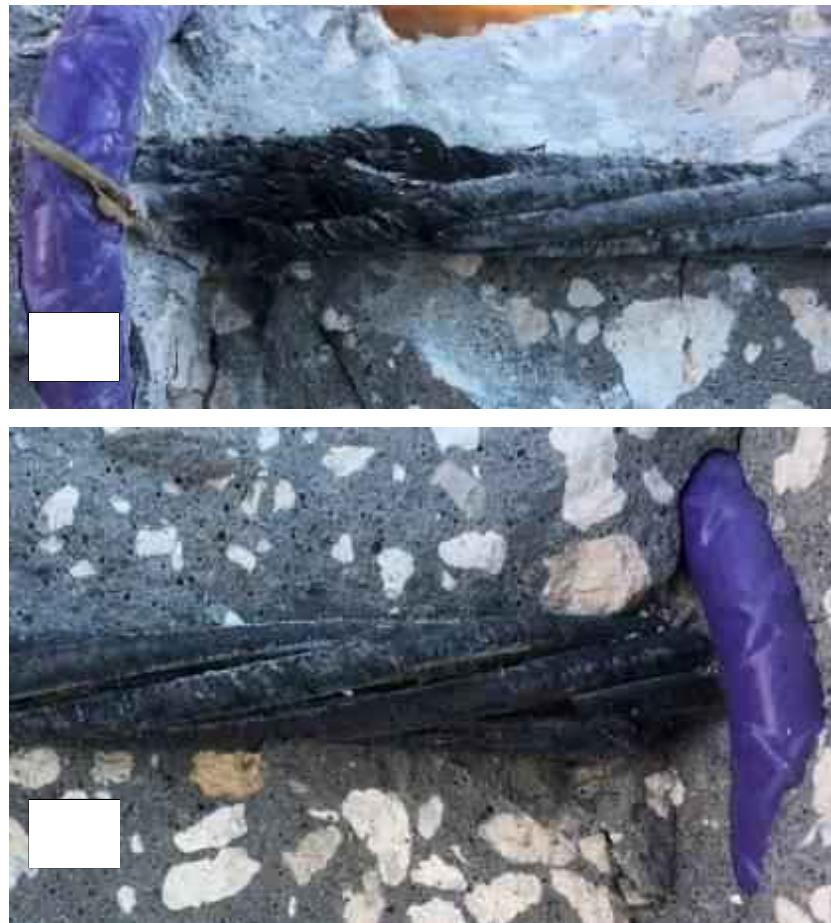
Figure 6.36: A close up view of the strand rupture after 18 months exposure to sustained load only (a) top beam (b) bottom beam.
