Project Number
BE711

Florida Department of Transportation Research

Macrotexture Assessment of Florida Pavements

December 2021

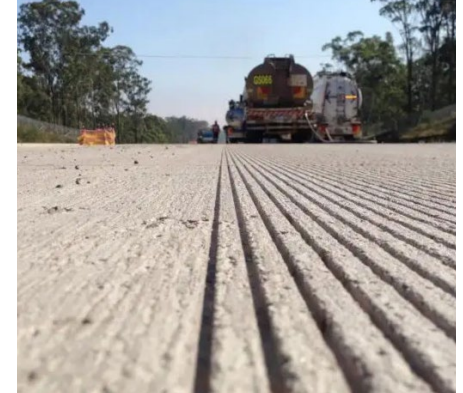
Tining, or adding groves to concrete pavement, improves traction but makes measuring macrotexture difficult.

Macrotexture is defined as pavement surface profile features with a wavelength between 0.5 and 50 millimeters. Pavement macrotexture provides the pathways for water to drain, which allows for the necessary grip between tire and pavement. As a pavement ages, the macrotexture of a pavement can change and pose hazardous conditions for the traveling public, especially in wet weather conditions. Traditionally, vehicle-mounted point-laser devices have been used by the Florida Department of Transportation (FDOT) State Materials Office to measure network-level macrotexture in accordance with the ASTM E1845 test standard. These point-laser systems are capable of accurately measuring macrotexture on asphalt pavement; however, the point-laser system fails to completely capture anisotropic (measurements in different directions produce different values) texturing of rigid pavement, such as longitudinally diamond-ground (LDG) concrete pavement.
