| LAST REVISION<br>07/01/14 | REVISION | DESCRIPTION: | <b>2016</b><br>DESIGN STANDARDS | <b>CONCRETE SLAB REPLACEMENT</b> | INDEX NO.<br><b>308</b> | SHEET NO.<br><b>1 of 2</b> |

**SLAB REPAIR AND REPLACEMENT CRITERIA**

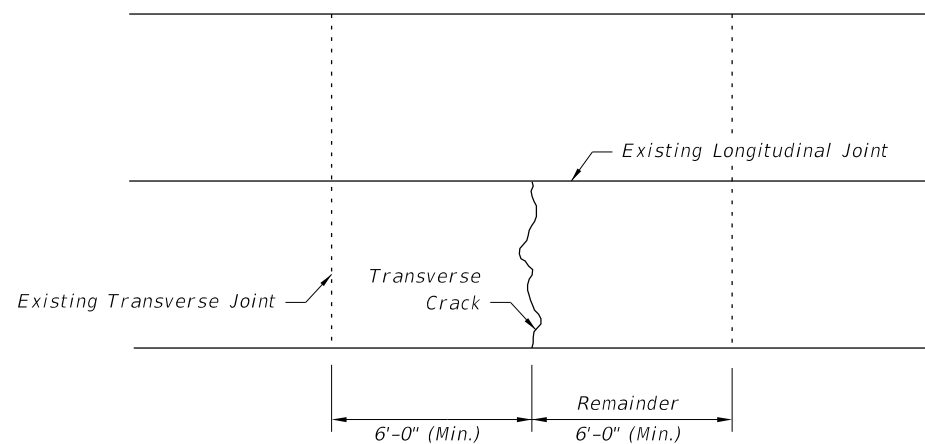
FIGURE 10.2 - REPAIR METHOD: NONE OR CLEAN AND SEAL

| <i>DISTRESS PATTERN</i> | <i>SEVERITY/DESCRIPTION</i> | | <i>REPAIR METHOD</i> | <i>REFERENCE</i> |
|--|---|---|--|---|
| Longitudinal | Light | <1/8", no faulting, spalling <1/2" wide | None | Figure 10.2 |
| | Moderate | 1/8" <width <1/2", spalling <3" wide | Clean and Seal | Figure 10.2 |
| Transverse | Light | <1/8", no faulting, spalling <1/2" wide | None | Figure 10.2 |

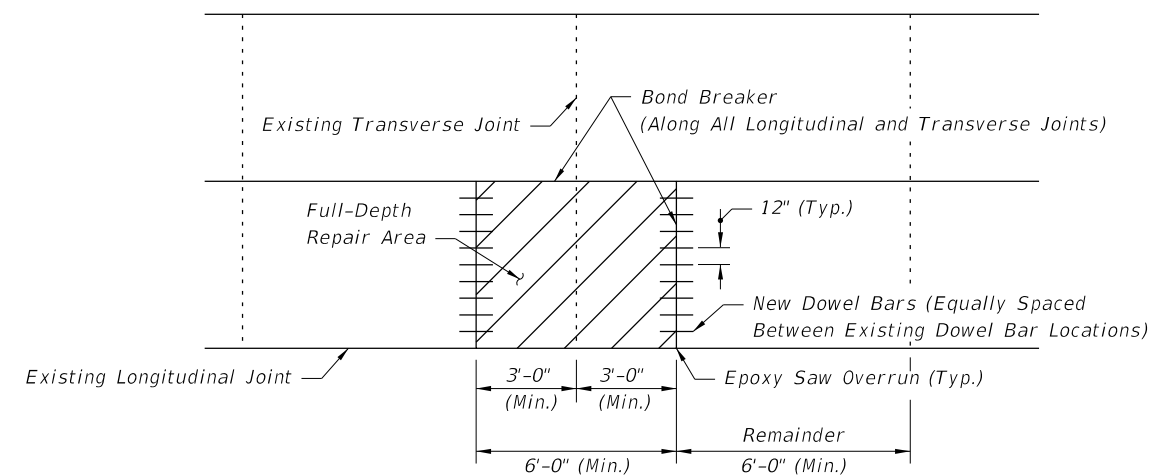
FIGURE 10.5 - FULL-DEPTH REPAIR ON BOTH SIDES OF THE JOINT

| <i>DISTRESS PATTERN</i> | <i>SEVERITY/DESCRIPTION</i> | | <i>REPAIR METHOD</i> | <i>REFERENCE</i> |
|--|---|---|--|---|
| | Severe | width >1/2", spalling >3" faulting >1/2" | Replace | Figure 10.3, 10.4 and 10.5 |
| Corner Breaks | A corner of the slab is separated by a crack that intersects the adjacent longitudinal and transverse joint, describing an approximate 45° angle with the direction of traffic. | | Full Depth | Figure 10.4 and 10.5 |
| | Severe | spall width >3" or length >12" | Full Depth | Figure 10.4 and 10.5 |

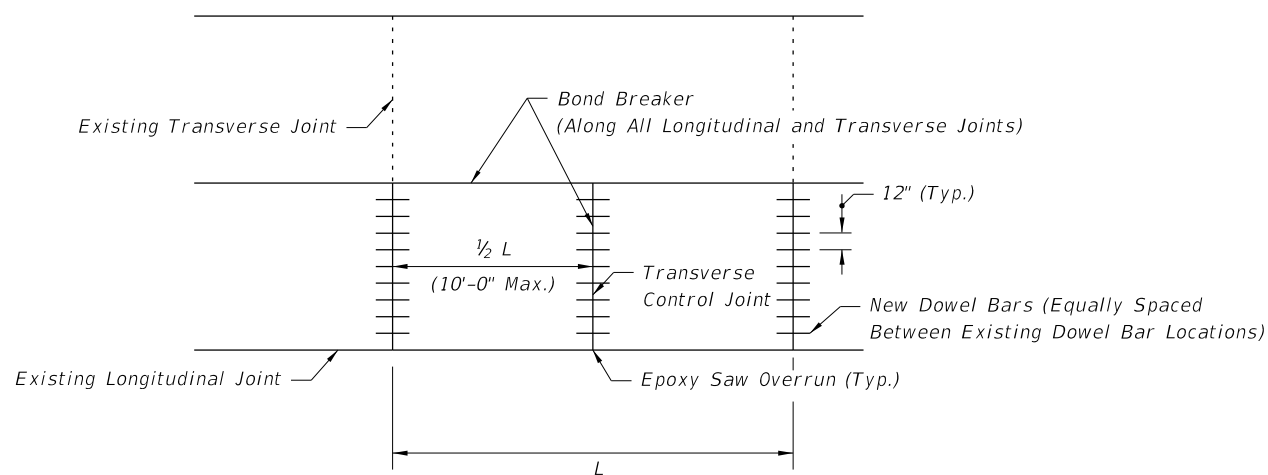
FIGURE 10.3 - FULL SLAB FULL DEPTH REPLACEMENT

| <i>DISTRESS PATTERN</i> | <i>SEVERITY/DESCRIPTION</i> | | <i>REPAIR METHOD</i> | <i>REFERENCE</i> |
|--|---|---|--|---|
| | Severe | width >1/2", spalling >3" faulting >1/2" | Replace | Figure 10.3 |
| Intersecting Random Cracks<br>(Shattered Slab) | Cracking patterns that divide the slab into three or more segments. | | Full Depth | Figure 10.3 and 10.4 |
| Blowups | Upward movement at transverse joints or cracks often accompanied by shattering of the concrete. | | Full Depth | Figure 10.3 and 10.4 |

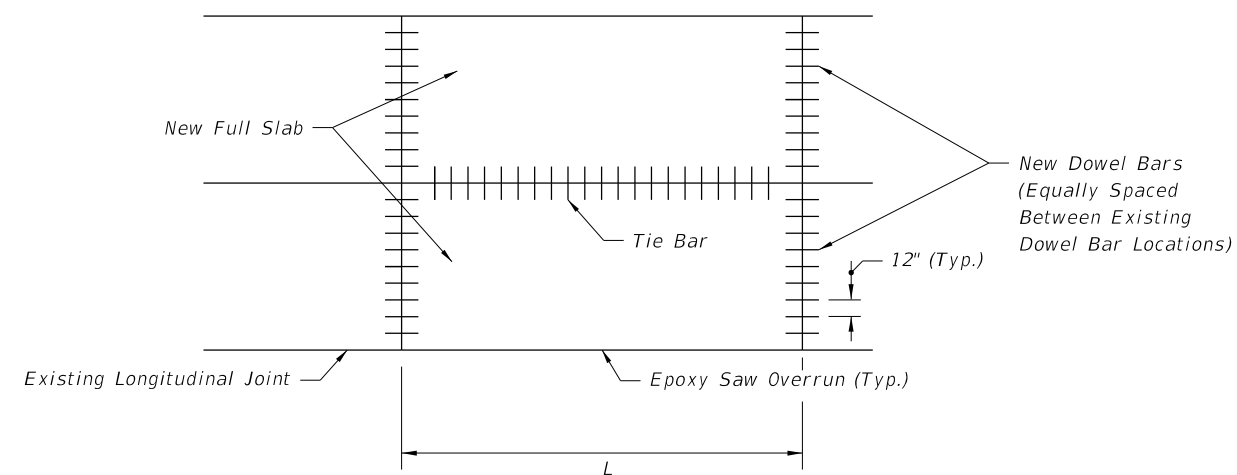
FIGURE 10.6 - MULTIPLE SLAB FULL DEPTH REPLACEMENT

8. Install tie bars at longitudinal joints when two full adjacent or multiple replaced slabs.

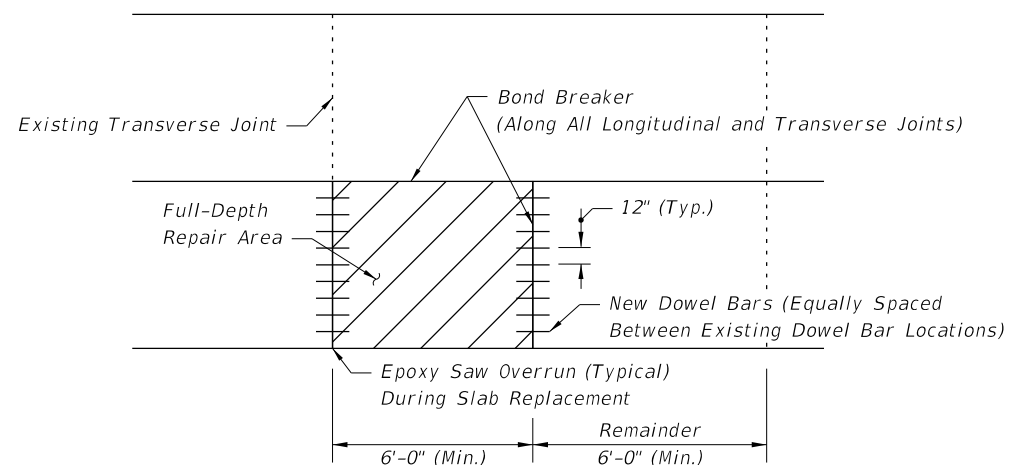
FIGURE 10.4 - PARTIAL SLAB FULL DEPTH REPLACEMENT

| <i>DISTRESS PATTERN</i> | <i>SEVERITY/DESCRIPTION</i> | | <i>REPAIR METHOD</i> | <i>REFERENCE</i> |
|--|---|---|--|---|
| | Severe | Flying debris deemed a traffic hazard | Full Depth | Figure 10.4 |
| | Light | Deemed to be a traffic hazard | Full Depth | Figure 10.4 |
