FDOT Evaluation Guide – Temporary Concrete Barrier

This is a guide developed to aid in evaluating the condition of Temporary Concrete Barrier used in work zones and is based, in part, on information published by the American Traffic Safety Services Association (ATSSA). This guide illustrates examples of FDOT specific Temporary Concrete Barriers, which include Type K, proprietary concrete (i.e. JJ Hook), and Low-Profile categorized into acceptable and unacceptable conditions. It should not be considered comprehensive and should be used in conjunction with good engineering judgement.

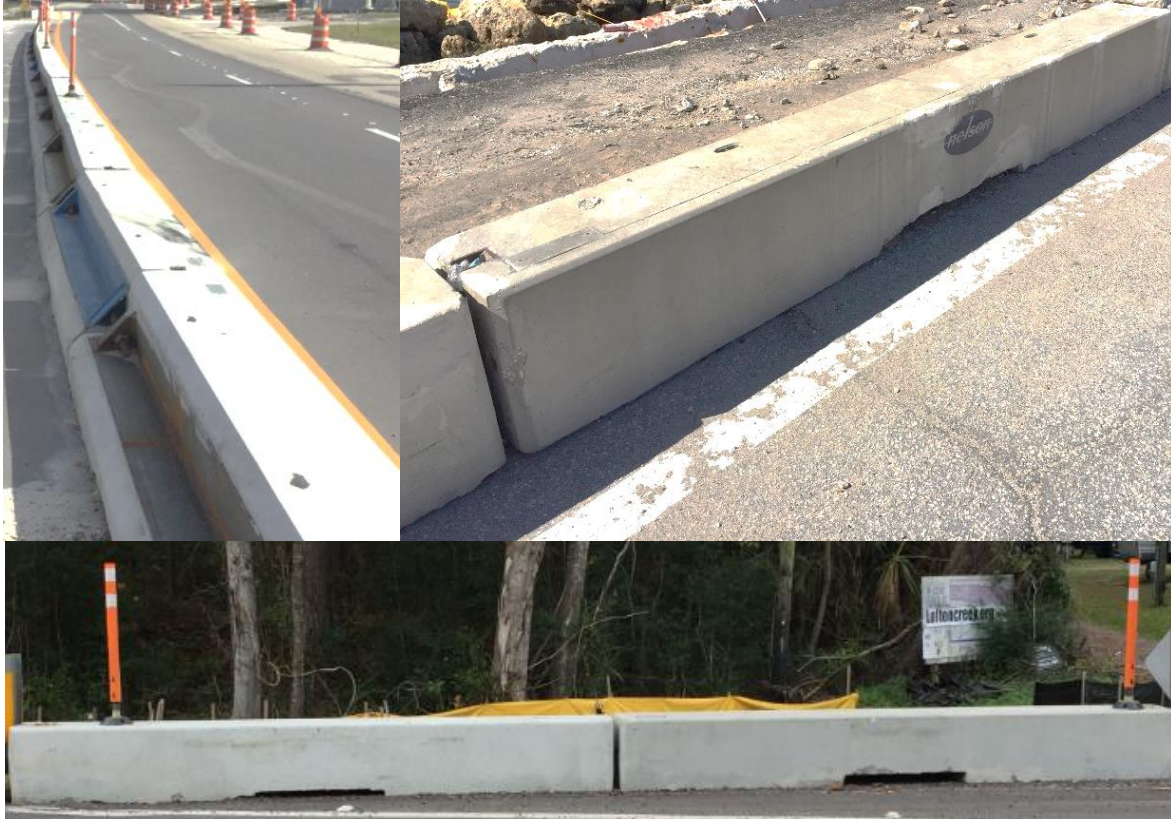
Figure 1: Examples of Acceptable Low-Profile Concrete Barrier

1. The barrier is completely intact and has only minor blemishes or imperfections, which may include superficial gouges or minor cracks. The barrier has no structural cracks or cracks that exist through the entire cross-section.
2. Minor spalls with a depth of 1.5 inches or less, and no exposed rebar (excluding anchor slots).
3. The unit-to-unit connection assemblies are functional with no damage, are all intact, and fixed in their positions.
4. Temporary Concrete Barrier previously repaired in accordance with Specification 102.
5. Examples of acceptable Low-Profile concrete barrier are shown in Figures 1 and 2.
6. Examples of acceptable Type K or Proprietary concrete barrier are shown in Figures 3, 4, and 5.

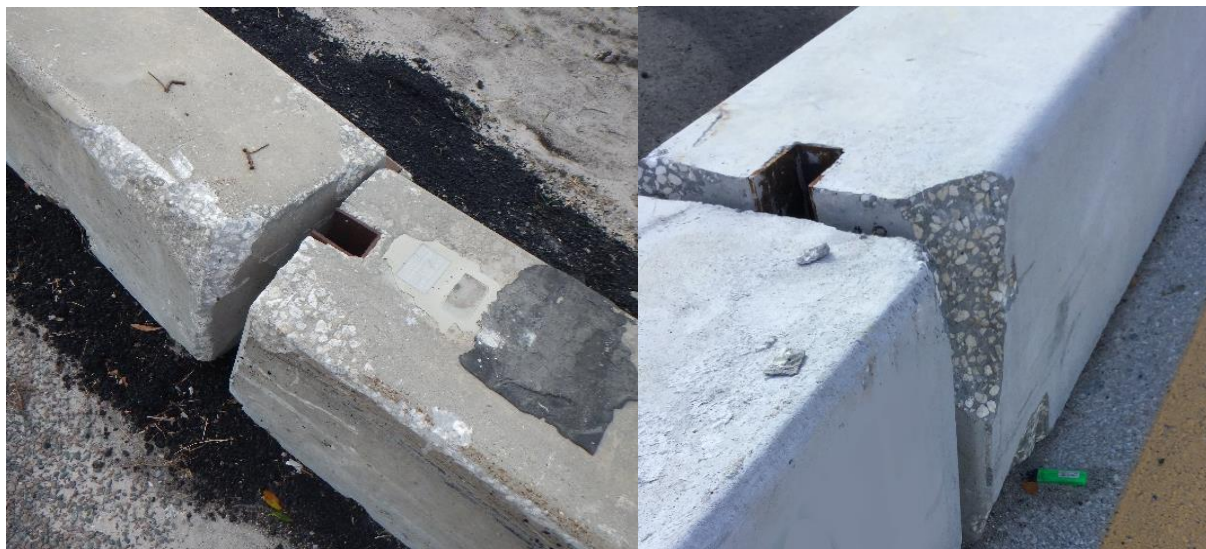
Figure 2: Acceptable Low-Profile Concrete Barrier with spalls of 1.5 inches or less

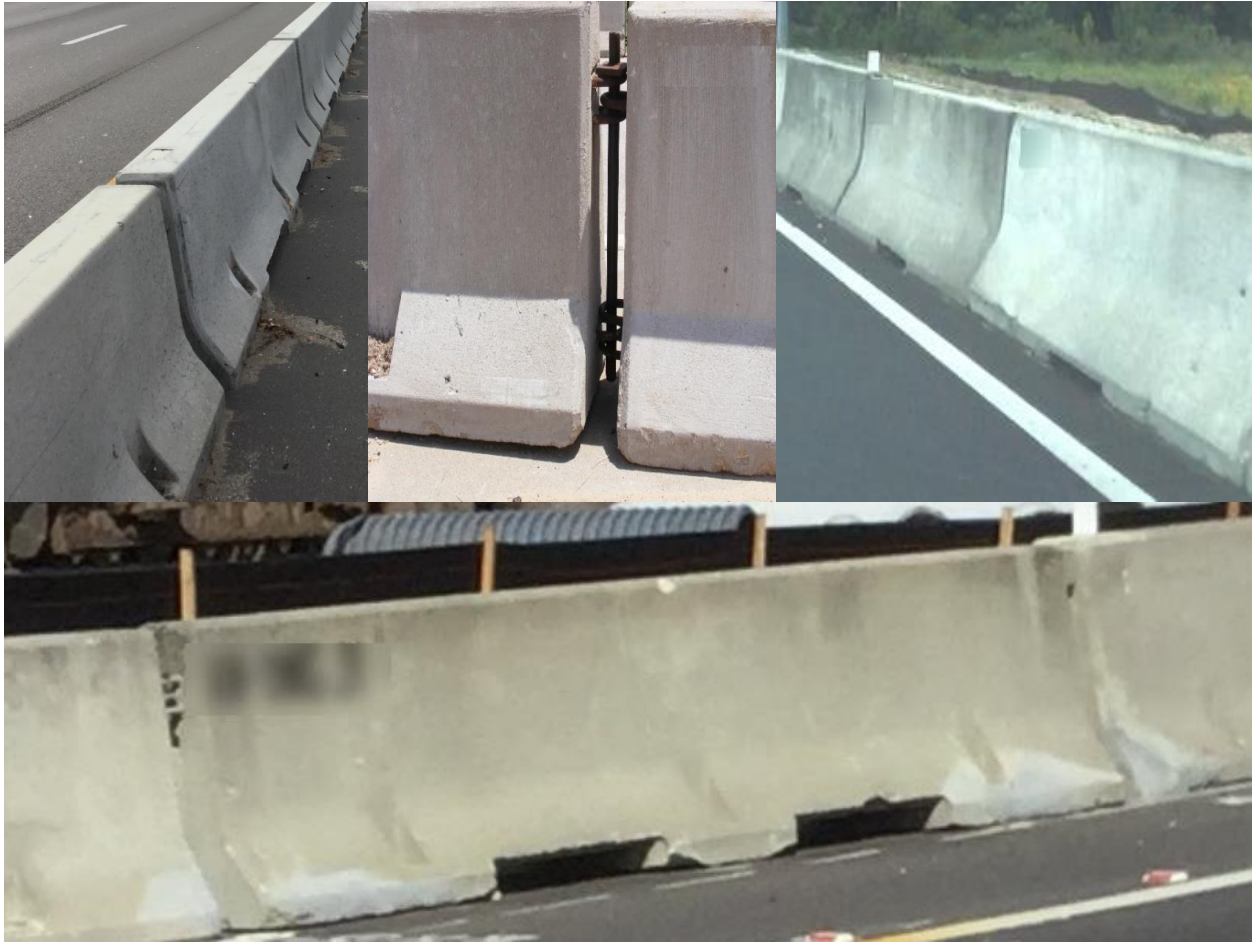
Figure 3: Examples of Acceptable Type K or Proprietary Concrete Barrier

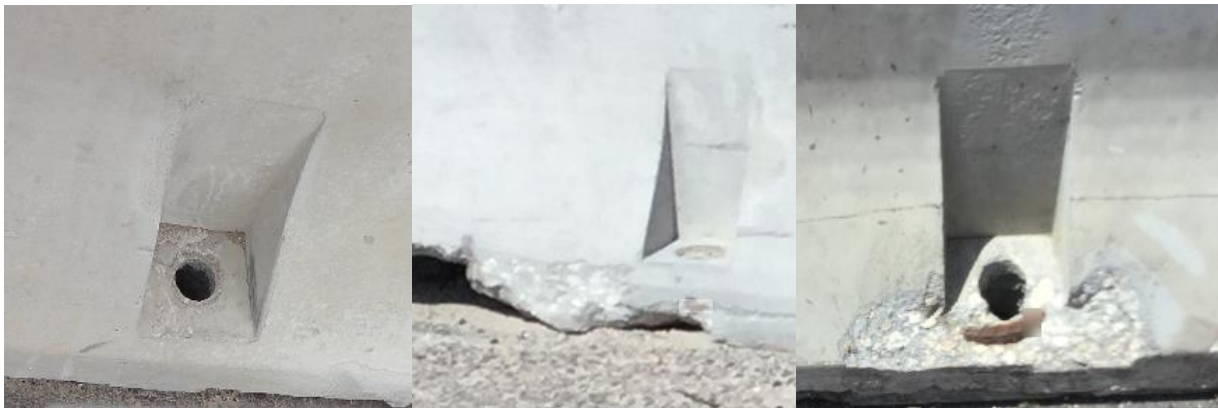
Figure 4: Acceptable Type K or Proprietary Concrete Barrier Anchor Slots – From left to right: Undamaged anchor slot; Anchor slot with spalled concrete less than 1.5 inches in depth; Anchor slot with spalled concrete less than 1.5 inches in depth and exposed rebar

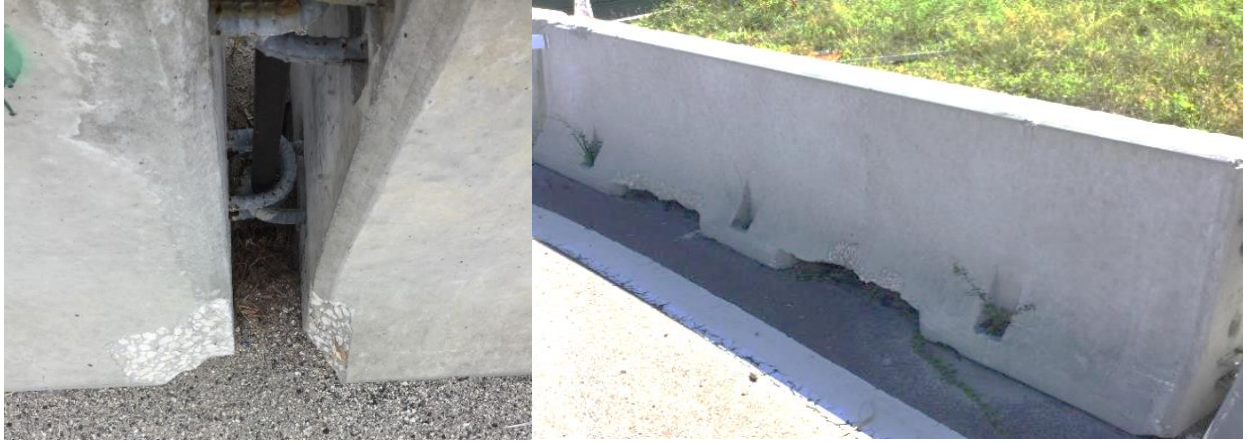
Figure 5: Examples of Acceptable Type K or Proprietary Concrete Barrier with spalls of 1.5 inches or less

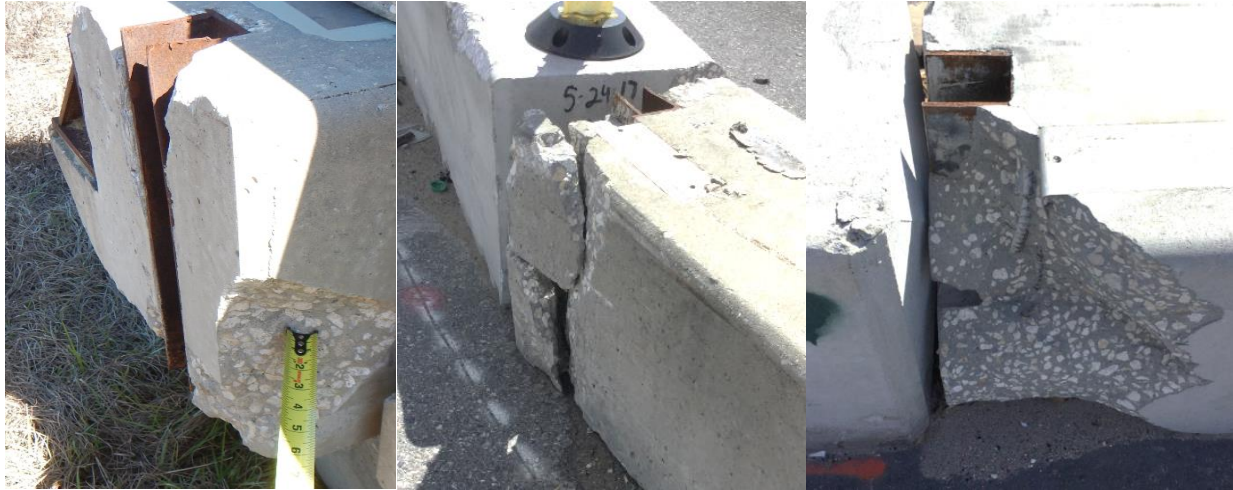
Figure 6: Examples of Unacceptable Low-Profile Concrete Barrier – From left to right: Barrier with spall greater than 1.5 inches; Barrier with cracked and broken concrete that could easily be dislodged resulting in conditions 1 or 2 above; Barrier with damage to a connection assembly and spalling greater than 1.5 inches in depth with exposed rebar.

1. The barrier has multiple cracks throughout, structural cracks or cracks through the entire cross-section.
2. Spalls with a depth greater than 1.5 inches; any location with exposed rebar or rebar protruding from the barrier (excluding anchor slots); or bolts protruding from the barrier face.
3. Cracked or broken concrete that could easily be dislodged if hit, resulting in either of the two conditions above.
4. Anchored barrier with broken concrete with shear cracks.
5. The unit-to-unit connection assemblies are deformed, bent, broken, or no longer in a fixed position.
6. Examples of unacceptable Low-Profile concrete barrier are shown in Figure 6.
7. Examples of unacceptable Type K or Proprietary concrete barrier are shown in Figures 7 through 10.

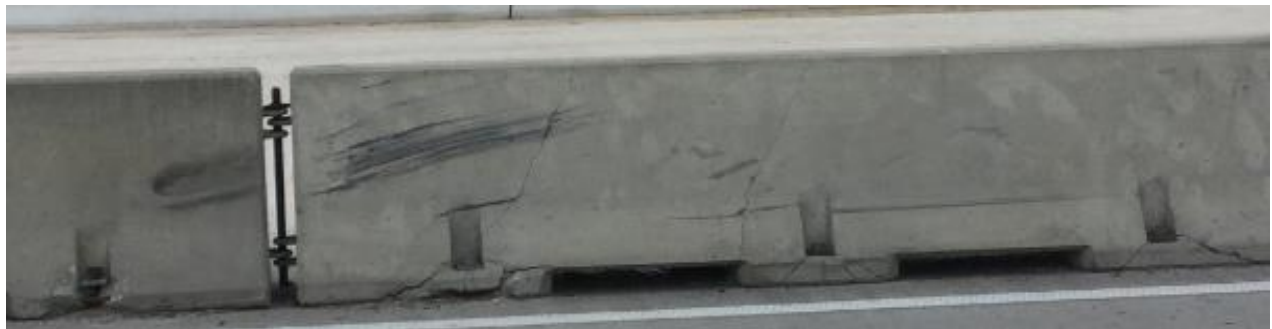
Figure 7: Example of Unacceptable Type K or Proprietary Concrete Barrier – Barrier has multiple cracks that extend through the entire cross-section and broken concrete with shear cracking around the anchor slots.

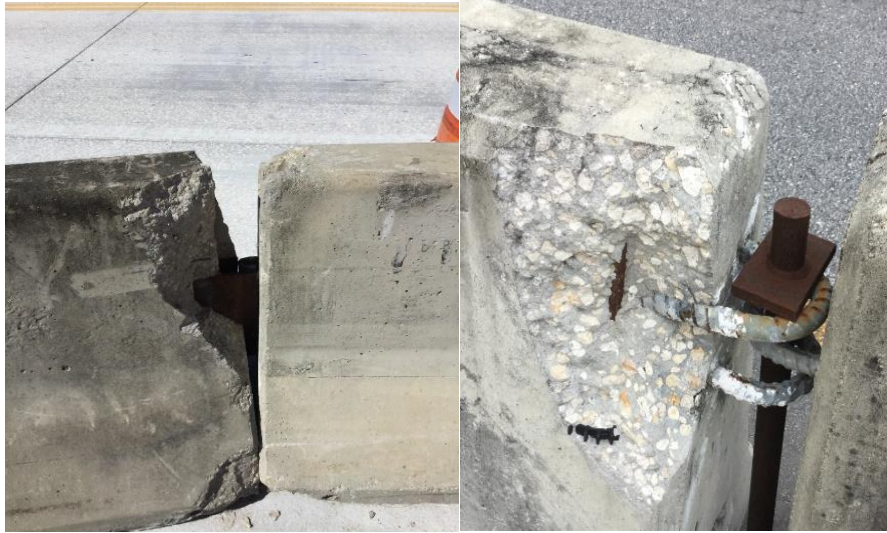
Figure 8: Examples of Unacceptable Type K or Proprietary Concrete Barrier with connection assembly damage – From left to right: Barrier has damage to unit-to-unit connection assembly and spalls greater than 1.5 inches in depth; Barrier has damage to unit-to-unit connection assembly, spalls greater than 1.5 inches in depth, and exposed rebar.

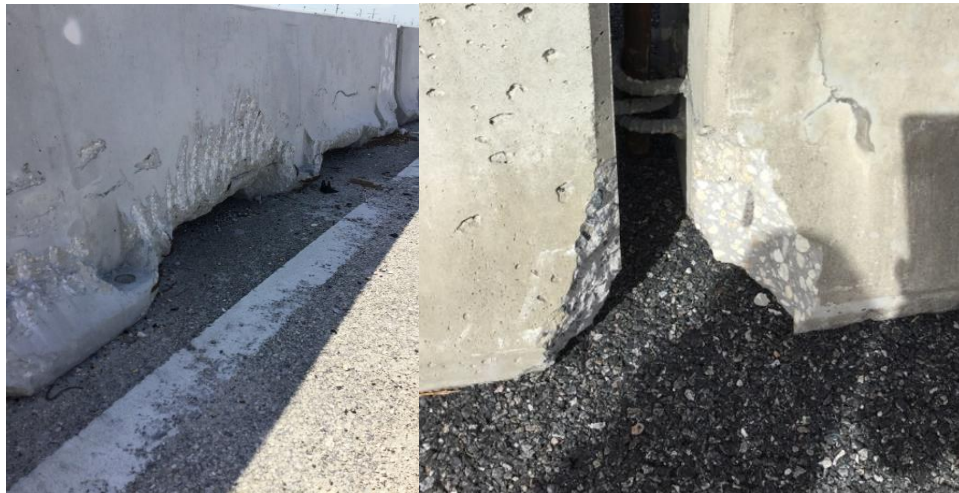
Figure 9: Examples of Unacceptable Type K or Proprietary Concrete Barrier with spalls greater than 1.5 inches– From left to right: Barrier has spalls greater than 1.5 inches in depth; Barriers have spalls greater than 1.5 inches in depth and the righthand unit has exposed rebar.

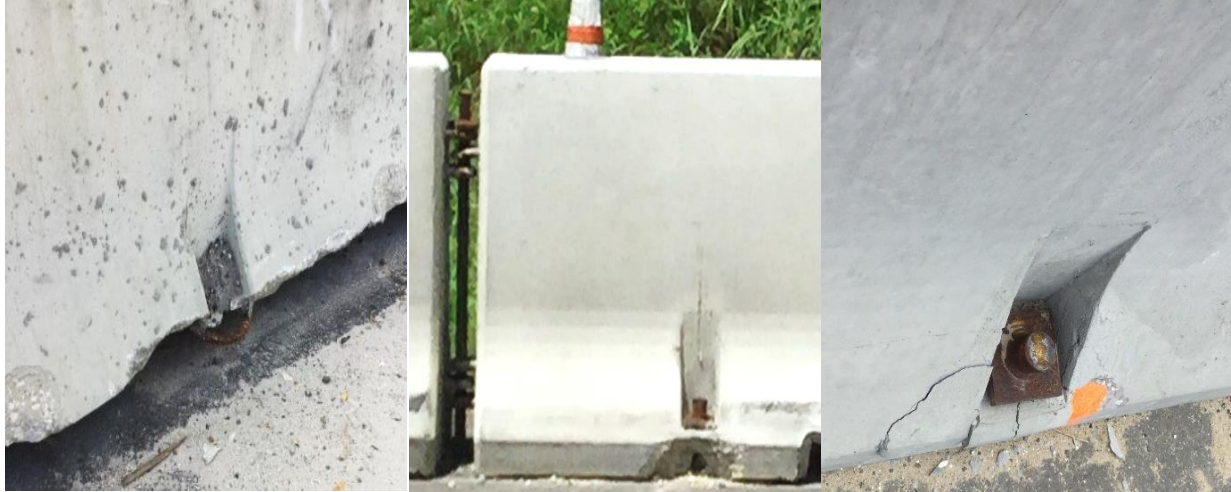
Figure 10: Examples of Unacceptable Type K or Proprietary Concrete Barrier with broken concrete or shear cracking at the anchor slot – From left to right: Concrete has completely broken away at the anchor slot due to shear cracking; Broken concrete at the anchor slot due to shear cracking; Broken concrete at the anchor slot due to shear cracking.
