# Pavement Conditions

THE FOLLOWING PICTURES ARE EXAMPLES OF SOME OF THE PAVEMENT CONDITIONS SPECIFIED IN SECTION 338.

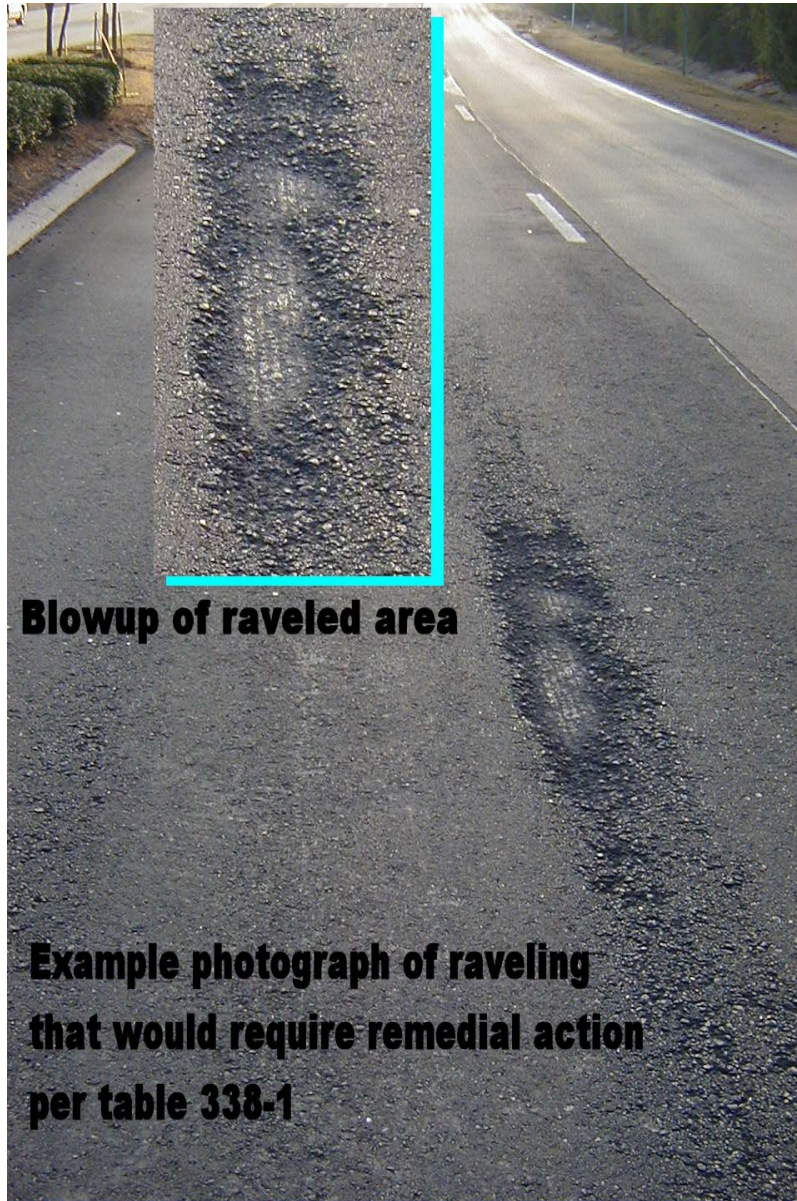
**RAVELING** - The progressive separation of aggregate particles in a pavement from the surface downward or from the edges inward.

**Blowup of raveled area**

**Example photograph of raveling  
that would require remedial action  
per table 338-1**

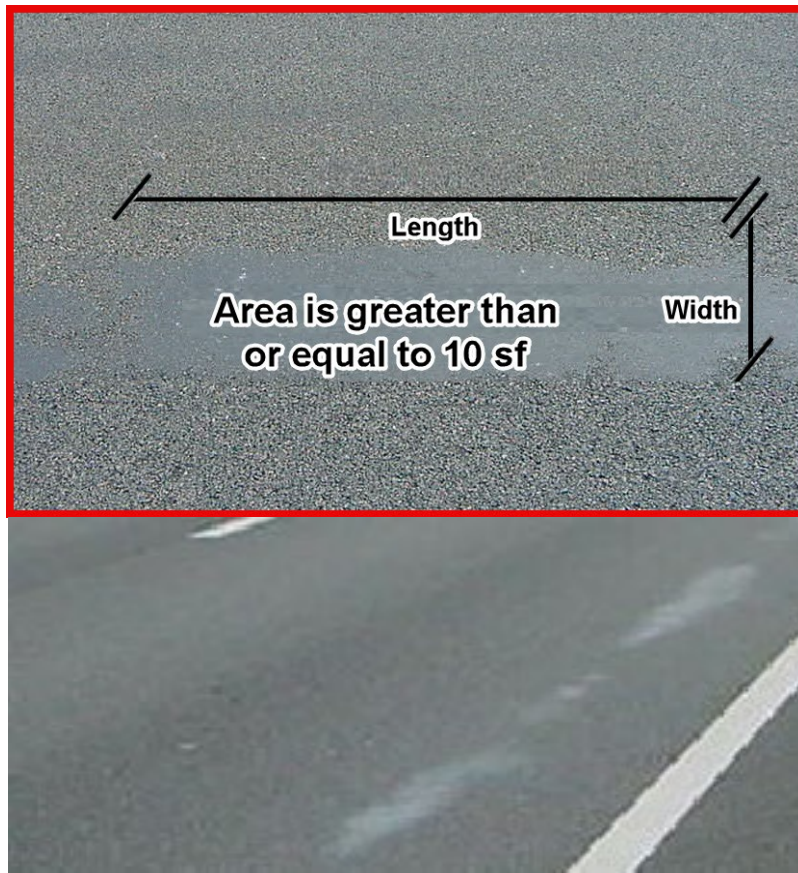
**BLEEDING** - The upward movement of liquid asphalt resulting in the formation of a film of asphalt on the surface.

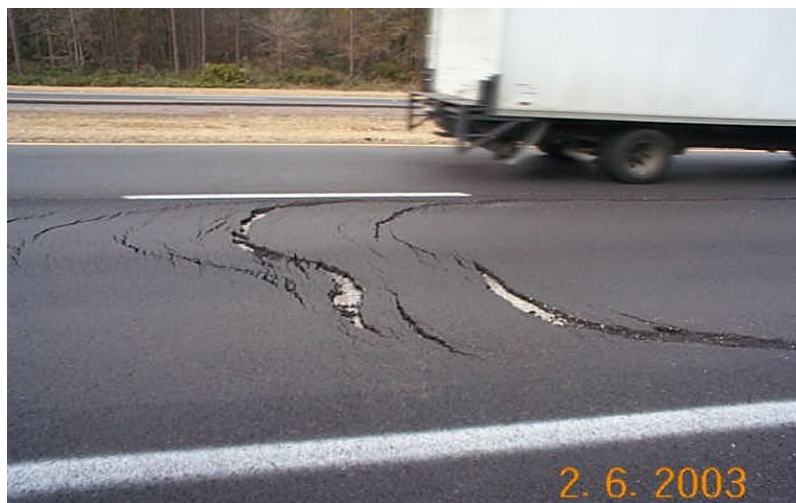
**SLIPPAGE**- The movement between layers when none should exist. Picture illustrates classical U pattern.
