**Materials Research Report  
Final Report**

**April 2019**

**UNF Project  
Contract No. BDV34-977-05**

# **Degradation Mechanisms and Service Life Estimation of Fiber Reinforced Polymer (FRP) Concrete Reinforcements**

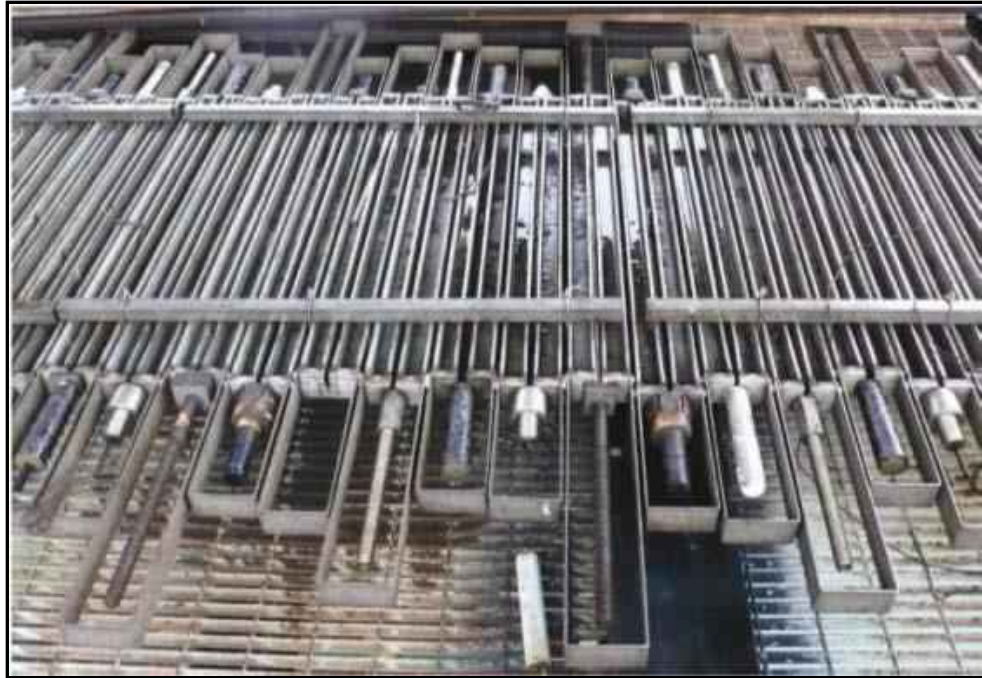
Figure 2.18: FRP cables pre-stressed in SUS flames (Sasaki and Nishizaki 2015)

In 2015, Sasaki and Nishizaki have carried out outdoor exposure tests for 17 years to verify the long-term durability. FRP cables, carbon, aramid, glass, and vinylon fibers were exposed in various conditions, such as initial prestressing tensile load, with/without direct sunlight radiation (Figure 2.17). After 3.5, 15, 17 years exposure, the specimens were retrieved and investigated with residual prestressing tensile load, strength, and material degradation. The results suggested that practical durability of carbon and aramid FRP cables seems to be still good, but initial loading level should be carefully considered for glass and vinylon FRP cables. The cables were also evaluated with chemical analysis such as SEM and FTIR microscopy. Loss of surface resin was observed for all the tested FRP cables; however, the deterioration between fiber and matrix resin was not found. Observation with FT-IR microscopy detected the deterioration in the surface of AFRP cables.

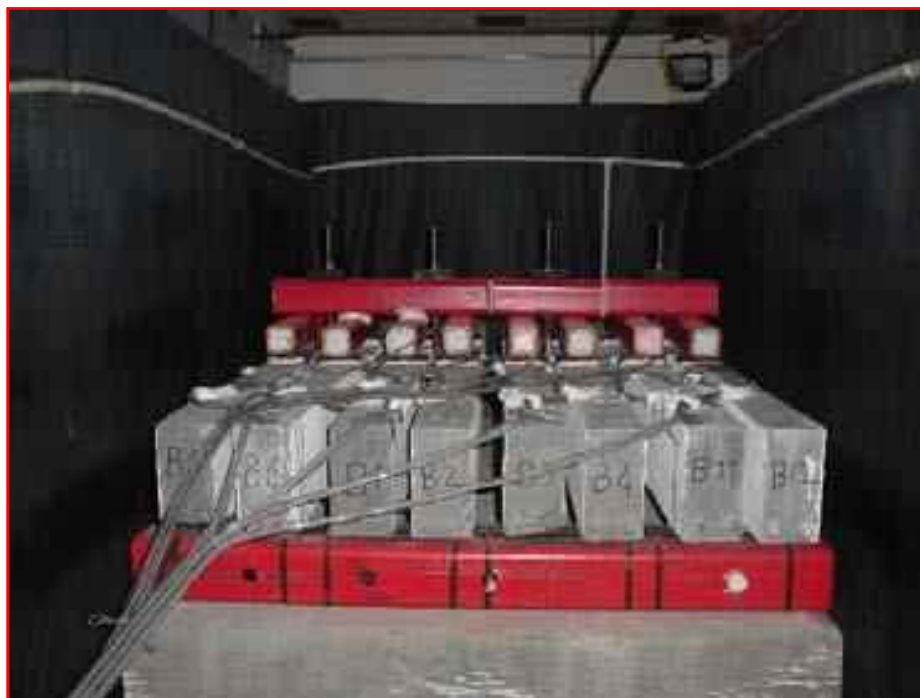
Figure 2.20: Test set-up for sustained loading (environmental exposure) (Mertol et al. 2007).

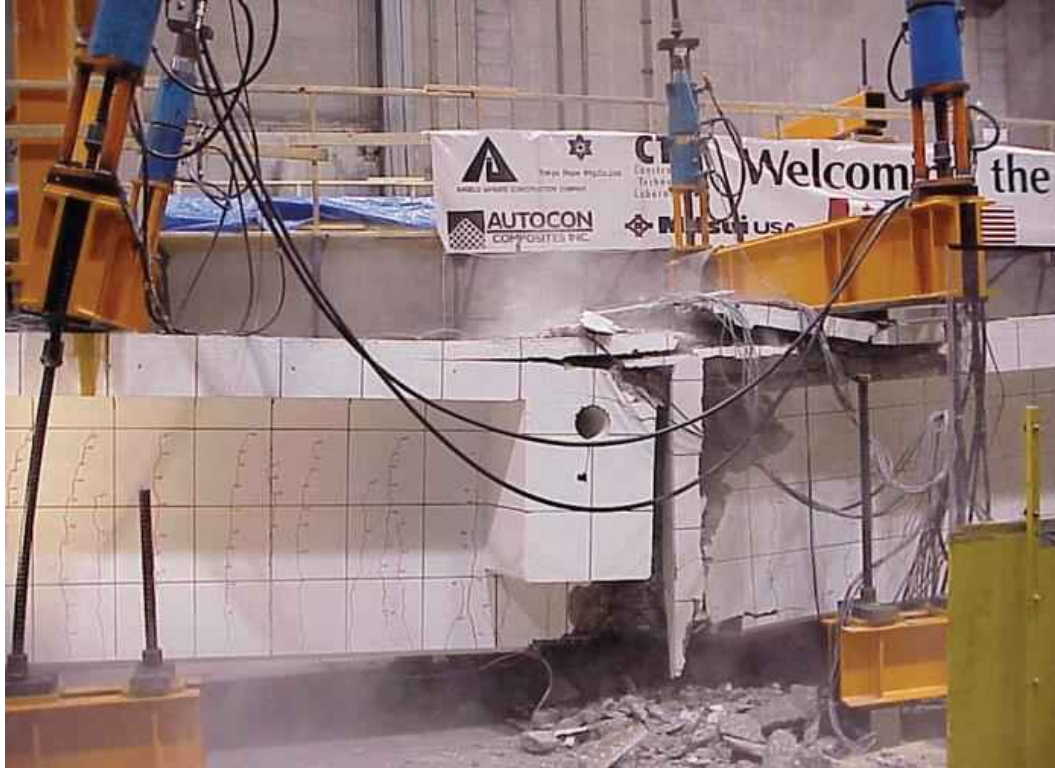
Figure 2.23: Failure of DT girder due to separation of concrete topping and crushing of concrete (Grace et al. 2003).

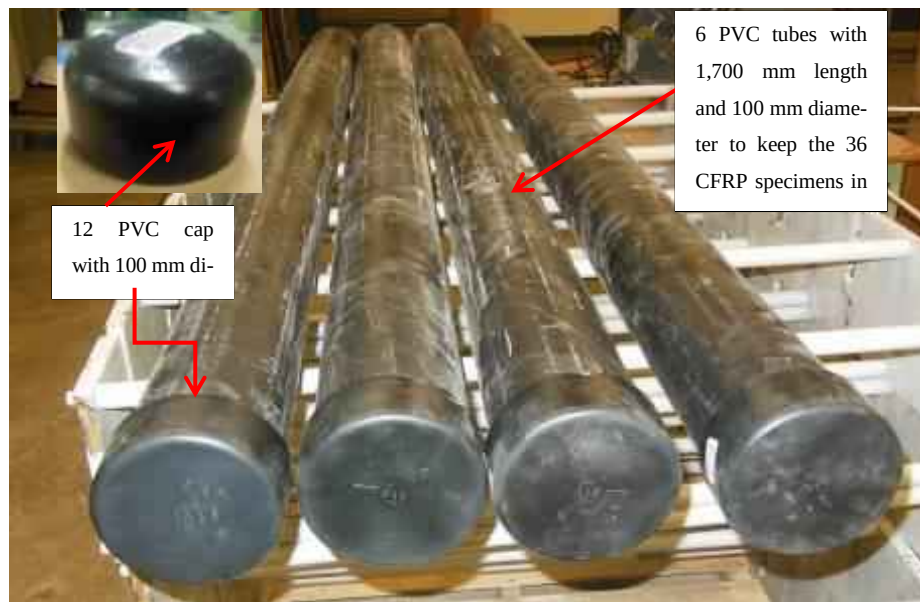
Figure 3.12: The CFRP specimens exposed to alkaline solution inside PVC tubes

40% and 65 % of their guaranteed strength. Figure 3.14 shows a schematic view of the one frame with six specimens placed in it. Figures 3.15 and 3.16 show the actual steel frame and a close up view of the anchors used to apply the sustained load. The alkaline solution was prepared using calcium hydroxide, potassium hydroxide, and sodium hydroxide (118.5 g of  $\text{Ca(OH)}_2$  + 0.9 g of  $\text{NaOH}$  + 4.2 g of  $\text{KOH}$  in 1 L of deionized water) according to CSA S806 and ACI 440.3R. The pH of the alkali solution was 12.8.

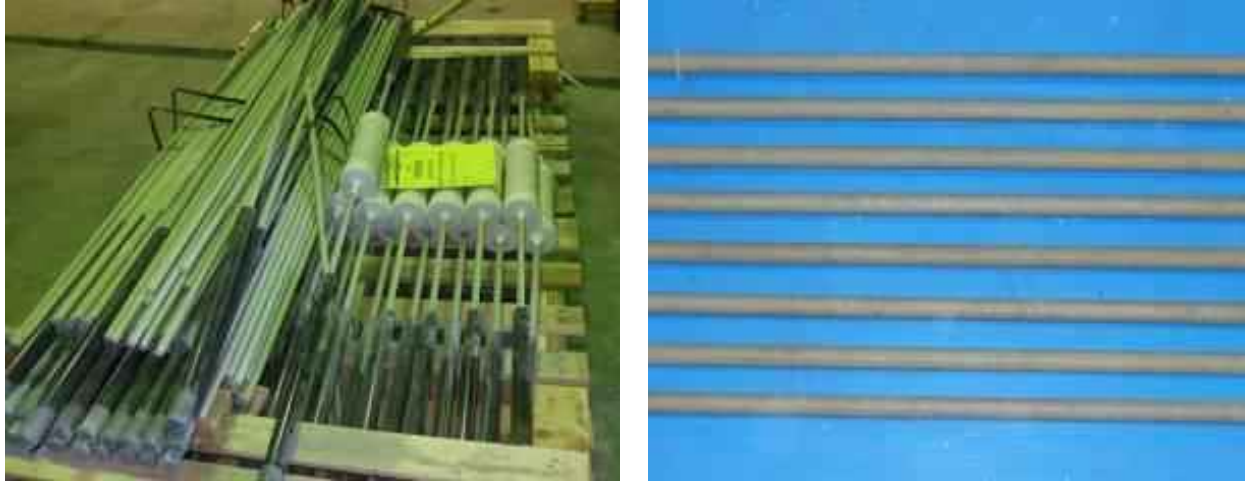
Figure 4.1: Pultrall GFRP bars as received (GFRP #5)

This chapter presents the physical and mechanical properties of two different types of GFRP bars, named Pultrall GFRP (No. 5) and Aslan GFRP bars (No. 6), under sustained tensile loading (0 % and 30%) in high alkali environment at different temperature exposures (see Figure 4.1 and 4.2) . In addition, an investigation on the durability of GFRP bars made with three different types of resin such as vinyl-ester, isophthalic polyester, or epoxy resins were evaluated and presented in this chapter.

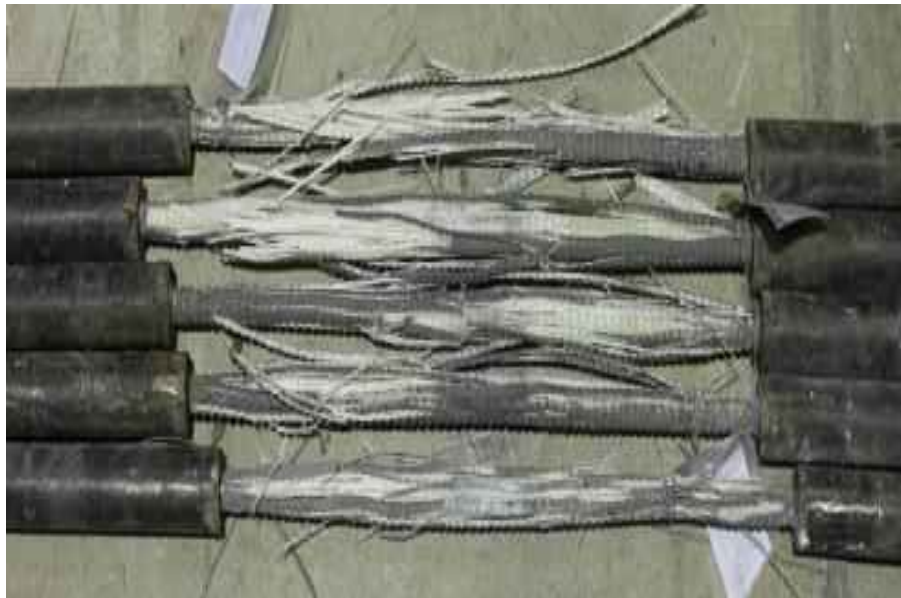
Figure 4.26: Typical mode of failure of vinyl ester GFRP bars

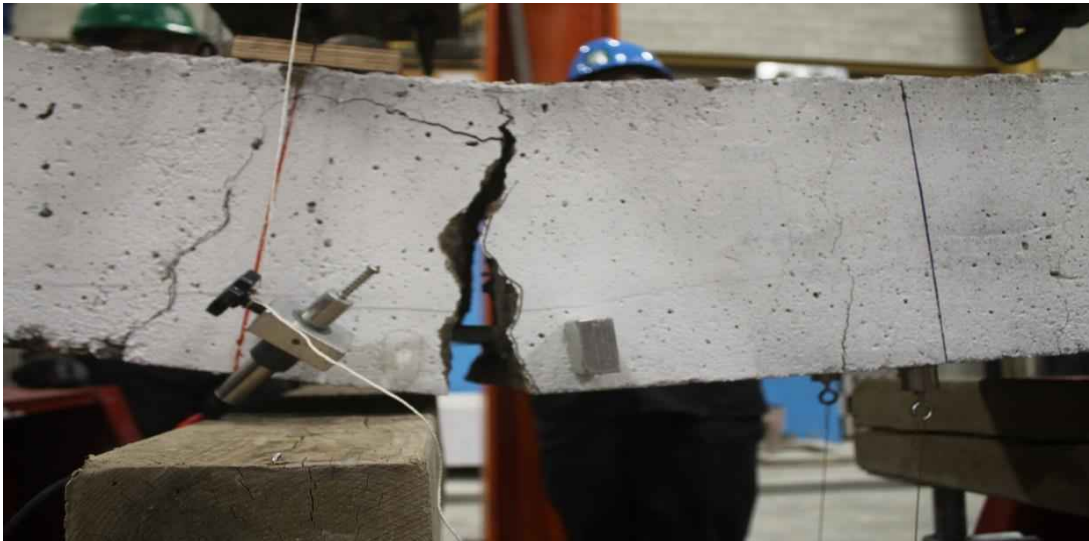
Figure 4.52: Flexural tension failure mode observed in all of the control and conditioned specimens

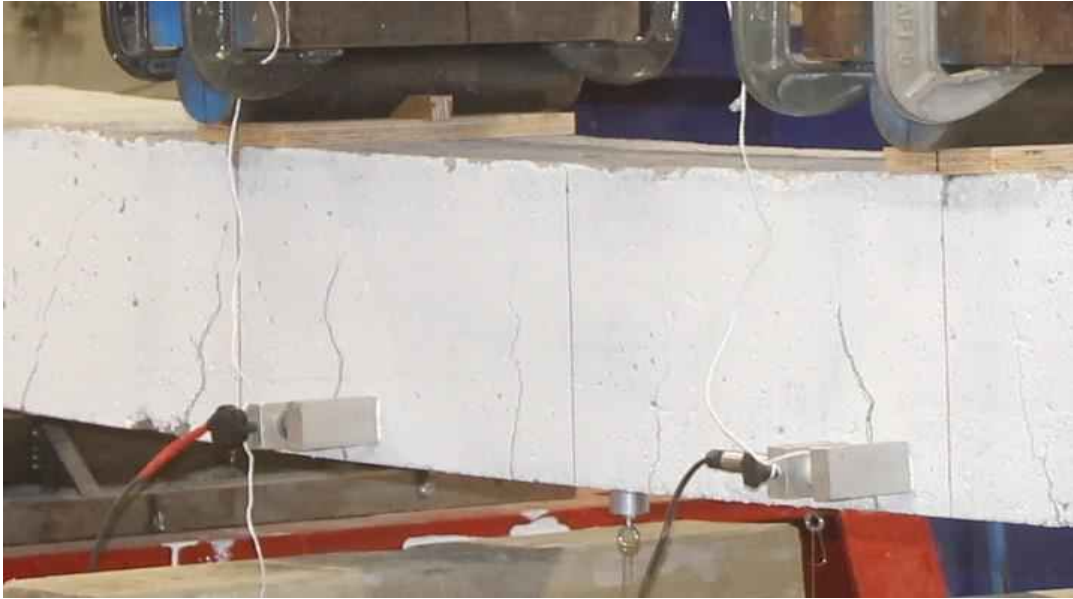
Figure 4.54: Crack pattern of the conditioned beam specimens

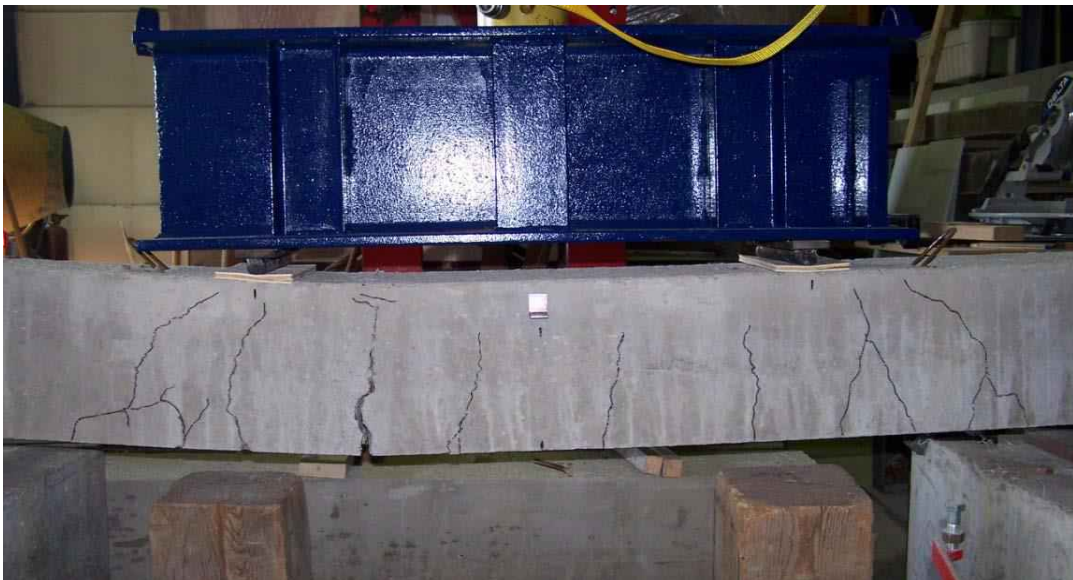
Figure 4.55: Crack pattern of the control beam specimens

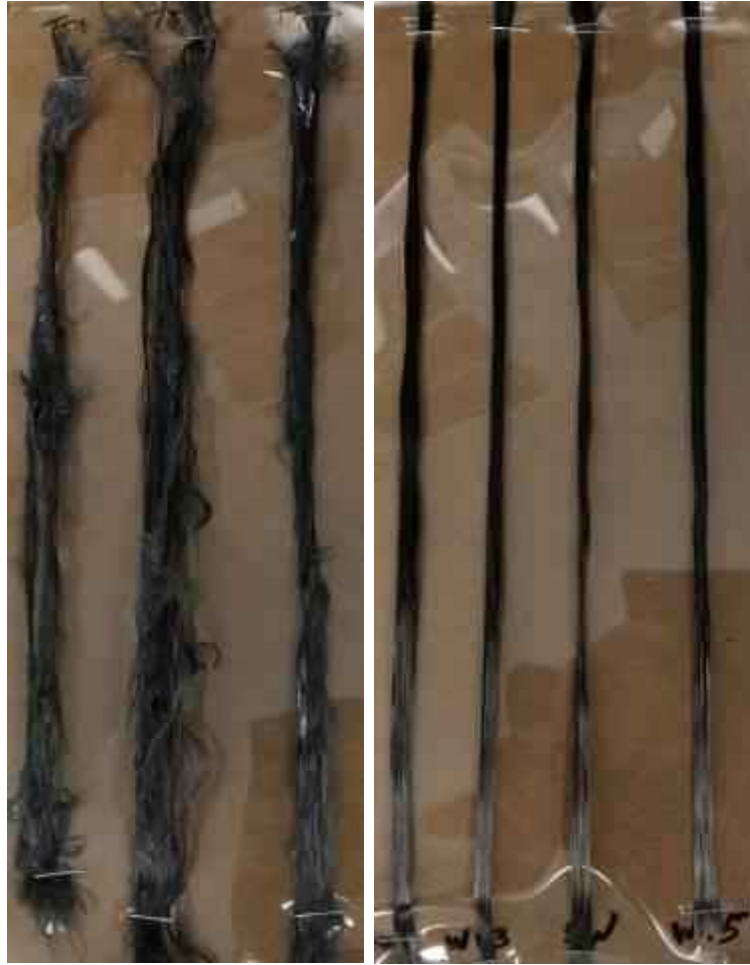
Figure 5.8: Comparison between specimens exposed to alkaline solution (left) and water (right).

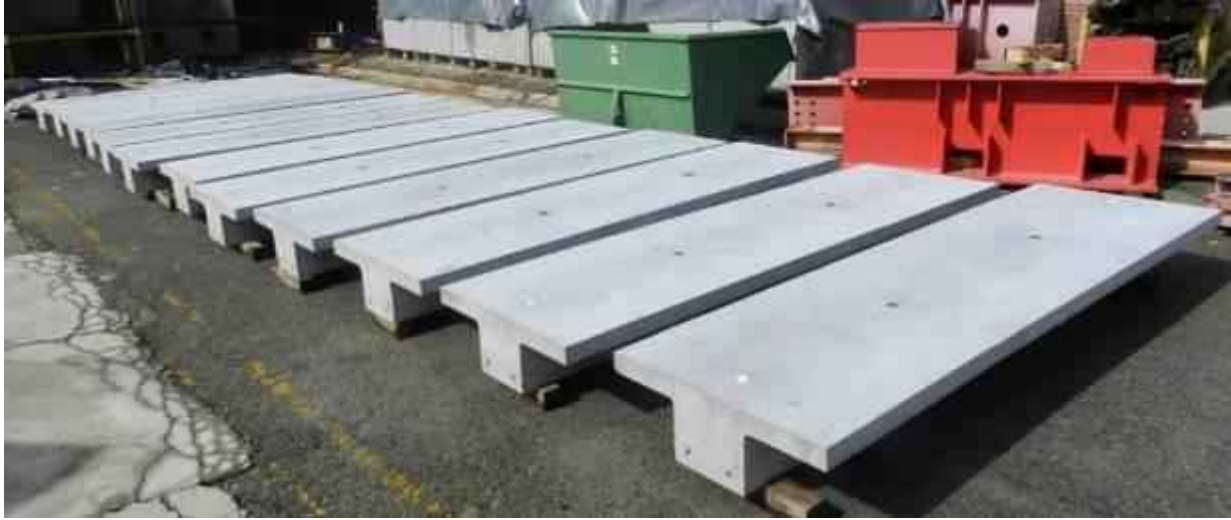
Figure 6.8: Beams stored at NCSU lab

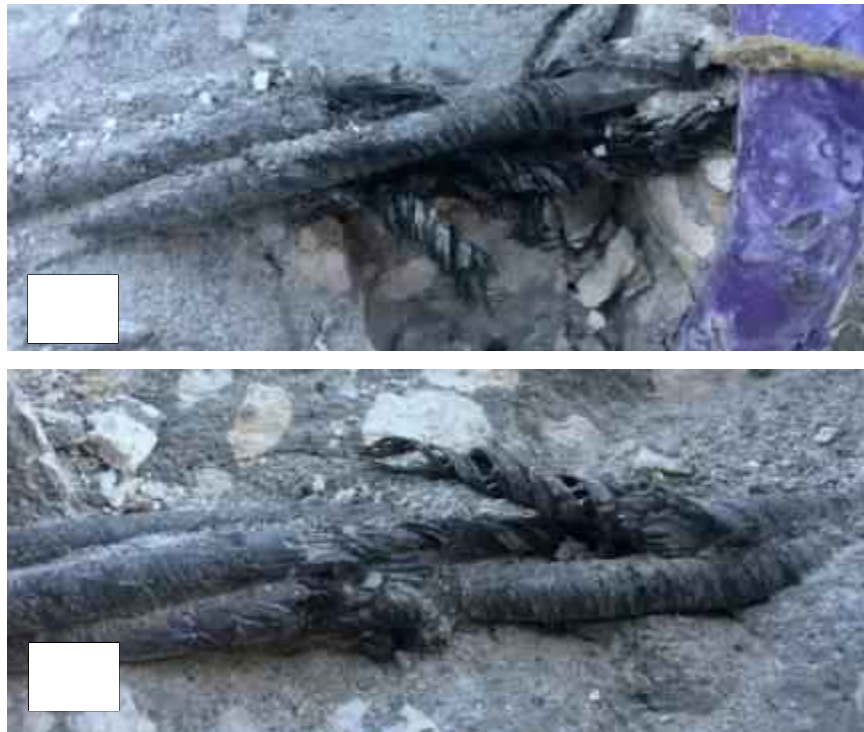
Figure 6.21: A close up view of the strand rupture after 3 months exposure (a) top beam (b) bottom beam.

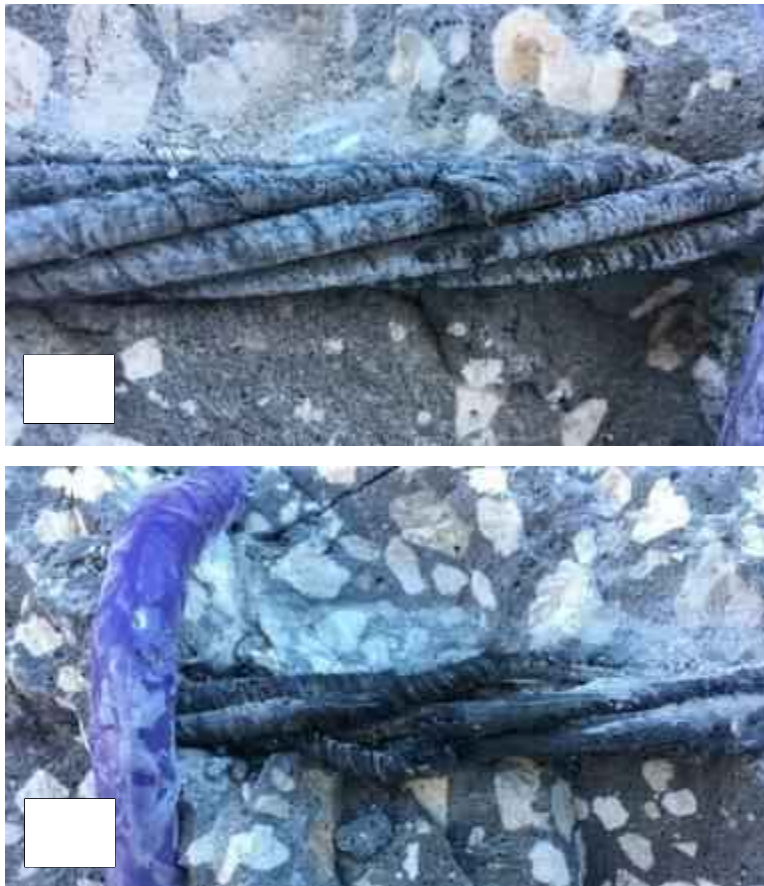
Figure 6.25: A close up view of the strand rupture after 6 months exposure (a) top beam (b) bottom beam.

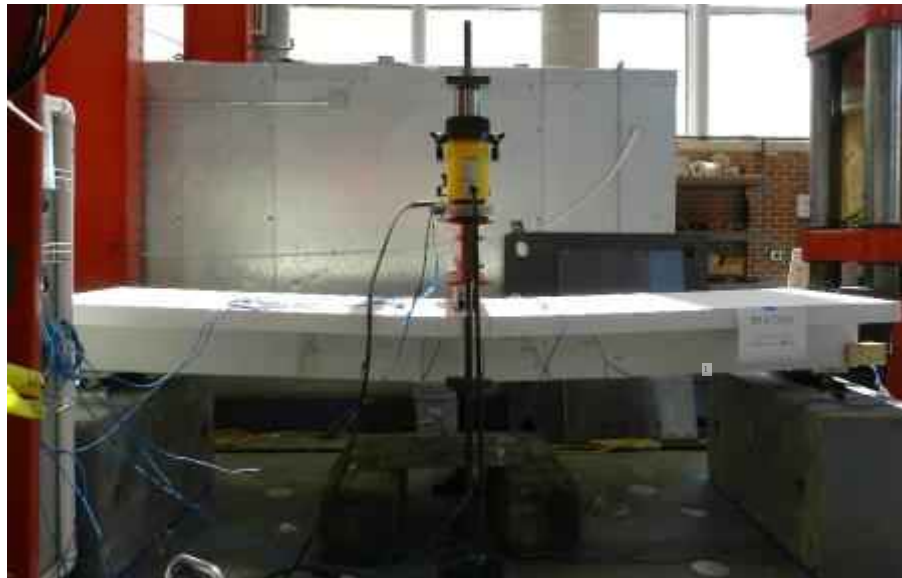
Figure 6.27: Failure of beam#7 after 12 months of exposure (Top Beam).

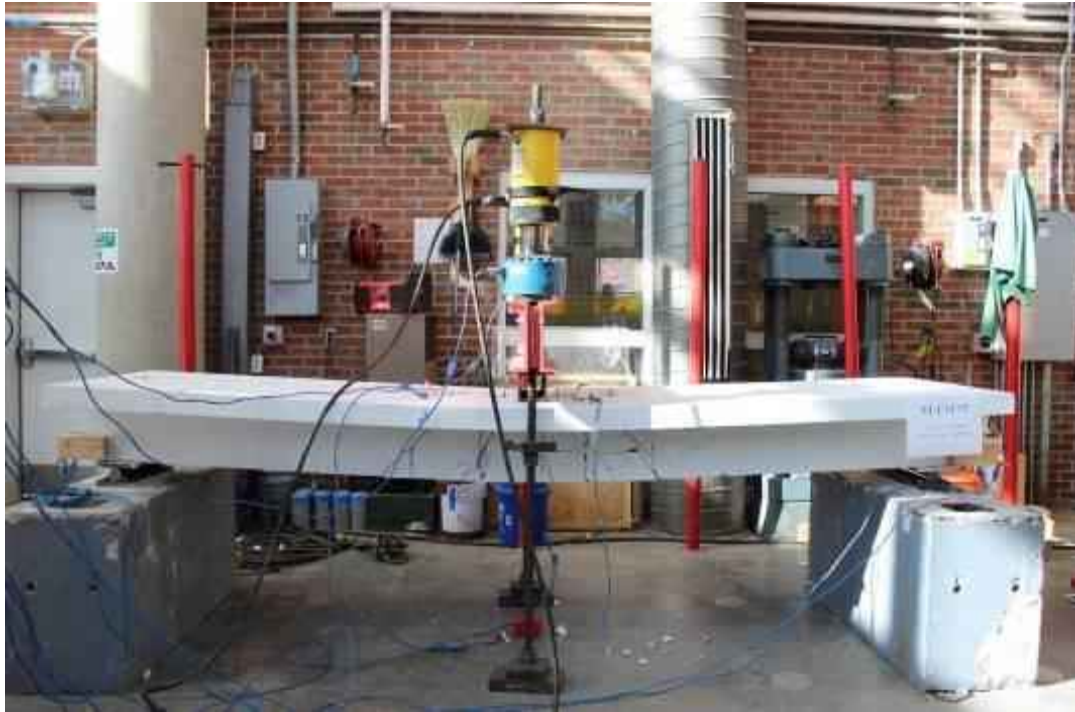
Figure 6.30: Failure of beam#9 after 18 months of exposure (Top Beam).

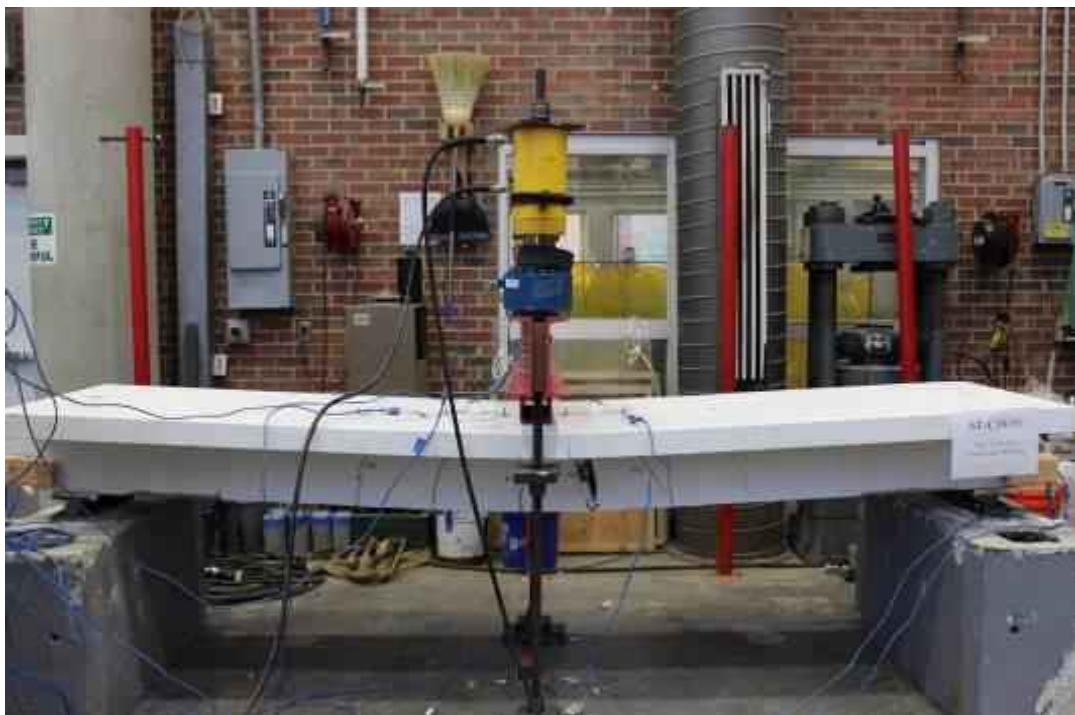
Figure 6.31: Failure of beam#10 after 18 months of exposure (Bottom Beam).

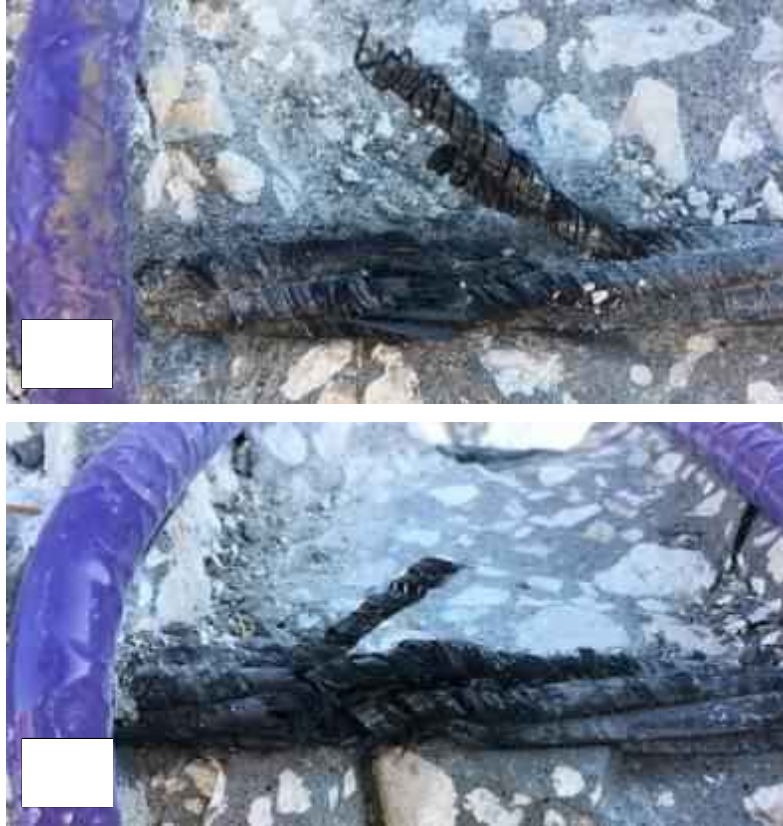
Figure 6.32: A close up view of the strand rupture after 18 months exposure (a) top beam (b) bottom beam.

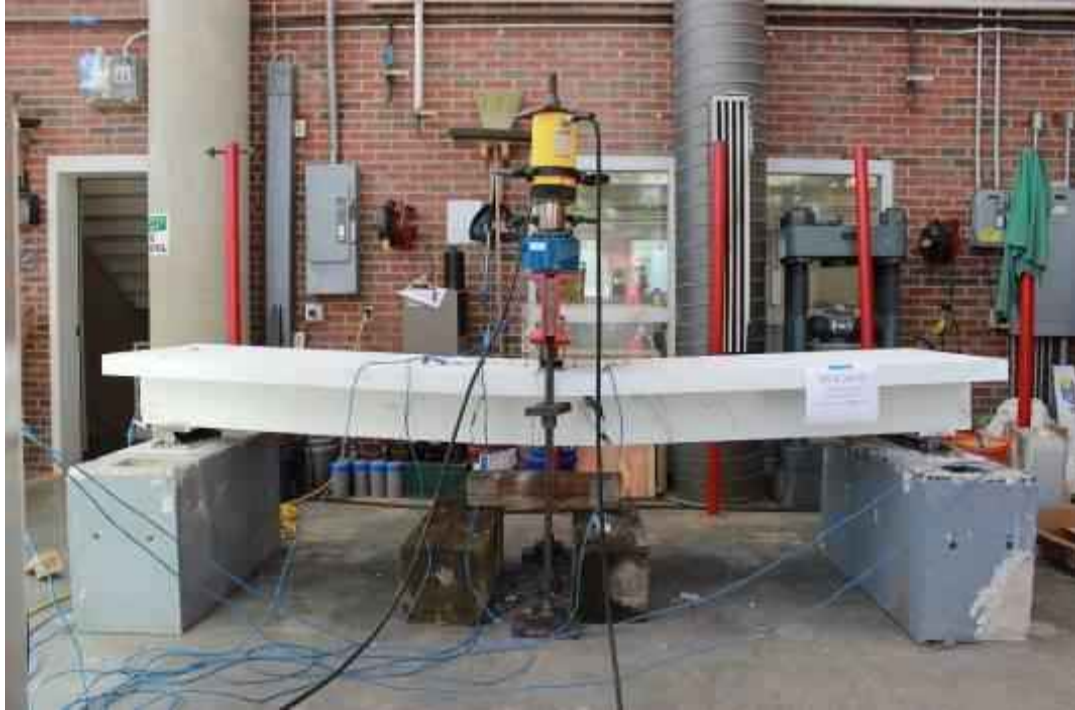
Figure 6.34: Failure of Beam#11 after exposure to sustained load for 18 months (Top Beam)

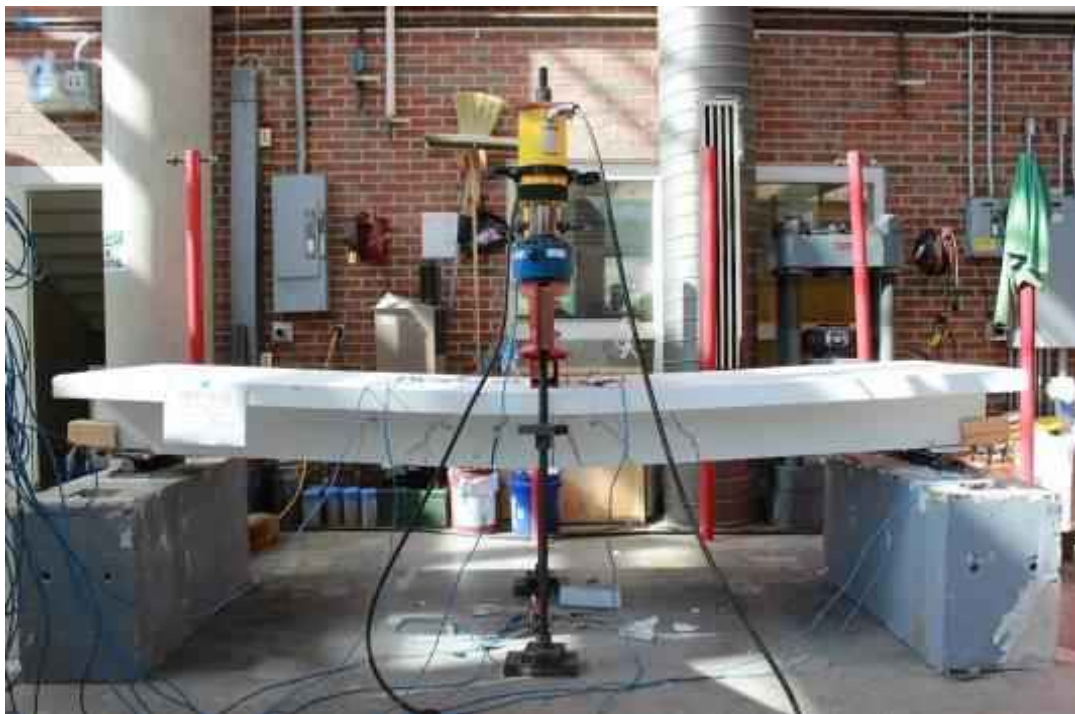
Figure 6.35: Failure of Beam#12 after exposure to sustained load for 18 months (Bottom Beam)

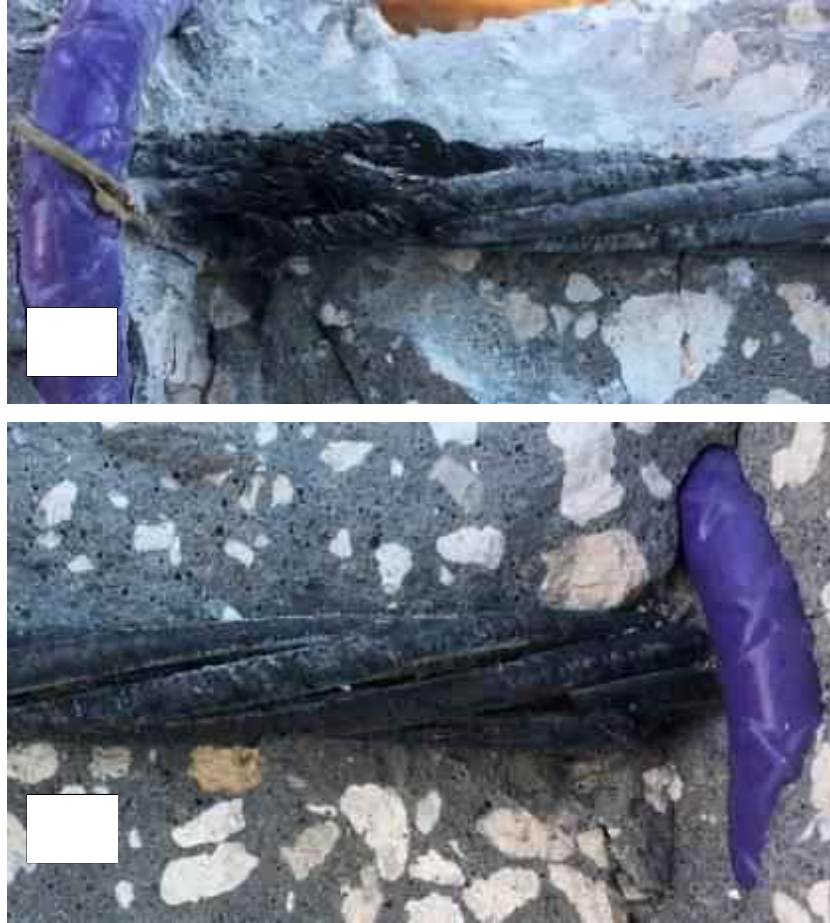
Figure 6.36: A close up view of the strand rupture after 18 months exposure to sustained load only (a) top beam (b) bottom beam.
