Aluminized Pipe Evaluation

FL/DOT/SMO 15-572

FDOT Office State Materials Office

Date of Publication 01-2015 Several recent aluminized pipe failures in the State of Florida prompted the Department to take a closer look at the quality of the pipe being produced today. Sections of pipe were sampled from all plants currently producing aluminized steel pipe for Department projects. These samples were sent to the State Materials Office, Corrosion Laboratory to perform an evaluation on the condition of the aluminum coating after fabrication. A total of nine pipe samples were acquired. See Table 1 for a list and description of these pipe samples.

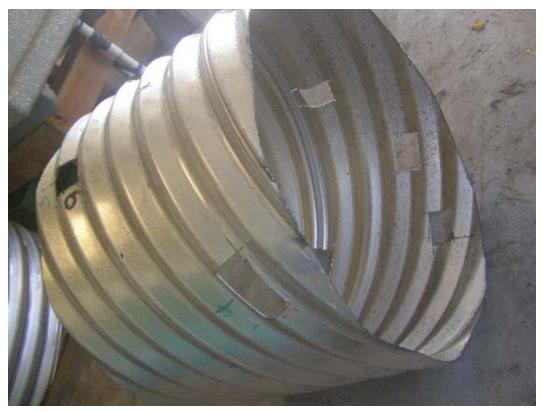
Figure 1. Pipe #2014-08-036 – 24" section of pipe. Eleven areas had visible damage, samples were removed for metallographic analysis

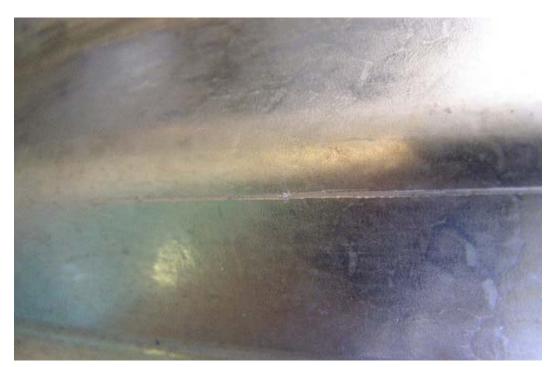
Figure 4. Pipe #2014-08-036 – Close up of a deep scratch on the corrugation. Visible damage to the aluminum coating is seen.

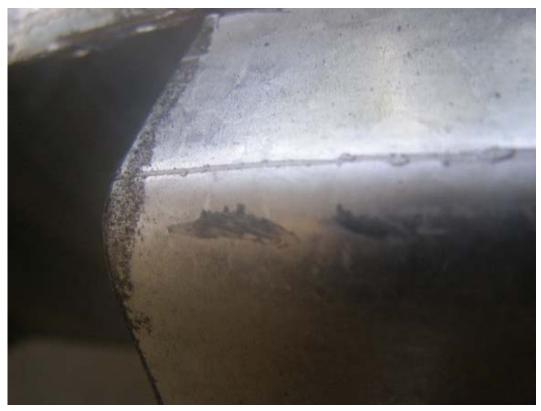
Figure 7. Pipe #2014-08-036 – Close up of gouges in the pipe. This shows visible damage.

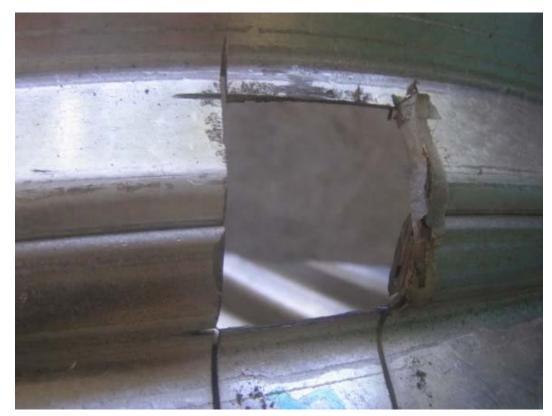
Figure 10. Pipe #2014-08-036 – Close up of the lock seam. There was no visible damage.

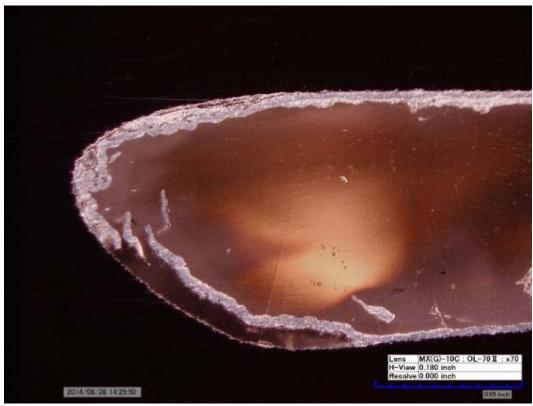
Figure 12. Pipe #2014-08-036 – The lock joint was examined under further magnification after additional polishing was performed. A clear separation of the aluminum layer is seen. 70x

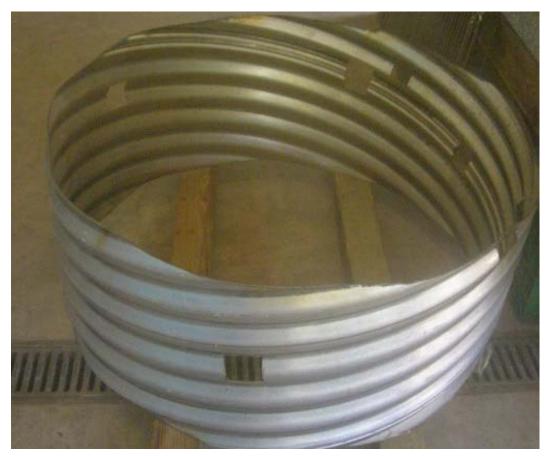
Figure 14. Pipe #2014-08-037 – 36" section of pipe. Five areas had visible damage, and samples were removed for metallographic analysis.

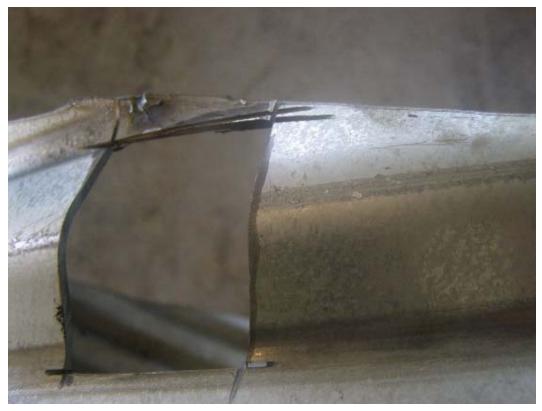
Figure 17. Pipe #2014-08-037 – Close up of a rolling mark showing visible markings on the exterior.

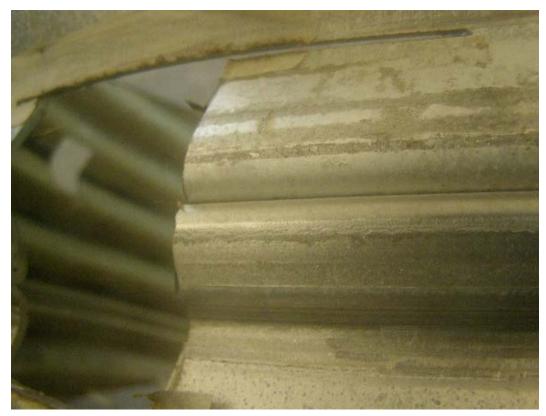
Figure 21. Pipe #2014-08-037 – Close up of the lock seam. There was no visible damage.

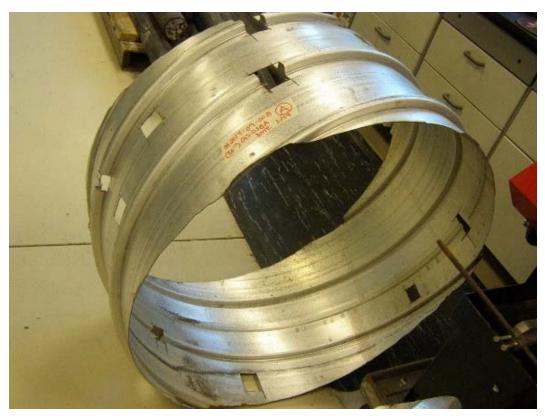
Figure 24. Pipe #2014-09-008 – 36" section of pipe. No visible damage to the aluminum coating. Multiple rolling marks on the corrugations.

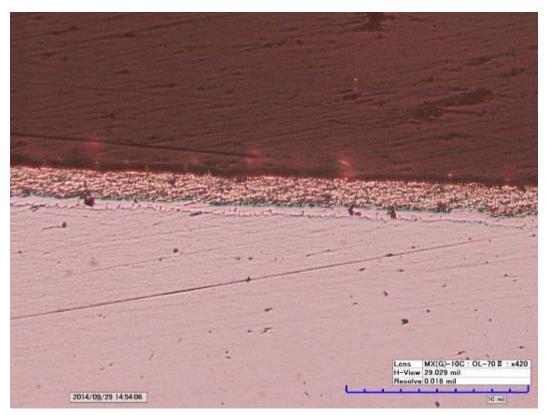
Figure 26. Pipe #2014-09-008 – Cross section of the control sample showing no visible damage to the aluminum layer; 420x

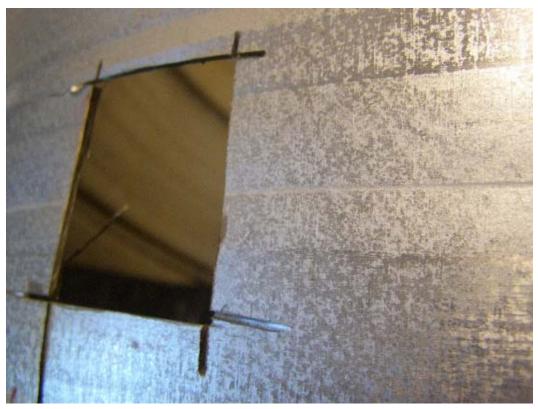
Figure 27. Pipe #2014-09-008 – Close up of rolling marks showing visible markings on the pipe surface.

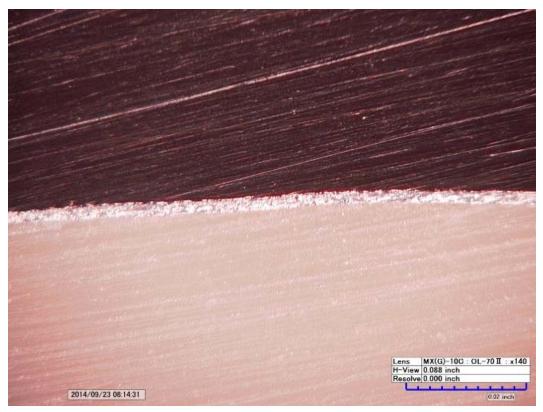
Figure 28. Pipe #2014-09-008 – Cross section of rolling mark area showing no visible damage to the aluminum layer. 140x

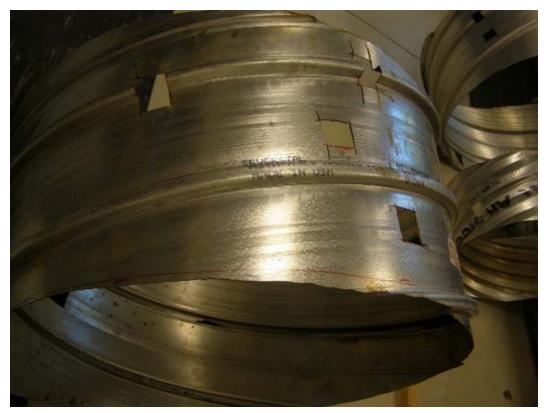
Figure 35. Pipe #2014-09-009 – 36" section of pipe. No visible damage to the aluminum coating. Multiple rolling marks on the corrugations.

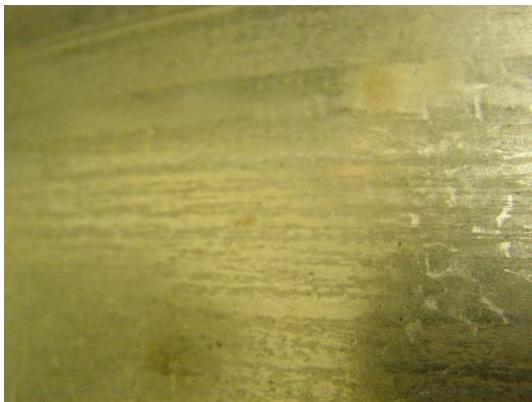
Figure 36. Pipe #2014-09-009 – Close up of the control sample showing no visible damage to the aluminum layer.

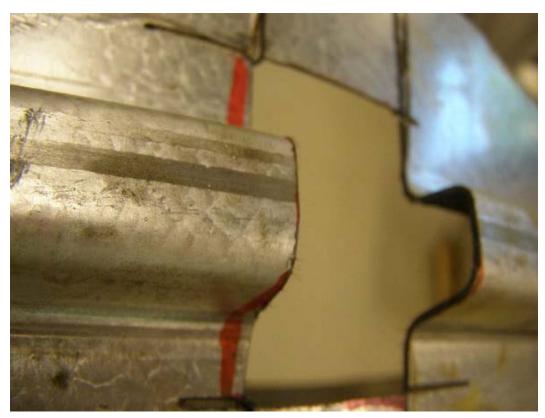
Figure 38. Pipe #2014-09-009 – Close up of rolling marks on top of the corrugation showing visible markings on the pipe.

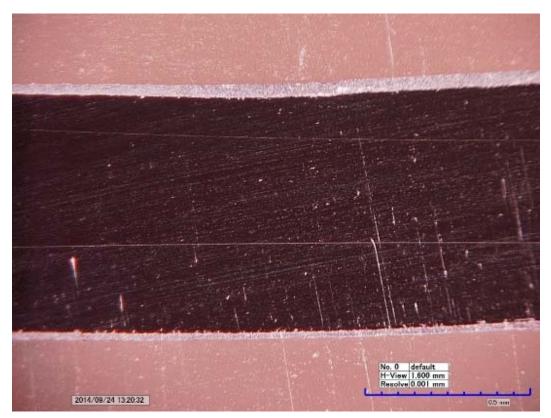
Figure 42. Pipe #2014-09-009 – Cross section of rolling mark area showing no visible damage to the aluminum layer. 70x

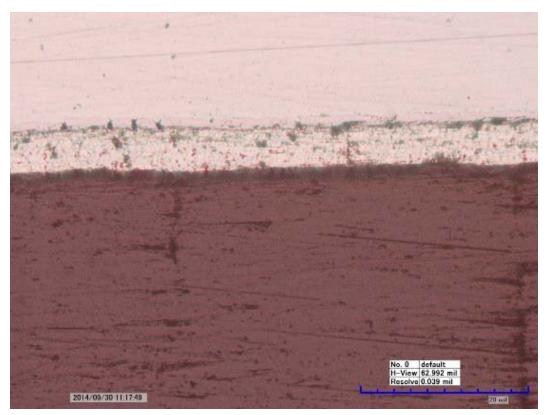
Figure 43. Pipe #2014-09-009 – Cross section of rolling mark area under further magnification showing no visible damage to the aluminum layer; 420x

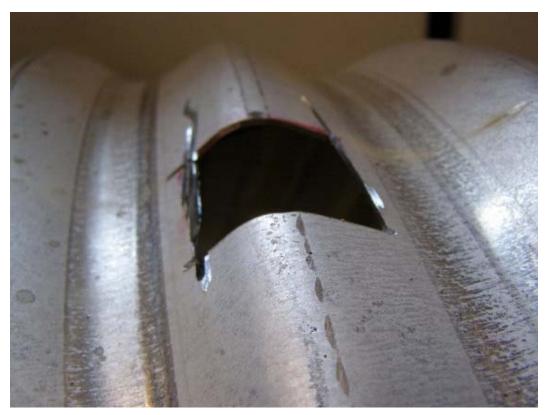
Figure 63. #2014-09-017 – Close up of rolling marks on top of the corrugation showing visible markings on the pipe.

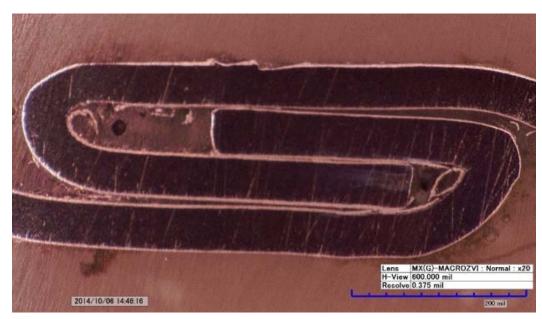
Figure 68. #2014-09-017 – Low magnification of the lock joint. There is apparent damage to the aluminum layer on the exterior, as well as the common damage in the folds to the aluminum layer. 20x

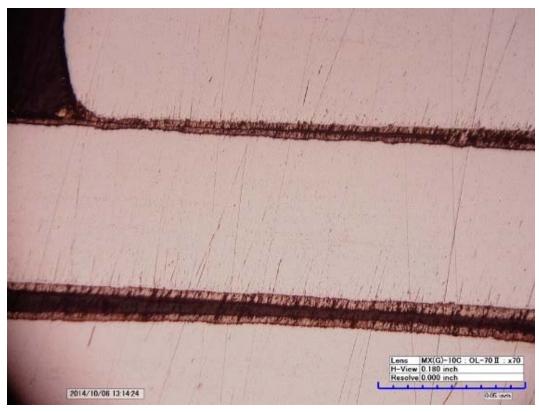
Figure 69. #2014-09-017 – The center of the lock joint shows no visible damage to the aluminum layer. 70x

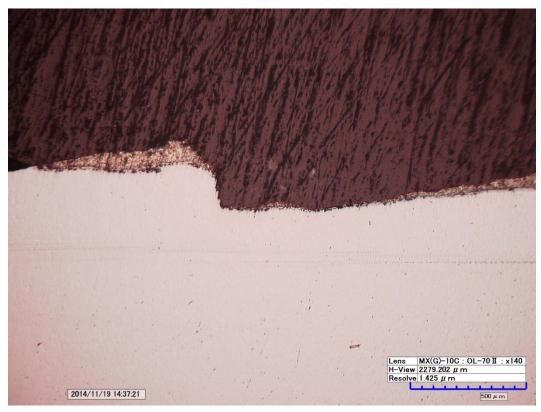
Figure 70. #2014-09-017 – Cross section of the lock joint showing damage on the top surface to the aluminum layer, inner metallic layer and the steel substrate. 140x

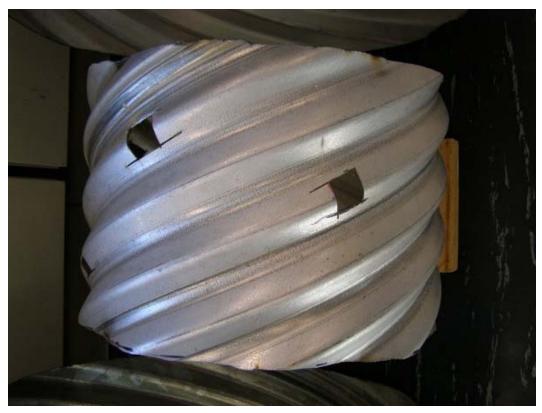
Figure 71. #2014-09-018 – 36" section of pipe. One area had visible damage, and samples were removed for metallographic analysis

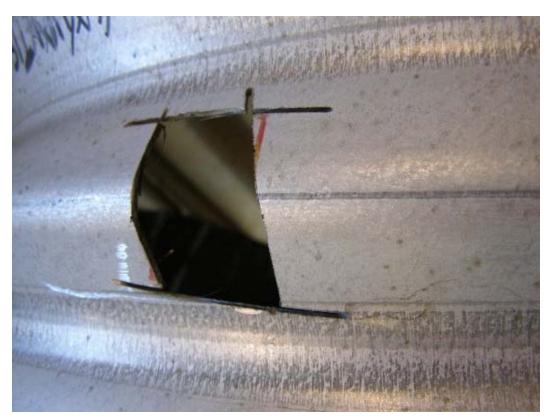
Figure 74. #2014-09-018 – Close up of rolling marks on top of the corrugation showing visible markings on the pipe.

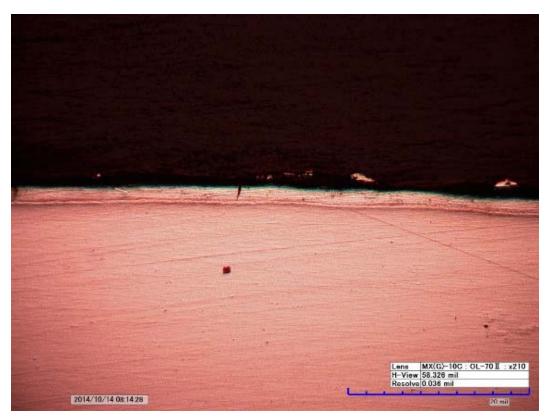
Figure 75. #2014-09-018 – Cross section of the rolling mark area shows no damage to the aluminized layer. 210x

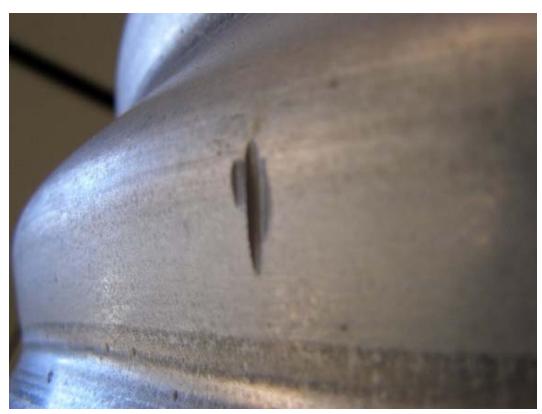
Figure 76. #2014-09-018 – Close up of a gouge or cut in the pipe.

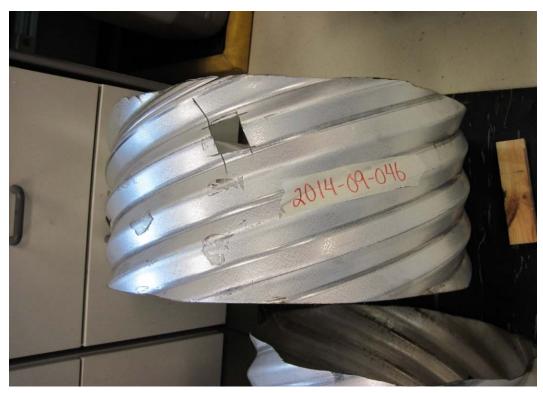
Figure 84. #2014-09-046 – 24" section of pipe. Two areas had visible damage, and samples were removed for metallographic analysis.

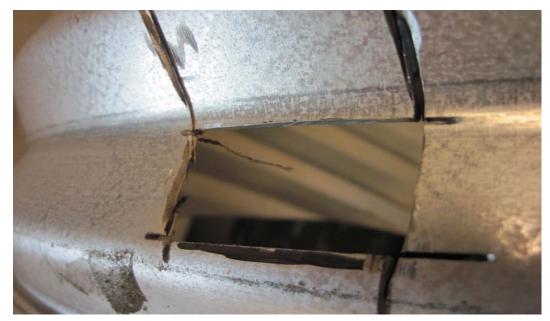
Figure 85. #2014-09-046 – Close up of a control sample. This shows no visible damage.

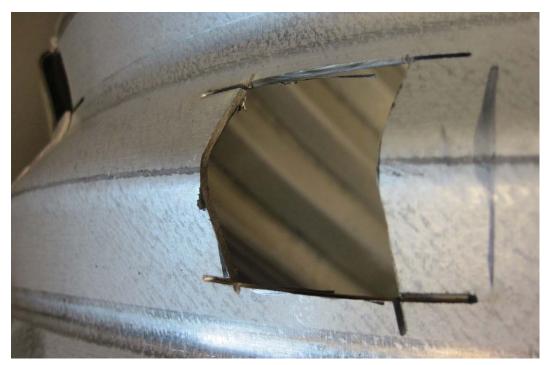
Figure 87. #2014-09-046 – Close up of rolling marks on top of the corrugation showing visible markings on the pipe.

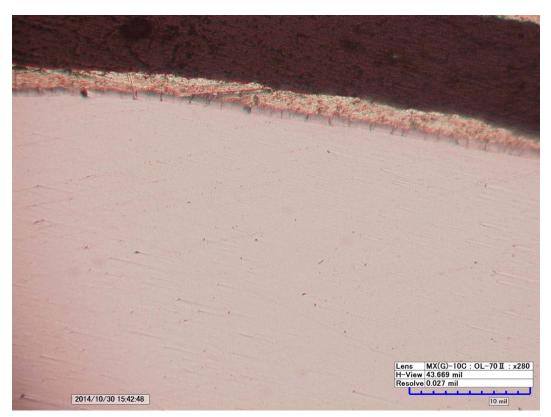
Figure 95. #2014-09-046 - Cross section of the lock joint showing no visible damage to the aluminum or inner metallic layer. 280x

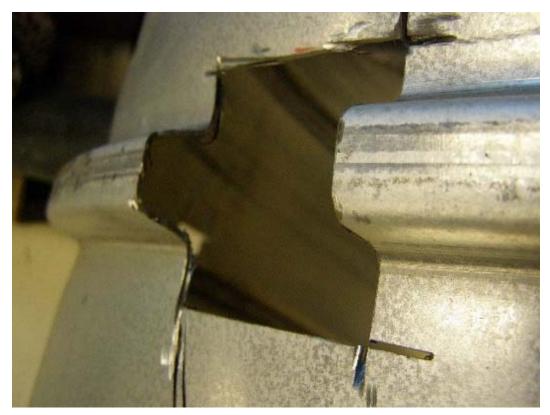
Figure 101. #2014-10-02 – Close up of rolling marks on top of the corrugation showing visible markings on the pipe.

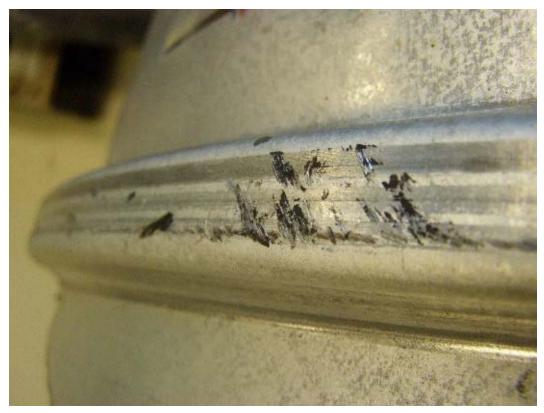
Figure 103. #2014-10-02 – Close up of scuff or scrape marks on the corrugation.

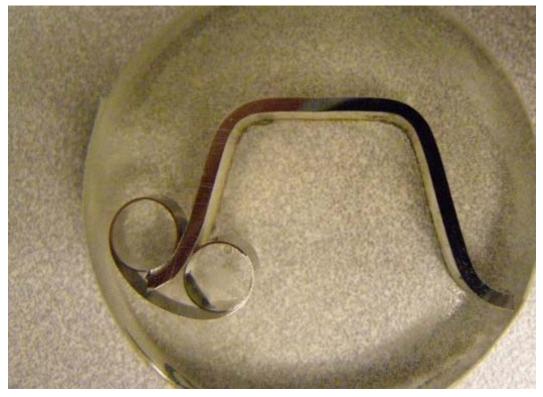
Figure 104. #2014-10-02 – Low magnification cross section of the corrugation at locations of scrapes.

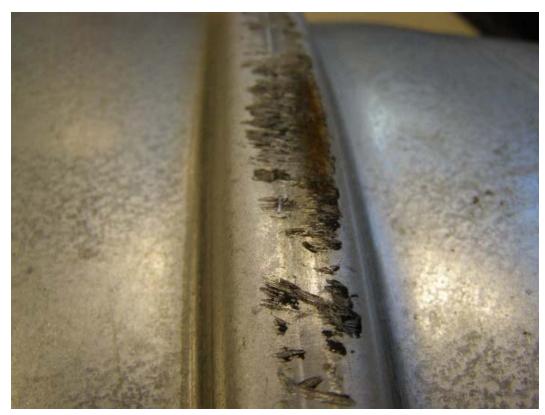
Figure 106. #2014-10-02 – Close up of scuff or scrape marks on the corrugation.

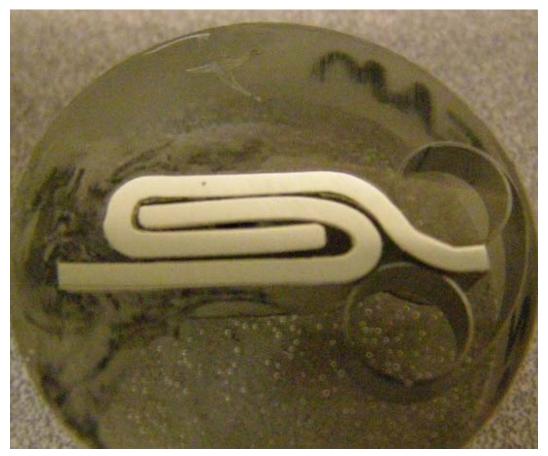
Figure 112. #2014-10-02 – Low magnification cross section of the lock joint showing no visible damage to the aluminum layer.
