*Florida Department of Transportation
Central Structures Office*

**TEST AND ASSESSMENT OF NDT METHODS
FOR POST-TENSIONING SYSTEMS IN SEGMENTAL
BALANCED CANTILEVER CONCRETE BRIDGES**

DMJM HARRIS

February 15, 2003

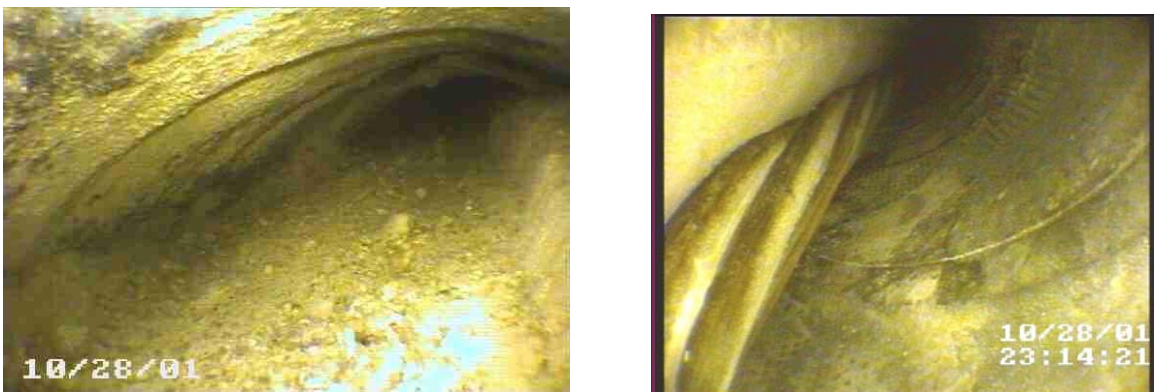
Figure 7.19 and 7.20 – Endoscopy inspection

Focusing only on the relevant flaws (large grout voids or ungrouted ducts), the endoscope inspection revealed that only 13 of 156 locations tested (8.3%) had inadequate strand protection.

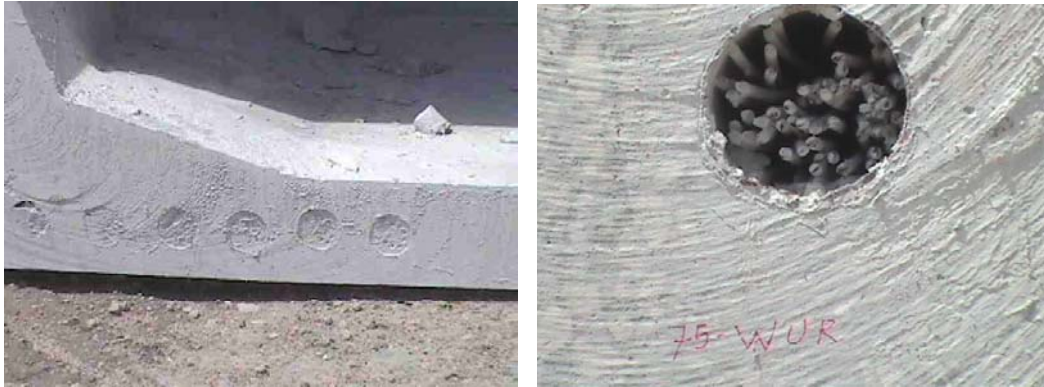
In all cases the bottom ducts were found completely grouted (Figure 7.37). Only the tendon ducts running through the webs (continuity tendons) and anchored at the pier segment diaphragms were found completely ungrouted at the pier diaphragm segment and the adjacent segment (Figure 7.38). This can be explained by the significant change in geometry of the duct at this location. At these locations the tendons were found in good condition, without signs of any corrosion. Also, during the visual inspection a case was found in which the segment was cut at the same location where the endoscopy was performed. There it was noticed that in two locations the endoscopy reached the duct surface but did not penetrate the duct (Figure 7.39). At these particular locations the ducts were previously rendered as fully grouted when, in reality, they had a small void.

Figure 7.37 and 7.38 –Tendons in bottom slab and continuity tendon in web

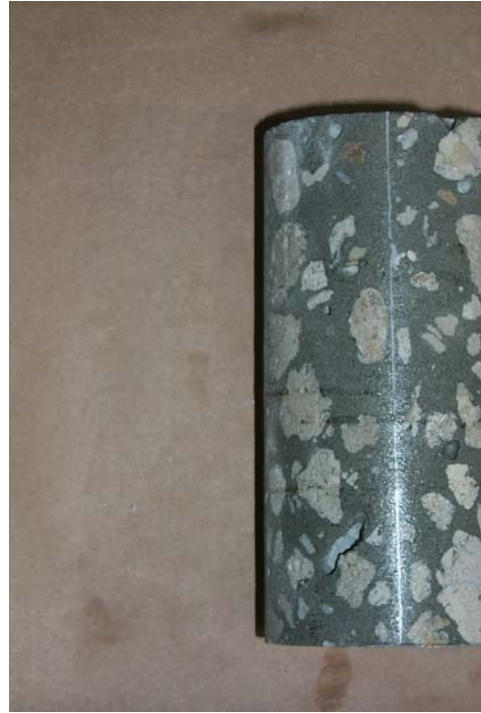
Picture 14 – Core #6 Core to be Split

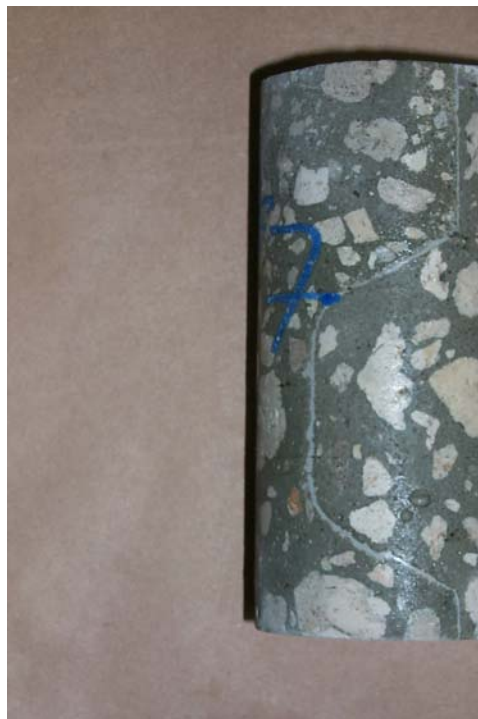
Picture 15 – Core#5 Core to be Split

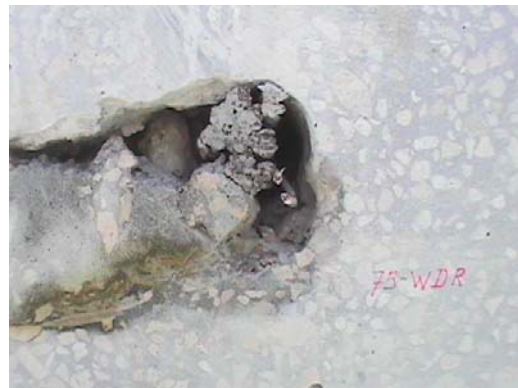
Picture 75-4

Note: Web tendons on the upstation face were completely ungrouted, on the downstation side right side was ungrouted. See pictures 75-4 & 75-5. Picture 75-6 shows the upstation face of the segment

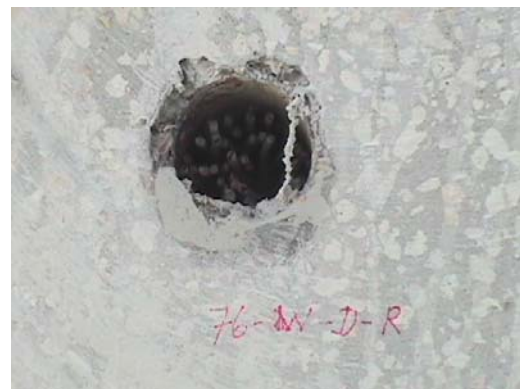
Picture 76-12

Note: Right Web tendon is almost completely ungrouted, pictures 76-12 & 76-13
