DRAINAGE COMPLAINT

S.R. 29

**From North of S.R. 78 to Chaparral Slough
(M.P. 4.709 – 6.877)**

Reference No. 05090-1

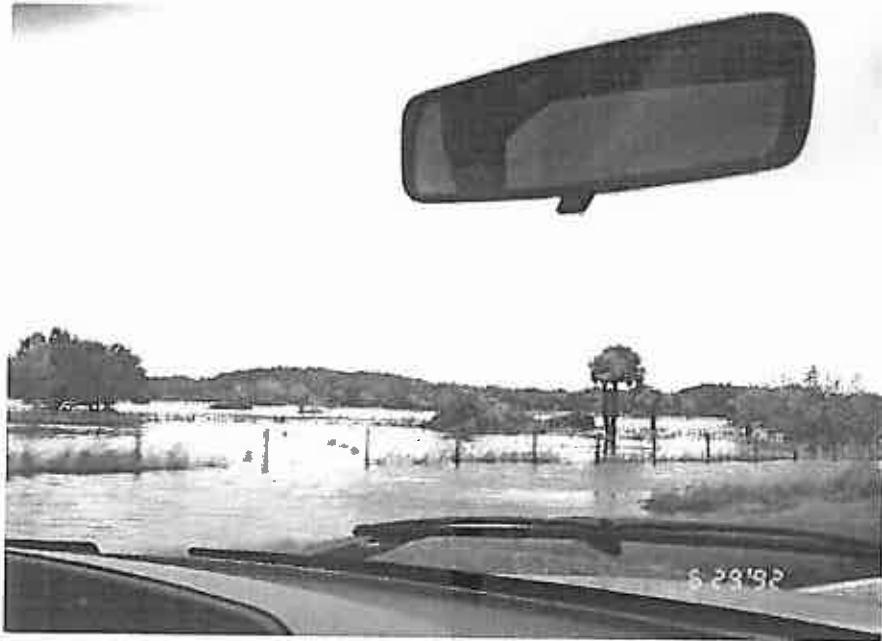
SR 29 - Between Bridge 050033 and SR 78 on June 29, 1992 - wet season.

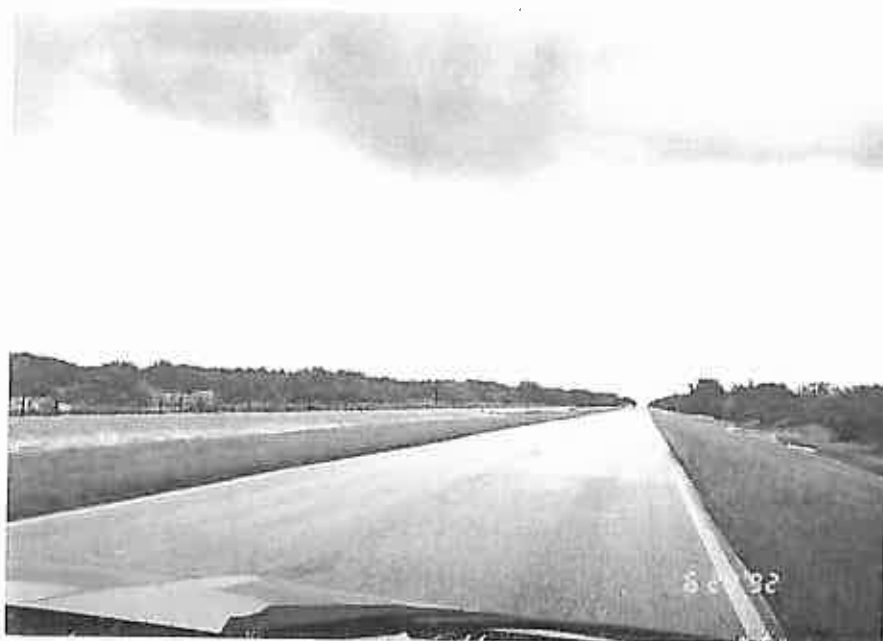
SR 29 - Between Bridge 050033 and SR 78 on June 29, 1992 - wet season.

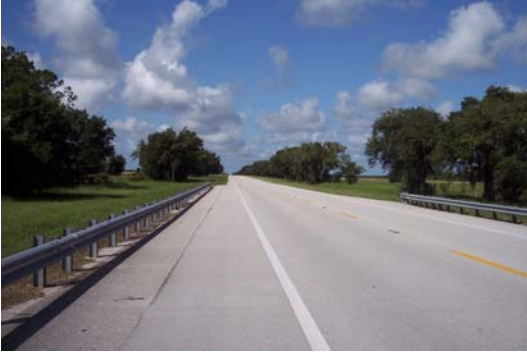
Looking south along S.R. 29 from the bridge culvert.

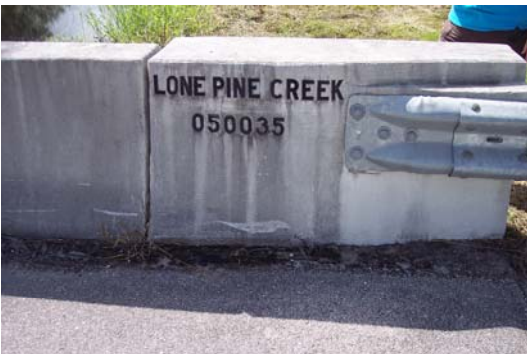
Bridge structure number and name of water body.

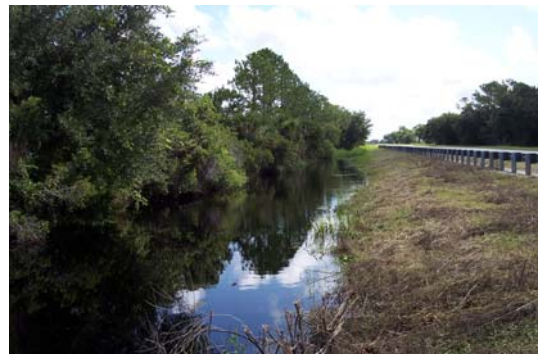
Ditch on north side of driveway facing north.

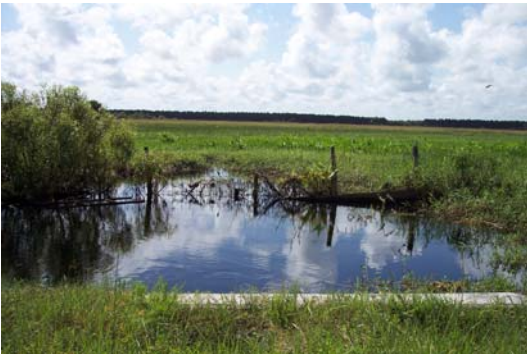
Looking east from east side of cross drain.

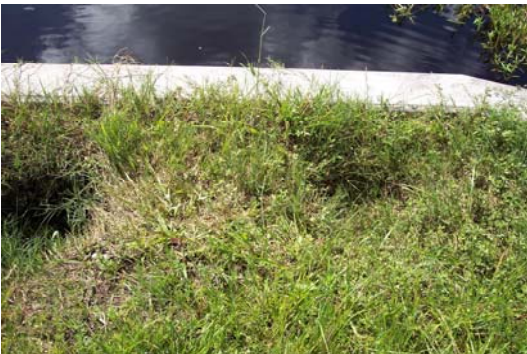
Erosion at headwall on east side of cross drain.

Therefore, the recommended temporary improvements to this area includes de-silting of the existing pipes and ditches, replacing the existing triple 30" pipes with quadruple 48" pipes at the first cross drain and replacement of the existing triple 36" pipes to the north due to failing joints.

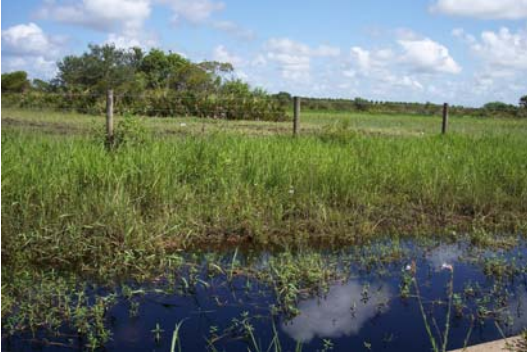
Looking west from headwall on west side of cross drain.

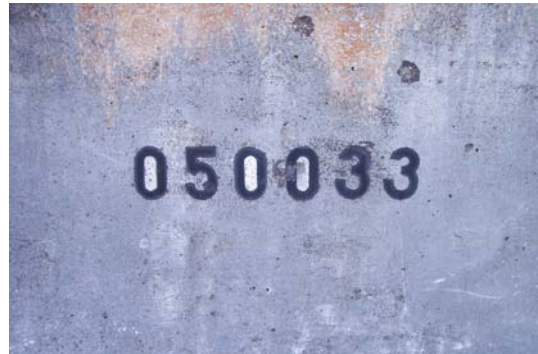
Bridge number.
