Florida LTAP Safety Circuit Rider Program

Final Report

FDOT Project BD545-52
UF52349

September 2009

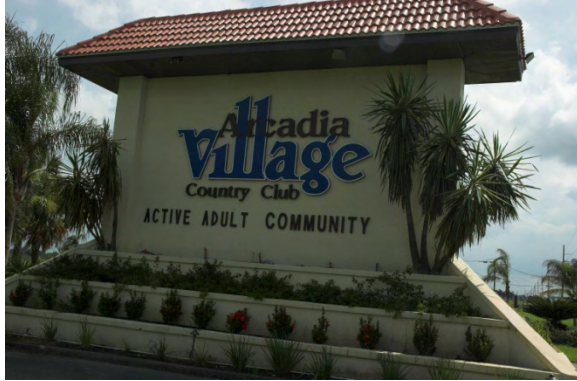
1 – Desoto County, Retirement community, Directly across from Wal-Mart Supercenter SR 70, Arcadia

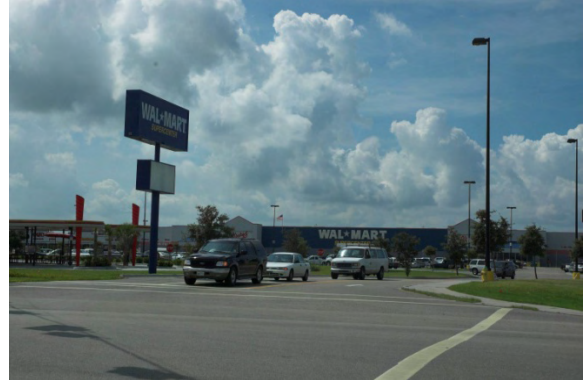
2 – Desoto County, Wal-Mart Supercenter, SR 70, Arcadia

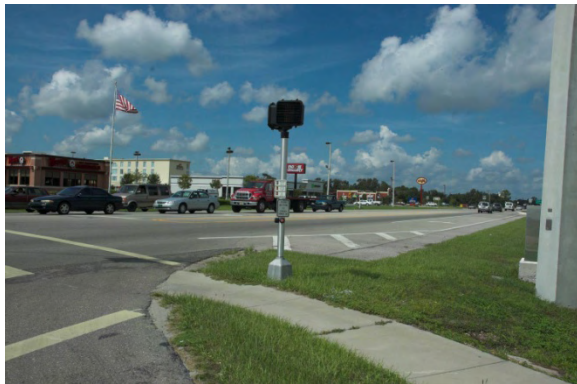
3 – Desoto County, Wal-Mart Supercenter, SR 70, Arcadia

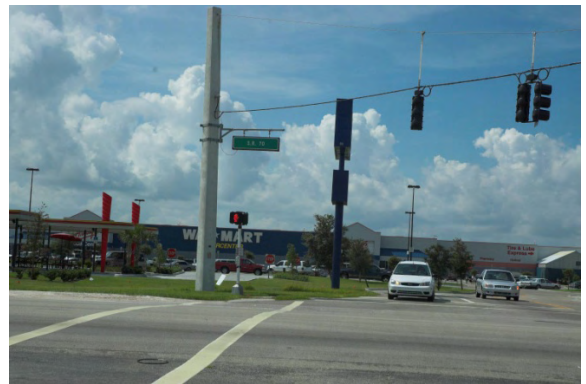
4 – Desoto County, Wal-Mart Supercenter, SR 70, Arcadia

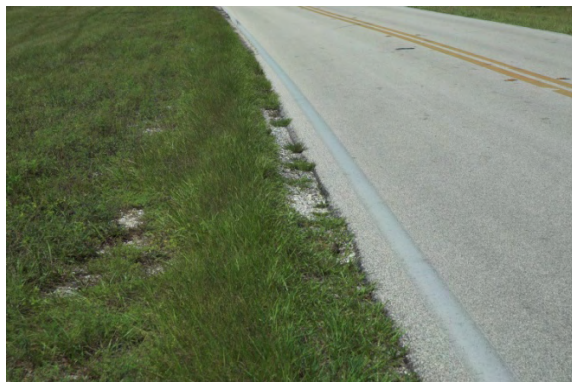
5 – Desoto County, CR 769, roadway before bridge

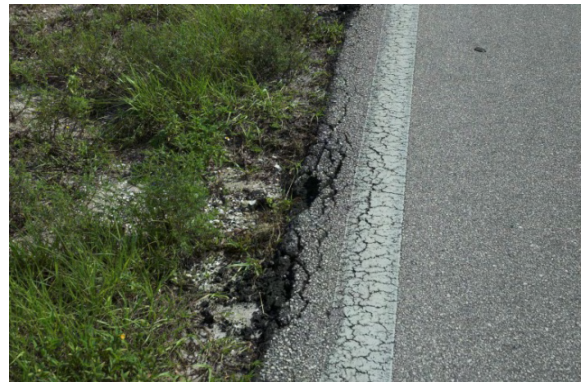
6 – Desoto County, Cr 769, roadway before bridge

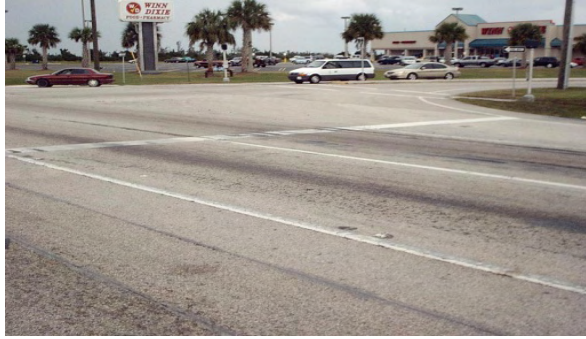
7 – Hardee County, northbound on US Hwy 17

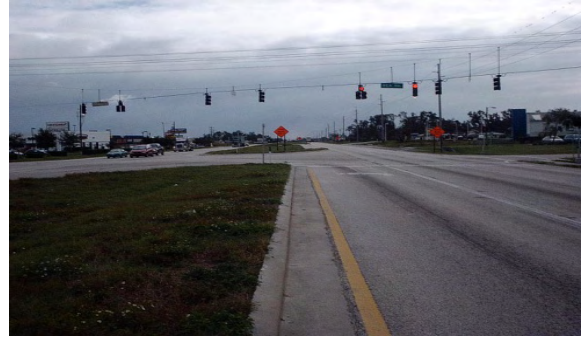
8 – Hardee County, southbound on US Hwy 17

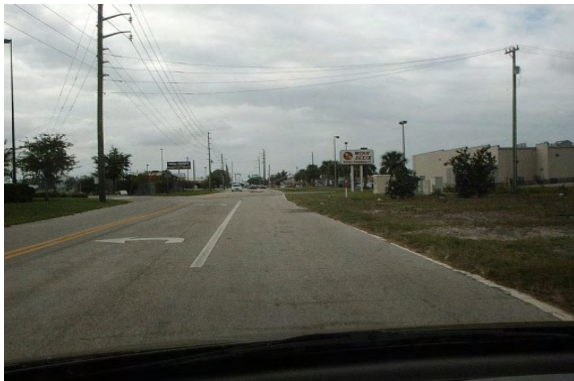
9– Hardee County, eastbound on REA Road

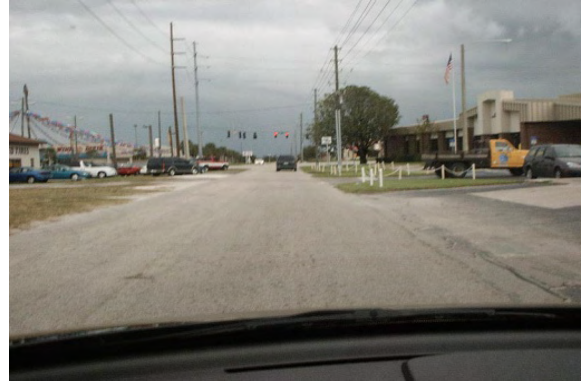
10 – Hardee County, westbound on REA Road

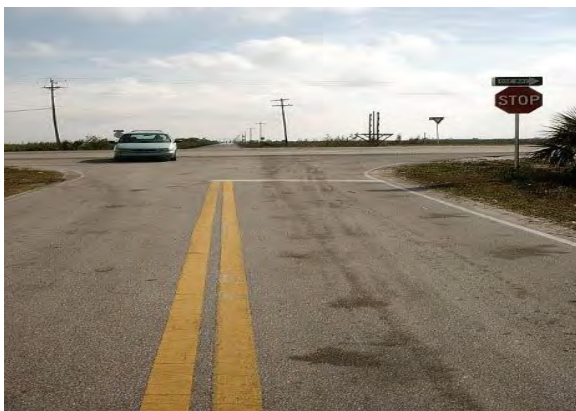
11 – Glades County, facing east on CR 720 approaching US Hwy 27

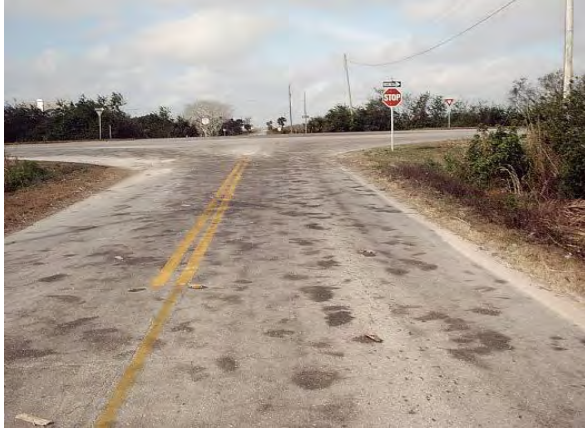
12 – Glades County, facing west on CR 720 approaching US Hwy 27

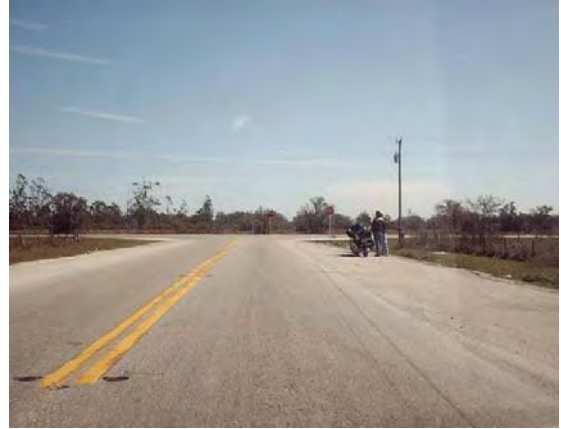
13 – Glades County, CR 74 facing east at intersection of SR 29

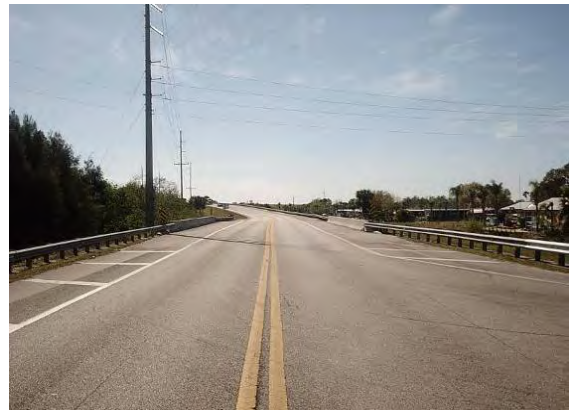
15 - Glades County, traveling south on SR 78

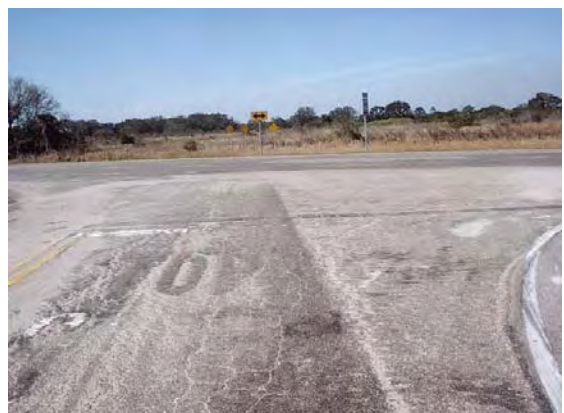
17 – Glades County, traveling on SR 78 facing west, approaching SR 29

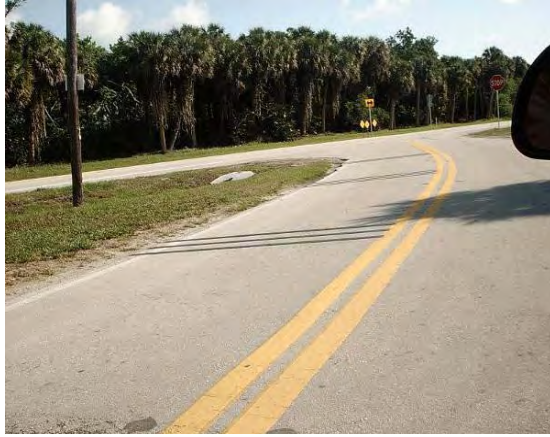
18 – Glades County, rumble strips approaching STOP sign at CR 721 north intersection with SR 78 (STOP sign not in photo)

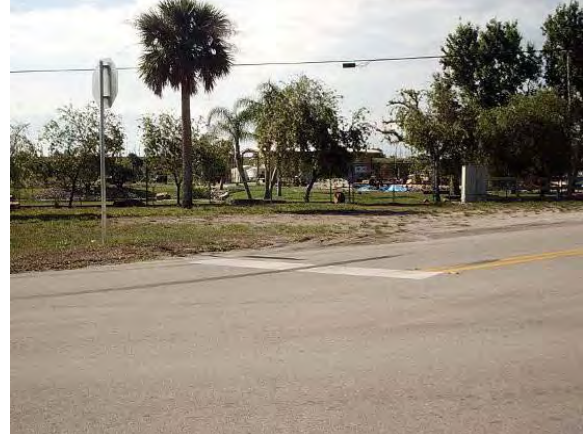
19 – Glades County - STOP bar at STOP sign installed on CR 721 north intersection with SR 78

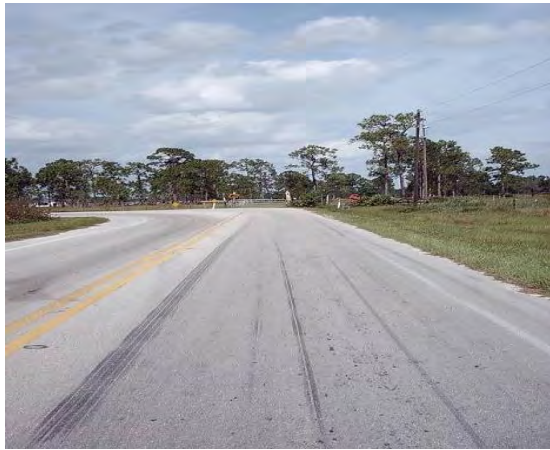
20 – Okeechobee County, traveling north on 128 Terrace

Site ID #	Date	County	Location	Pre-Review Statistics	Comments	Suggestions from SCR	Photo Reference	Actions taken by Agency	Follow-Up Statistics
Okeechobee-9	Feb - Apr 2006	Okeechobee	120 Street Northeast and 128 Terrace Northeast		Numerous crashes at this intersection occurred due to failing to recognize end of road segment. Drivers ran through signs onto private property.	(1) Advance warning of STOP and turn on same sign post at both approaches. (2) Replace yellow triple diamond 9 dot object markers with red triple diamond 9 dot object markers. Consider placing north set on private fencing. (3) Add rumble strips at both approaches. (4) Pavement markings: Re-stripe all existing center and sideline markings beginning at advanced warning signs, replace STOP bars with new bright long lasting product and add STOP AHEAD wording on the pavement in between rumble strips. (5) Replace all RPMs beginning at advanced warning signs. (6) Replace street light with higher lumens lamp. (7) Replace damaged STOP signs, consider larger STOP signs.	20, 21, 55, 56	(1) Advance warning of STOP and turn sign on different posts at both approaches. (2) Replaced yellow triple diamond 9 dot object markers with red triple diamond 9 dot object markers. (3) Added rumble strips at both approaches. (4) Pavement markings: Re-striped all existing center and sideline markings beginning at advanced warning signs, replaced STOP bars with new bright long lasting product and added STOP AHEAD wording on the pavement in

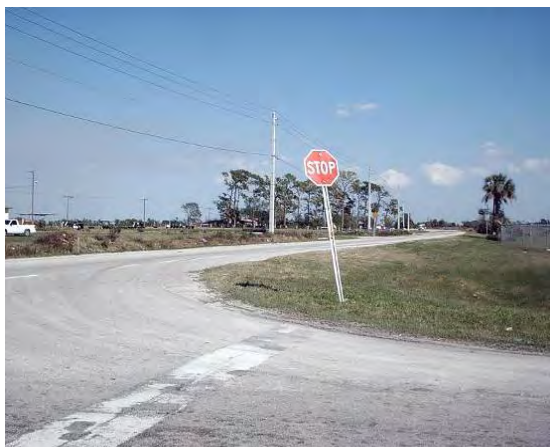
22- Okeechobee County, standing on SE 70 Avenue looking at east SR 70

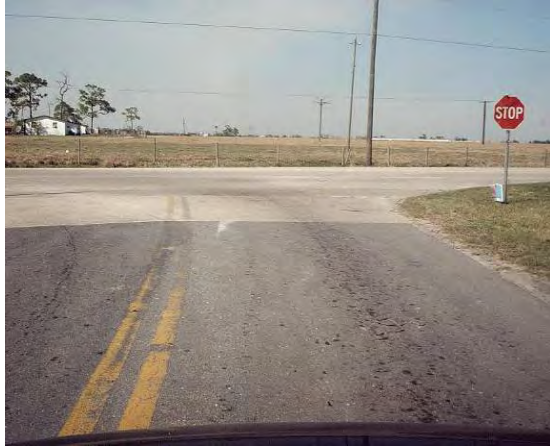
24 – Okeechobee County, standing on SE 64 Avenue SE looking at SR 70 E

Okeechobee-4	Late 2005	Okeechobee	SR 70 East and 64 Avenue Southeast		Missing triple 9 dot object markers and double arrow across SR 70.	(1) Warn of upcoming intersection east and west SR 70 approaches. (2) Place object markers and double arrow across from 64 Avenue Southeast. (3) Warn of upcoming STOP on 64 Avenue Southeast.	24, 25	FDOT will complete (2) Place object markers and double arrow across from 64 Avenue Southeast.

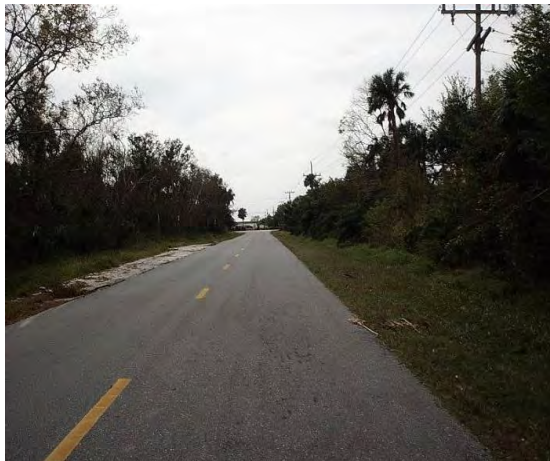
26 – Okeechobee County, SR 15 and CR 15B

Site ID #	Date	County	Location	Pre-Review Statistics	Comments	Suggestions from SCR	Photo Reference	Actions taken by Agency	Follow-Up Statistics
Okeechobee-5	Late 2005	Okeechobee	SR 15 and CR 15B		Final site improvement plan.	(1) Install advance warning of STOP on east approach. (2) Place 9 dot object markers on SR 15 around double arrow.	26, 27	(1) Advance warning sign of STOP on east approach was added.	
Okeechobee-6	Late 2005	Okeechobee	SR 710 and 128 Terrace Southeast			(1) Replace STOP sign.		(1) STOP sign replaced.	
Okeechobee-7	Late 2005	Okeechobee	SR 98 North and 144 Trail Northwest		County decided to place this site on the discuss later list.	(1) Add triple 9 dot object markers with double arrow. (2) Add rumble strips and STOP Ahead pavement markings to west approach. (3) Add street lighting to intersection. (4) Add advance warning of intersection signage to north and south approaches. (5) Consider reducing speed zone north and south approaches.		Suggestions (1) Add triple 9 dot object markers with double arrow, and (4) Add advance warning of intersection signage to north and south approaches, were referred to FDOT.

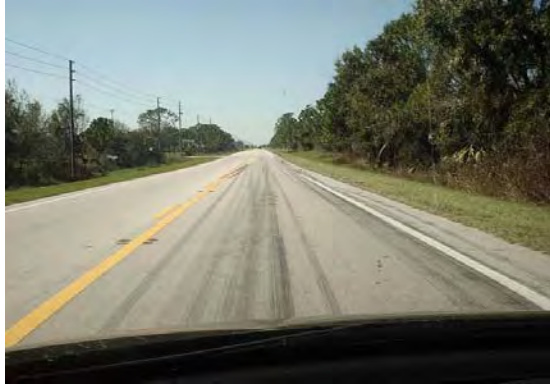
28 – Okeechobee County, traveling west on SR 70 W approaching SW 67 Drive on the left

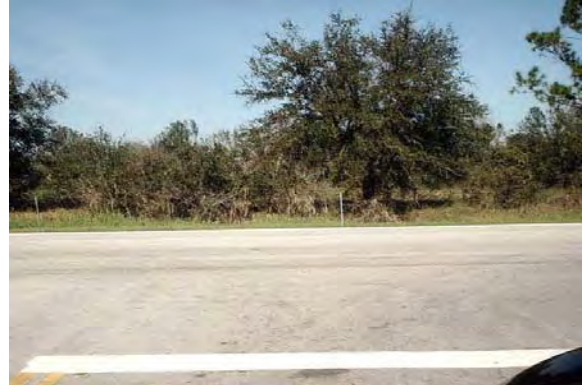
29 – Okeechobee County, traveling north on SW 67 Drive intersecting with SR 70 W

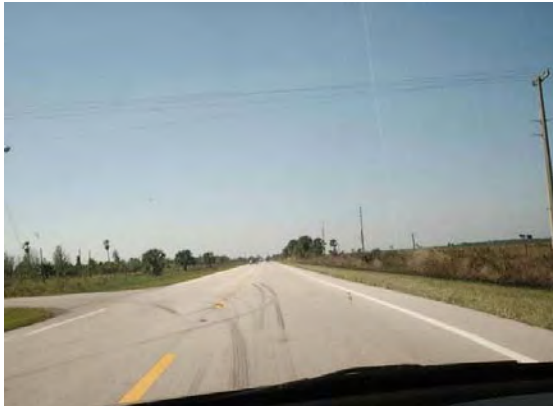
30 – Okeechobee County, traveling west on SR 70 W approaching SW 87 Terrace on the left

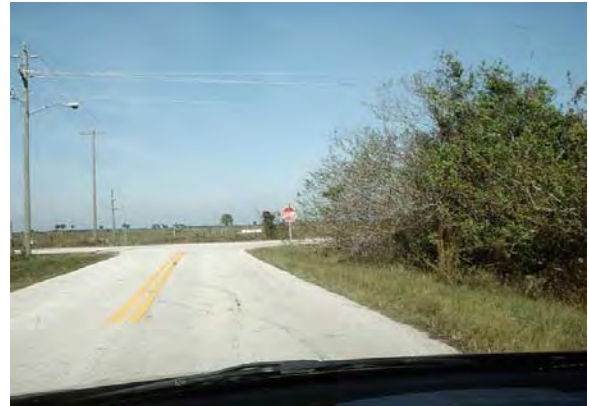
31 – Okeechobee County, traveling north on SW 87 Terrace intersecting with SR 70 W

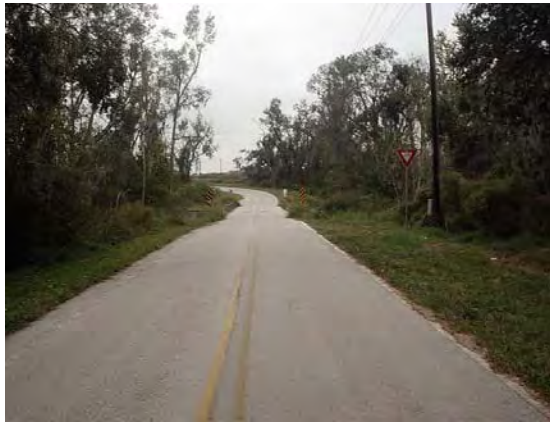
34 – Hardee County, CR 664 driving south 1.5 miles west of US 17 approaching one way bridge

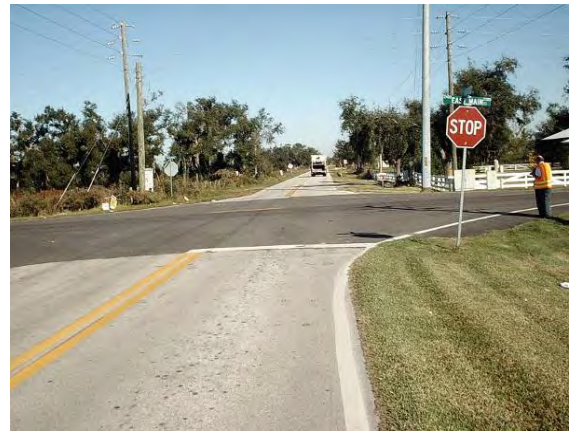
35 – Hardee County, approaching SR 636 from the south on Boyd Cowart Road

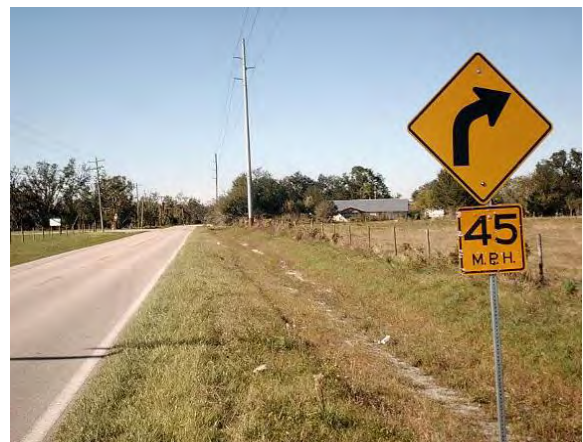
37 – Hardee County, heading west on Griffin Road approaching Popash Road

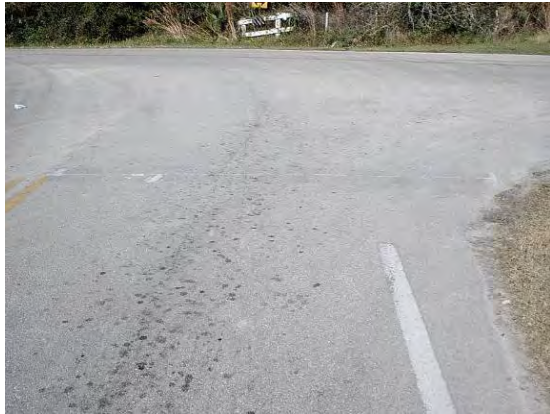
38 – Hardee County, on Griffin Road looking at Popash Road

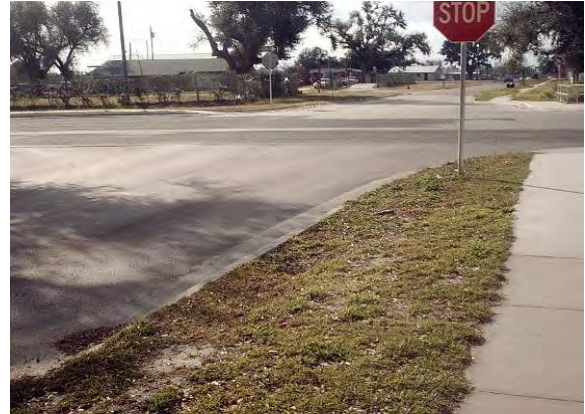
39 – Hardee County, driving west on Will Dukes Road toward SR 17

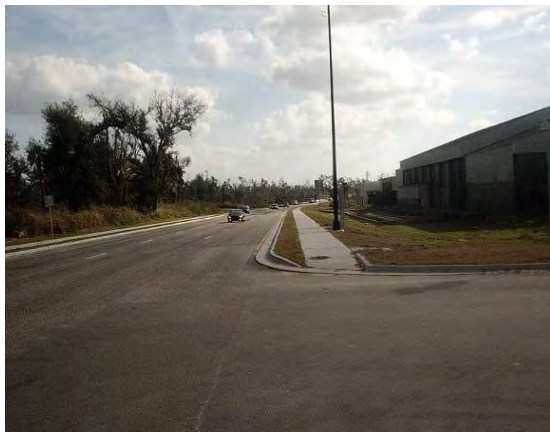
40 – Hardee County, looking south on SR 17 from west side of Will Dukes Road

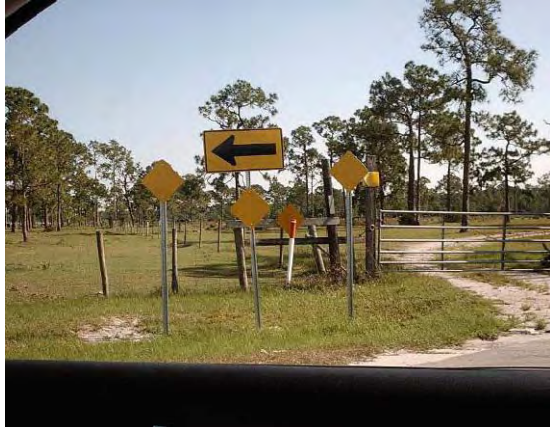
55 – Okeechobee County, new advance warning sign from south approach to 120 Street NE

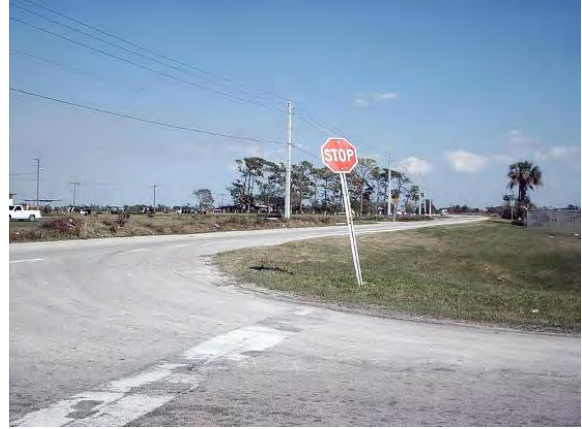
56 – Okeechobee County, 128 Terrace SE with new object markers

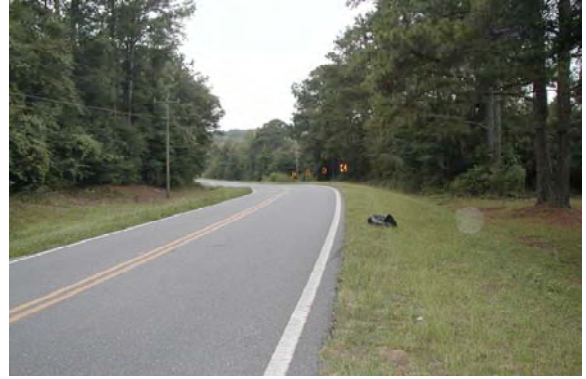
67 – Gadsden County, CR 161 prior to suggestions

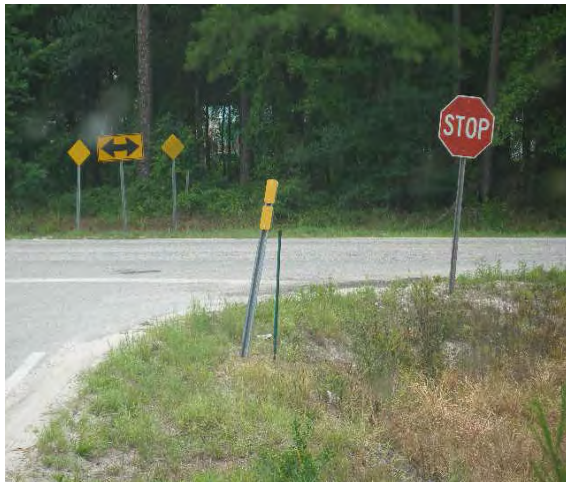
87 - Clay County, STOP sign is 18 feet from the edge line on CR 226

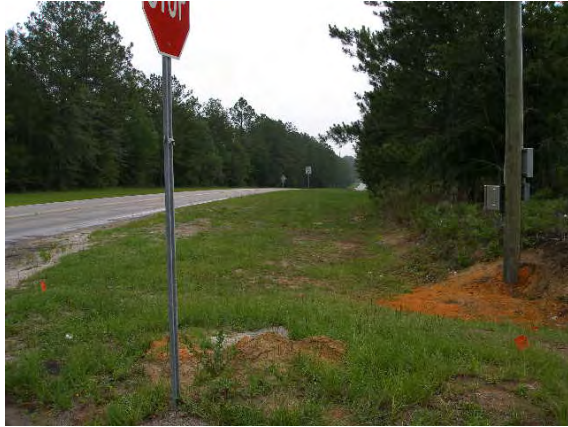
91 - Clay County, facing north at CR 215 from STOP bar on Santa Clara, note what appears to be a blind spot at the warning sign in the photo center

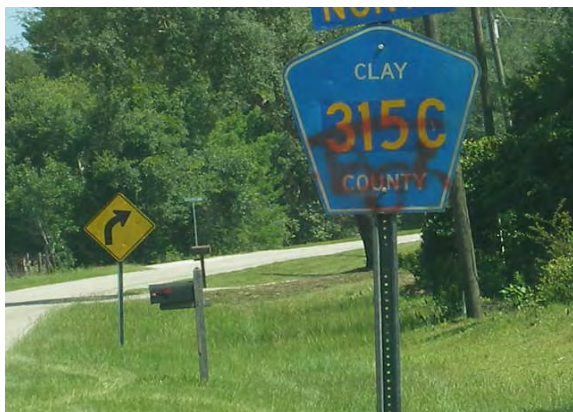
101 - Clay County, CR 315C and Bellamy Road, route marker has been vandalized

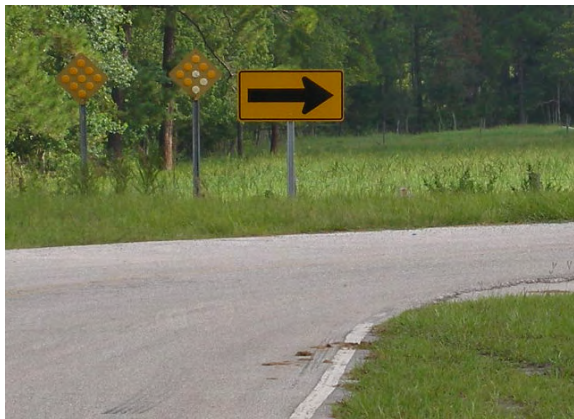
113 - Clay County, Mallard Road and CR 218, missing object marker, centerline and edge line through turn

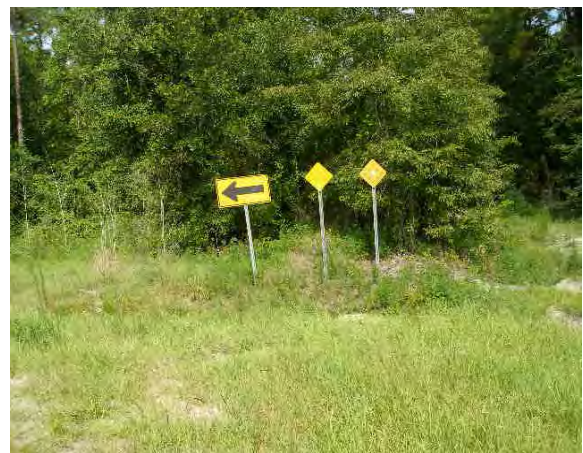
120 - Clay County, Mallard Road and CR 218, one object marker missing

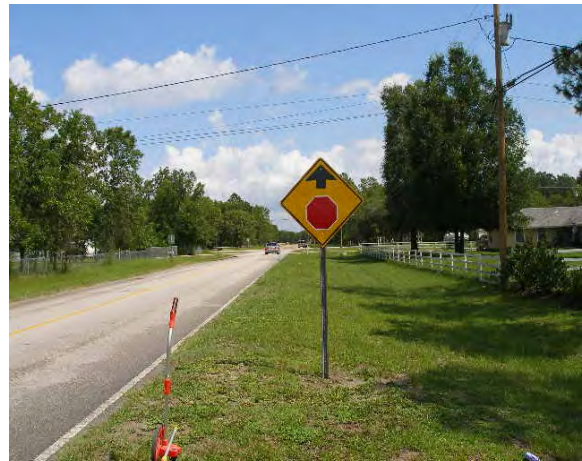
124 - Clay County, N Mimosa Avenue intersection with John's Cemetery Road, STOP Ahead is a 30" sign mounted 5 feet above the top of the edge of pavement

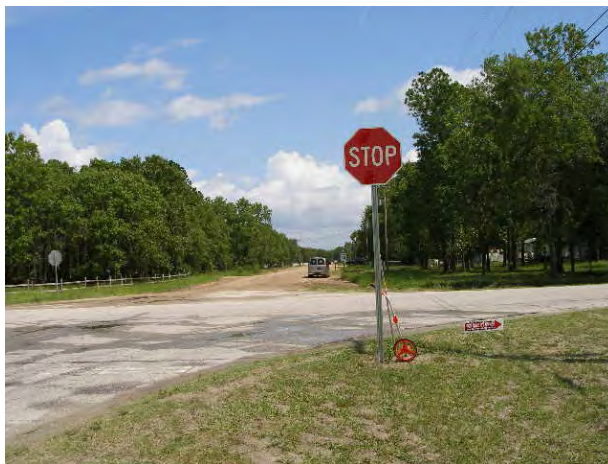
125 - Clay County, N Mimosa Avenue intersection with John's Cemetery Road, STOP sign is a 30" sign in excellent condition

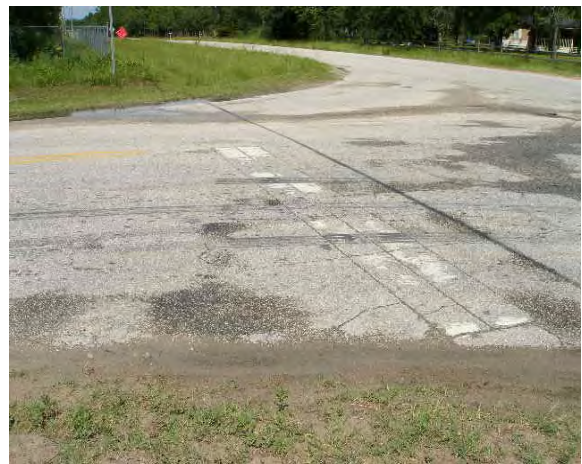
126 - Clay County, N Mimosa Avenue intersection with John's Cemetery Road, STOP bar is worn

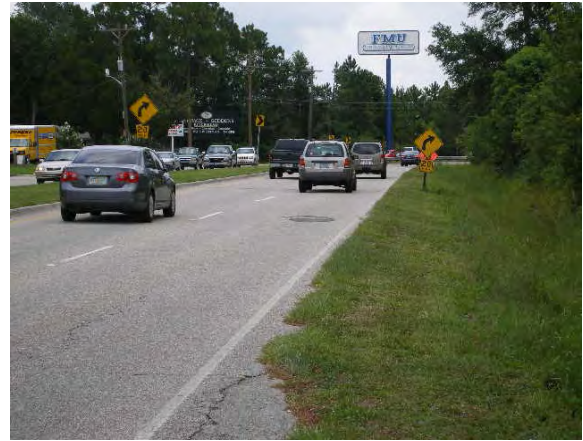
128 - Clay County, Wells Road, right curve with 20 mph advisory signs and beginning of Chevrons

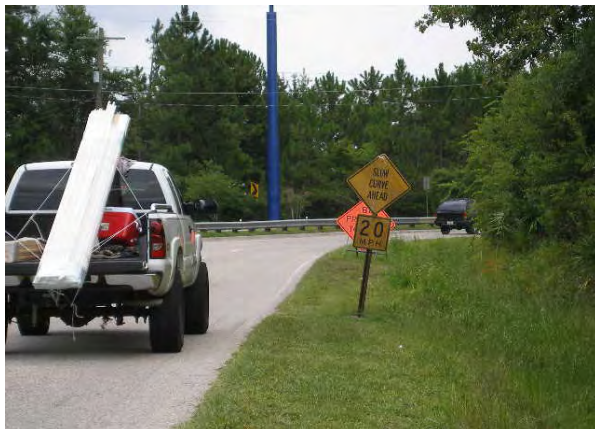
129 - Clay County, Wells Road, slow curve ahead sign is at beginning of curve

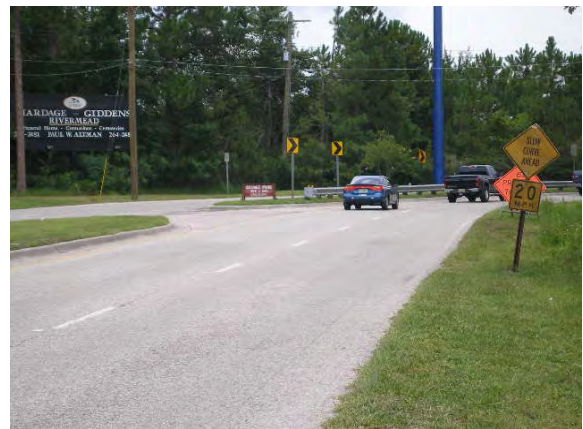
130 - Clay County, Wells Road, Chevrons mounted in double sided guardrail spaced along half of curve

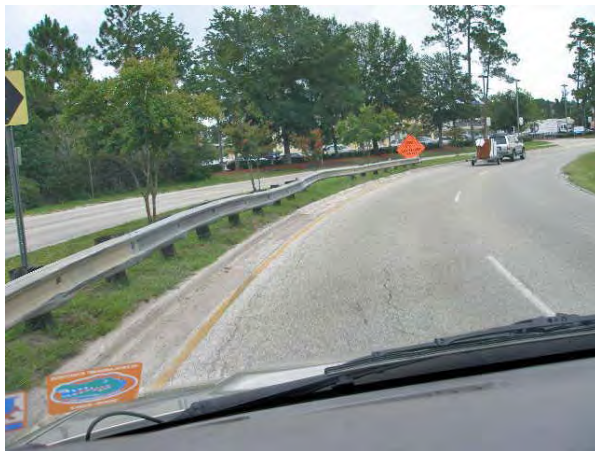
131 - Clay County, Wells Road, damaged guardrail

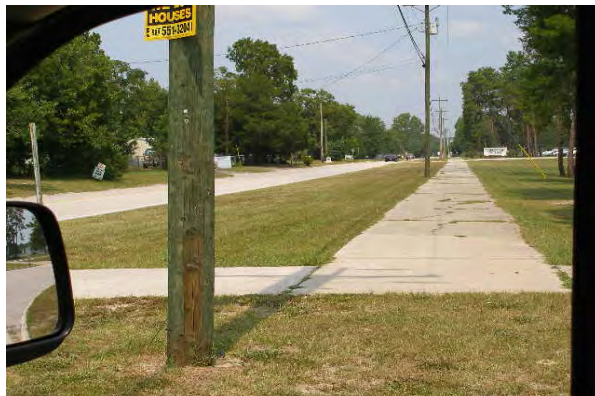
134 - Clay County, Madison Avenue and Harrison Avenue, southbound on Harrison looking west at Madison

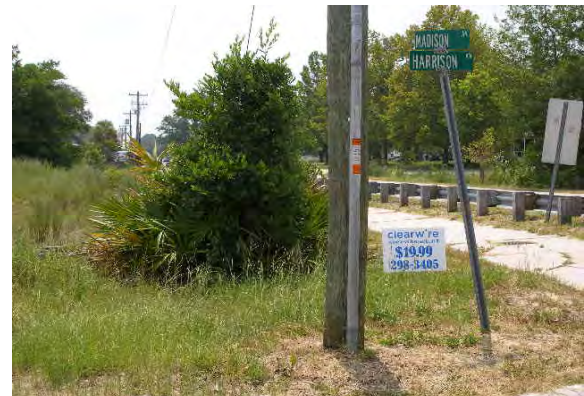
135 - Clay County, Madison Avenue and Harrison Avenue, southbound Harrison Avenue from STOP bar looking east

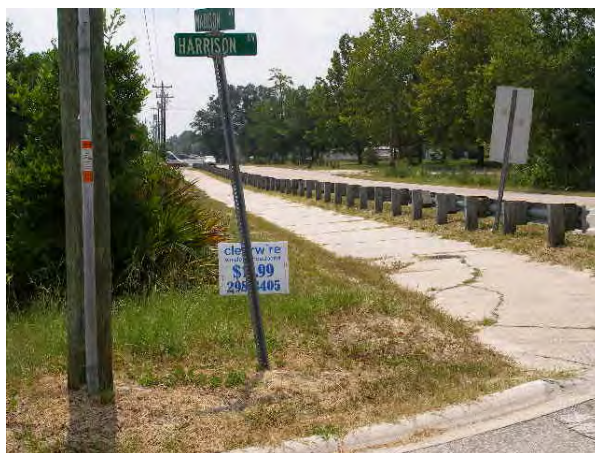
136 - Clay County, Madison Avenue and Harrison Avenue, southbound Harrison Avenue looking east four feet closer to Madison Avenue

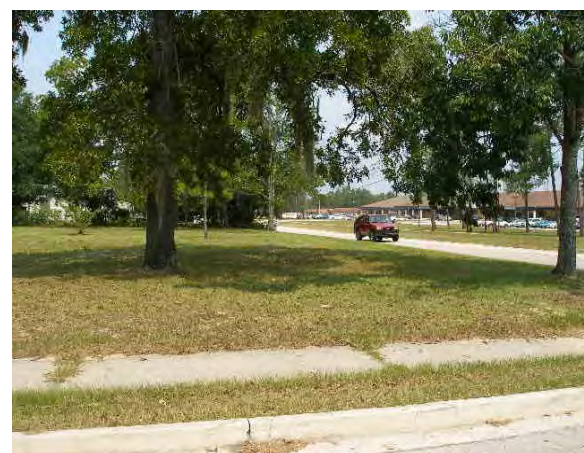
137 - Clay County, Madison Avenue and Harrison Avenue, northbound on Harrison looking west from existing STOP bar

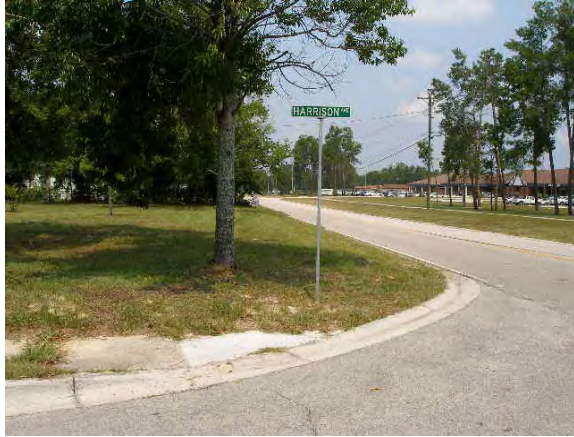
138 - Clay County, Madison Avenue and Harrison Avenue, northbound on Harrison looking west from a location twelve feet from the edge of Madison

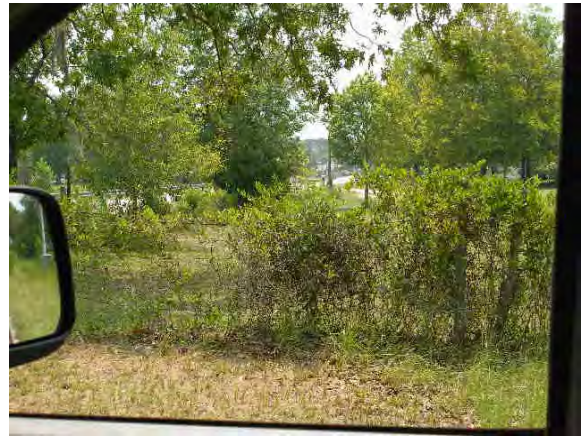
139 - Clay County, Madison Avenue and Harrison Avenue, northbound on Harrison looking west from existing STOP bar

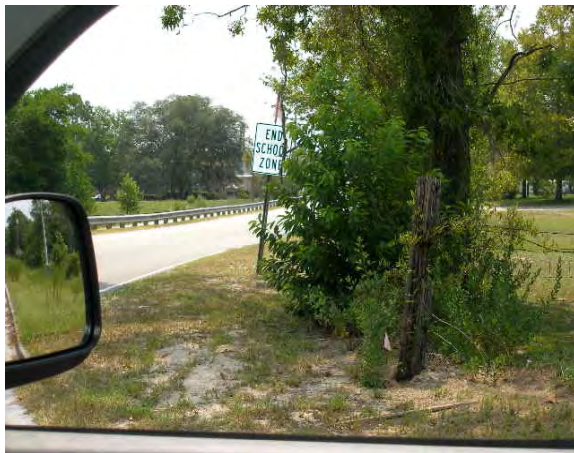
140 - Clay County, Madison Avenue and Harrison Avenue, northbound on Harrison looking east from twelve feet from the edge of Madison

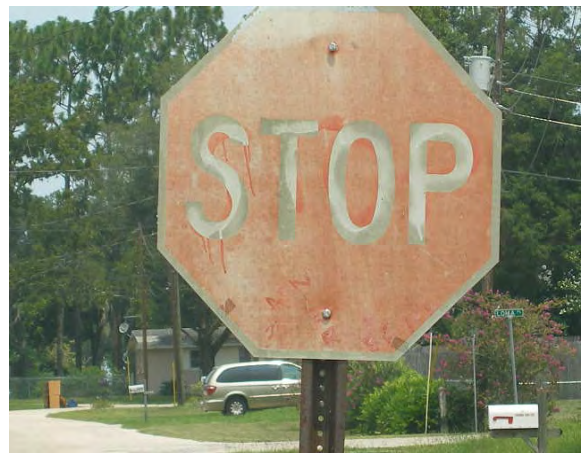
141 - Clay County, Parkwood Drive at Hilltop Drive, northbound STOP sign is faded

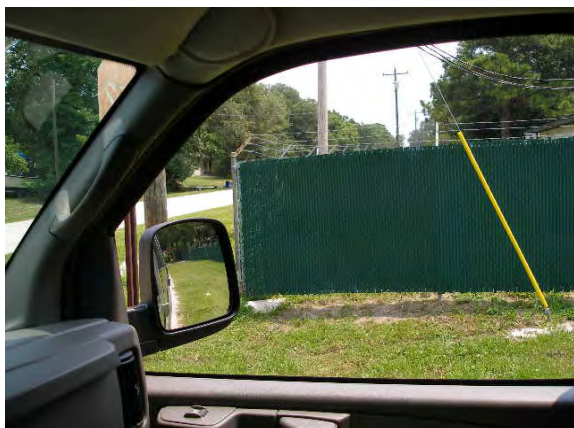
142 - Clay County, Parkwood Drive at Hilltop Drive, looking east on Hilltop at existing STOP Bar

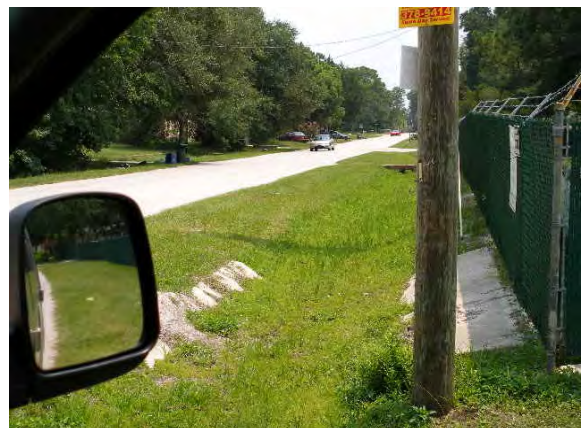
143 - Clay County, Parkwood Drive at Hilltop Drive, looking east from a point 6-8 feet from the edge of Parkwood

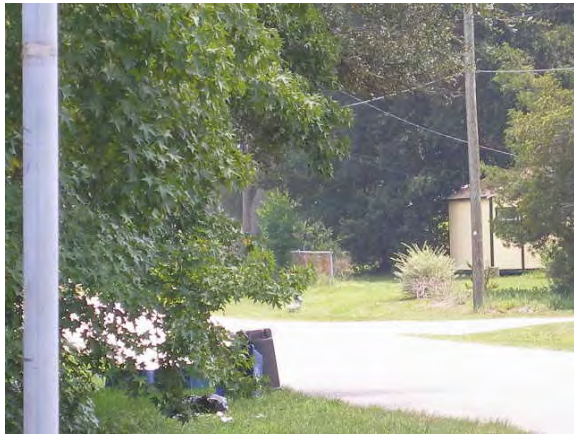
144 - Clay County, Parkwood Drive at Hilltop Drive, looking east on Parkwood from southbound Hilltop

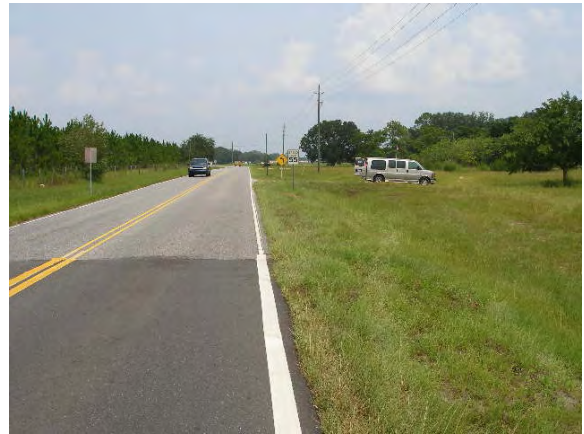
145 - Clay County, CR 739B (Sandridge Road) west of Feedmill Road, approaching curve on CR 739B eastbound prior to Feedmill Road

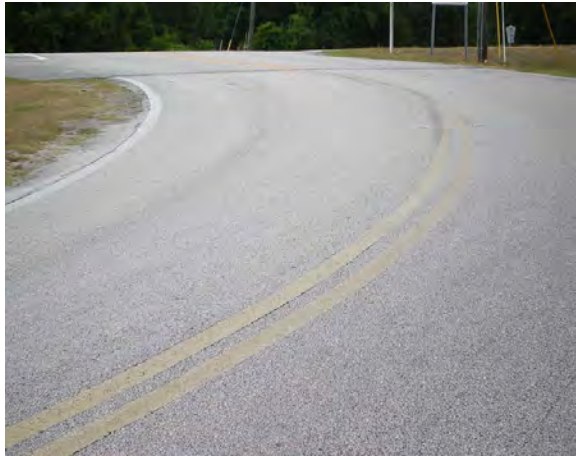
149 - Clay County, CR 209, faded double solid yellow centerline

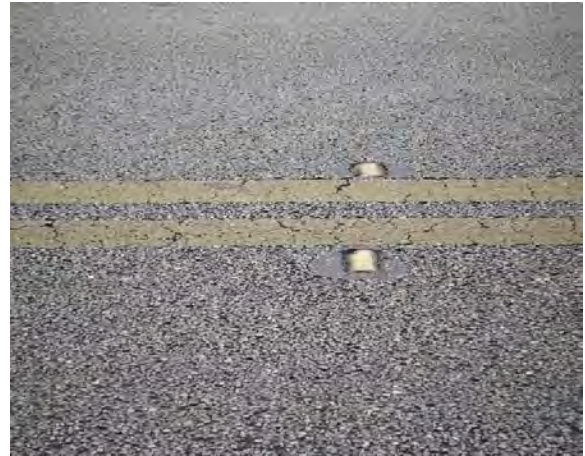
150 - Clay County, CR 209, RPMs buried in pavement

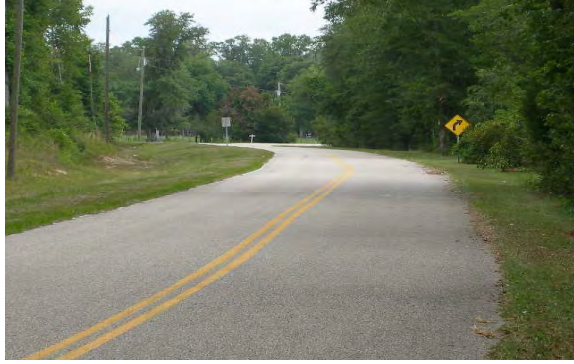
152 - Clay County, northbound on CR 209 approaching right curve

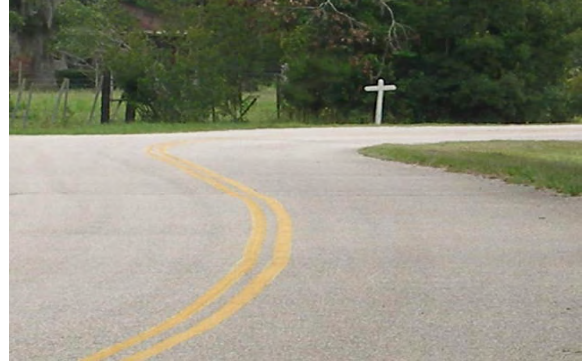
153 - Clay County, northbound on CR 209 approaching right curve

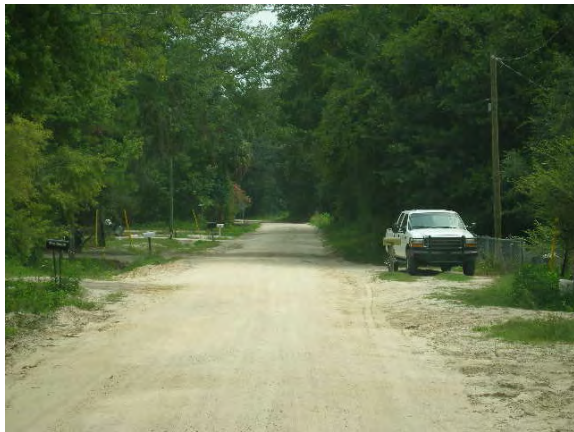
154 - Clay County, North Road 0.3 miles west of CR 15A, looking east on North Road

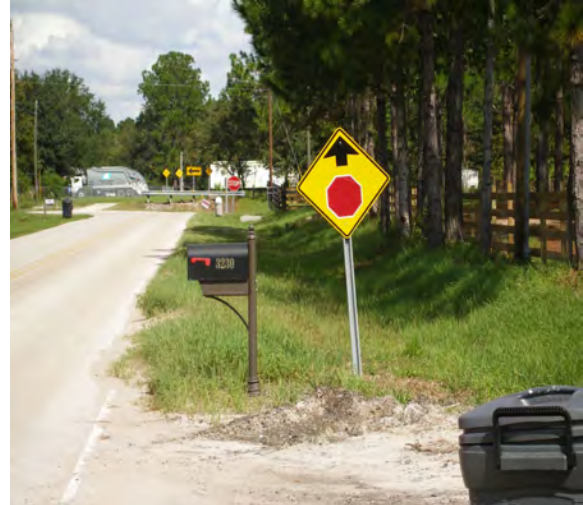
157 - Clay County, Thunder Road, northbound signing

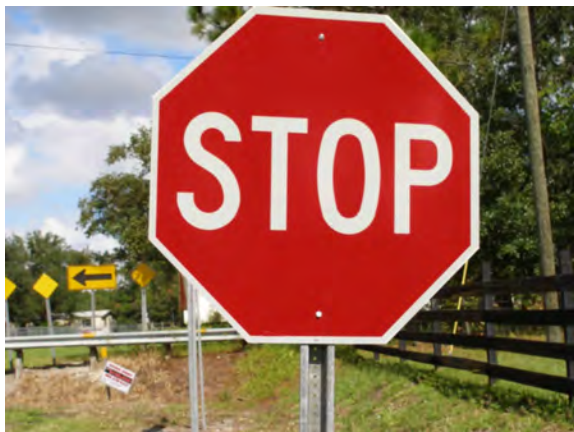
158 - Clay County, Thunder Road north of SR 16, 36 inch STOP sign erected March 2007

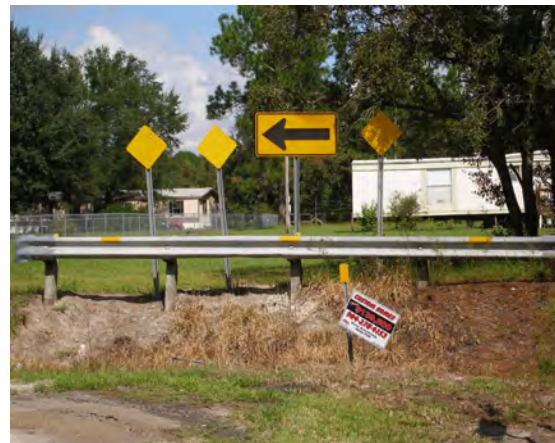
159 - Clay County, Thunder Road north of SR 16, assembly in accordance with FDOT Design Standard Index No. 17349 , Case I

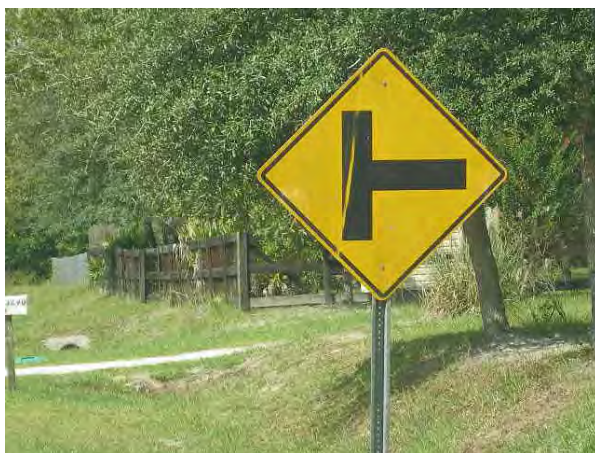
160 - Clay County, Thunder Road, sign approaching the west turn

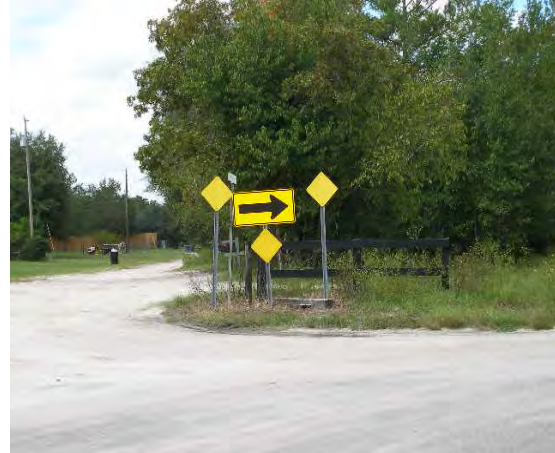
161 - Clay County, Thunder Road, assembly at the intersection of Thunder Road and dirt road

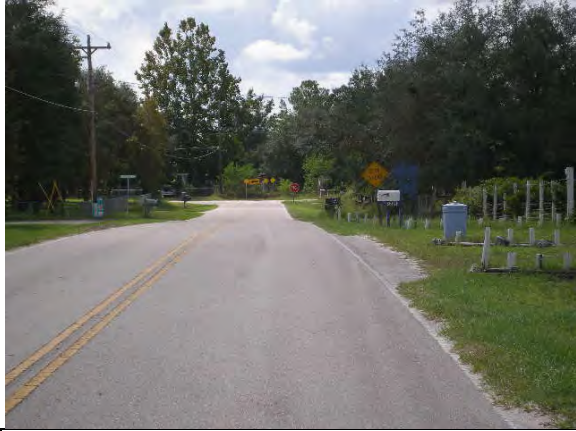
162 - Clay County, Thunder Road approaching western most turn from north

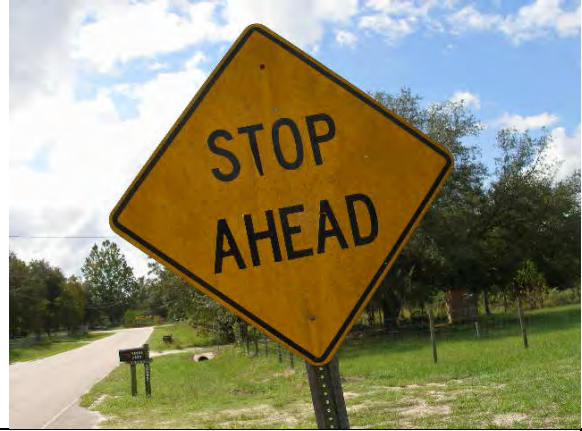
163 - Clay County, Thunder Road, 30 inch STOP Ahead

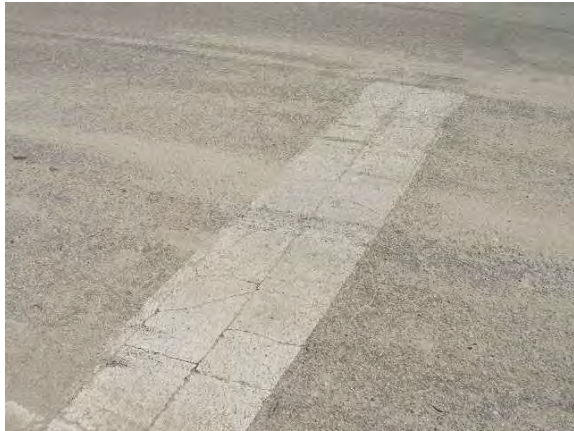
164 - Clay County, Thunder Road, STOP bar condition at western turn

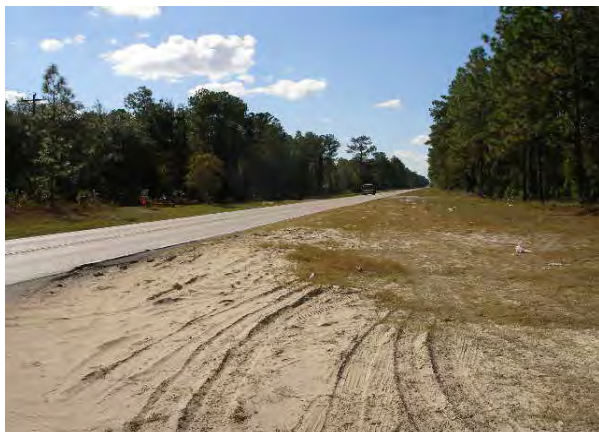
167 - Clay County, no sight distance problem looking south on CR 215 from Chicory Avenue west side

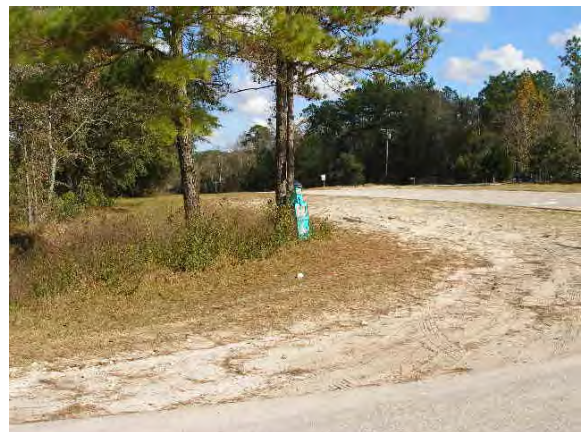
168 - Clay County, looking north on CR 215 from Chicory Avenue west side at existing STOP Bar

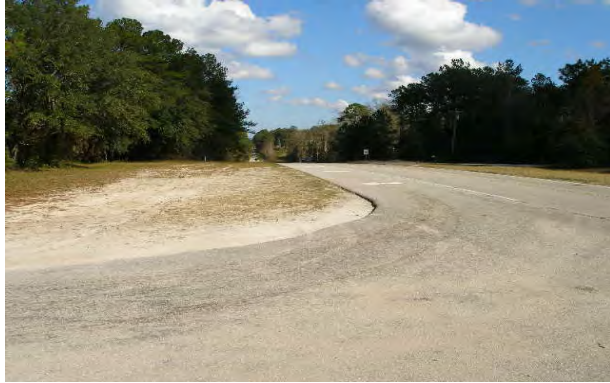
169 - Clay County, looking north on CR 215 from Chicory Avenue west side at a point 12 feet from the edge of the right turn lane

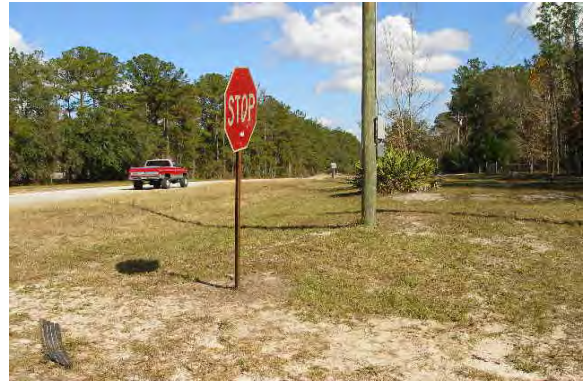
170 - Clay County, looking north on CR 215 from Chicory Avenue east side at existing STOP bar

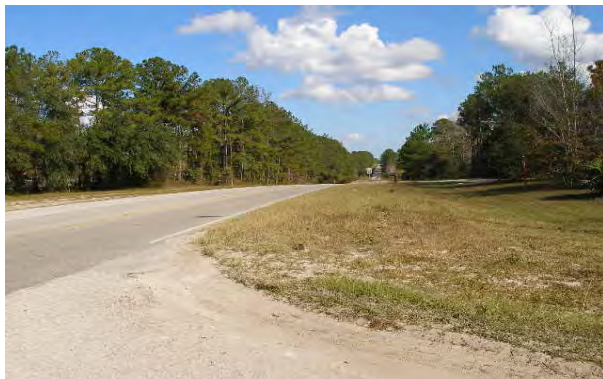
171 - Clay County, looking north on CR 215 from Chicory Avenue side from a point 12 feet from the edge of CR 215 pavement

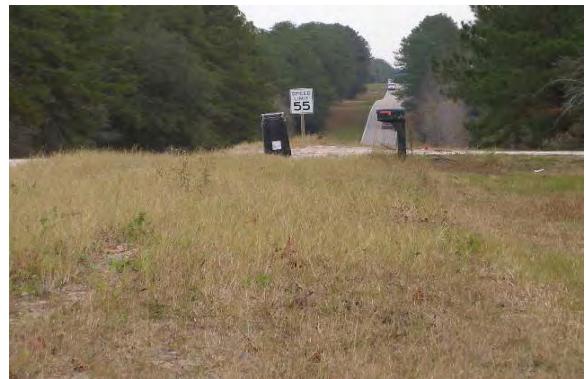
172 - Clay County, view of shoulder condition looking north from east side at Chicory Avenue. Shoulder is approximately 12 inches above the CR 215 edge of pavement

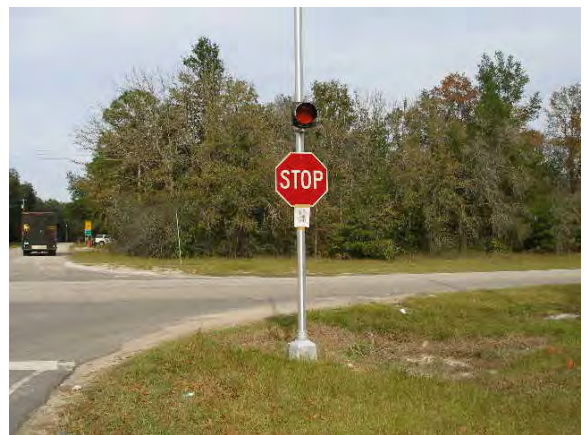
174 - Clay County, east side of CR 215 at Deer Avenue

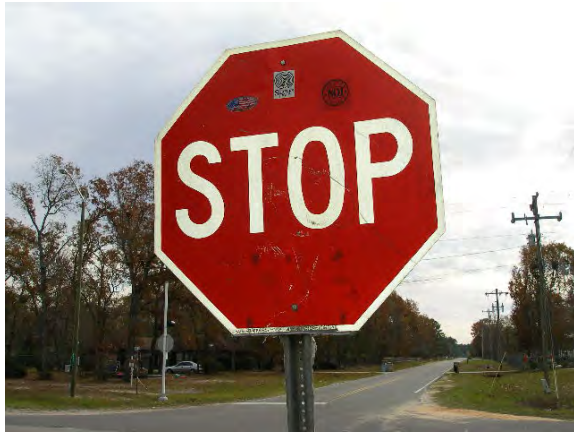
175 - Clay County, vandalized STOP sign on west side of CR 215 at Deer Avenue

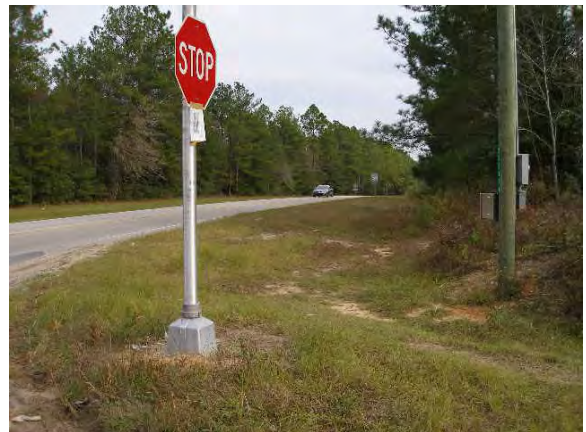
176 - Clay County, view looking north from the existing STOP bar at Santa Clara Avenue

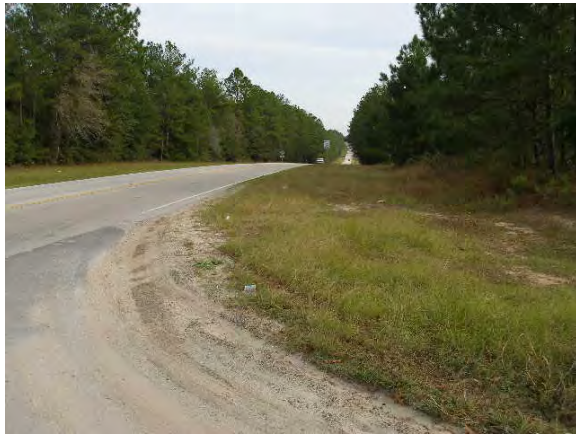
177 - Clay County, view looking north 12 feet from the pavement edge of CR 215 at Santa Clara Avenue

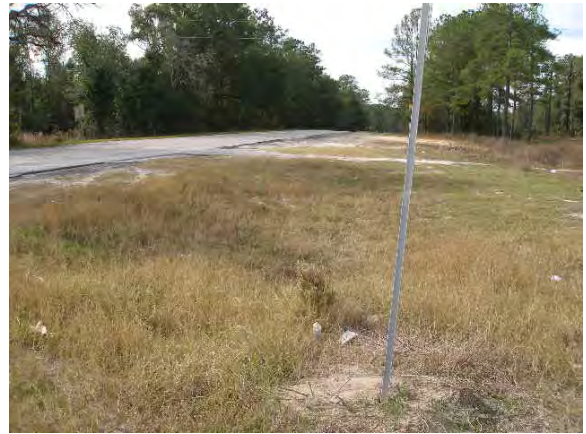
178 - Clay County, CR 215 and Primrose Avenue, view from STOP bar location looking south, post is STOP sign post

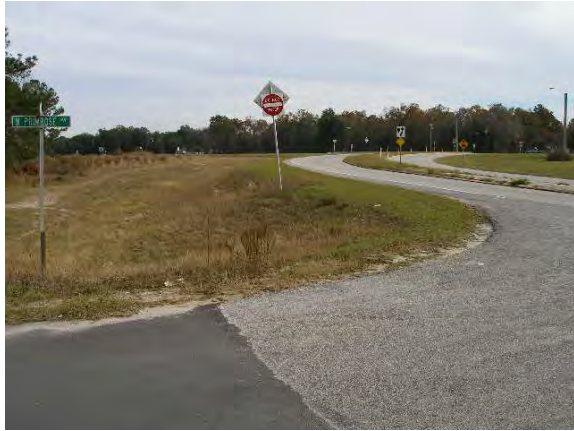
179 - Clay County, CR 215, view from STOP bar at Primrose Avenue looking north
