Florida LTAP Safety Circuit Rider Program

Final Report

FDOT Project BD545-52
UF52349

September 2009

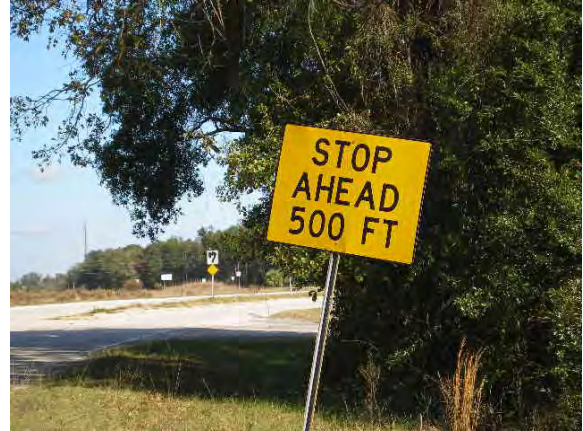
180 - Clay County, STOP Ahead sign northbound on CR 215 at Primrose Avenue

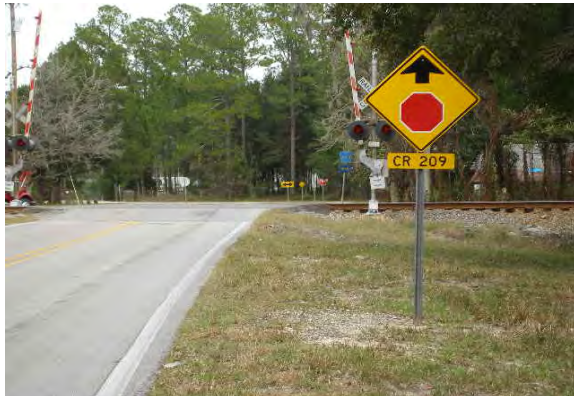
181 - Clay County, CR 226 approaching CR 209, new STOP Ahead sign

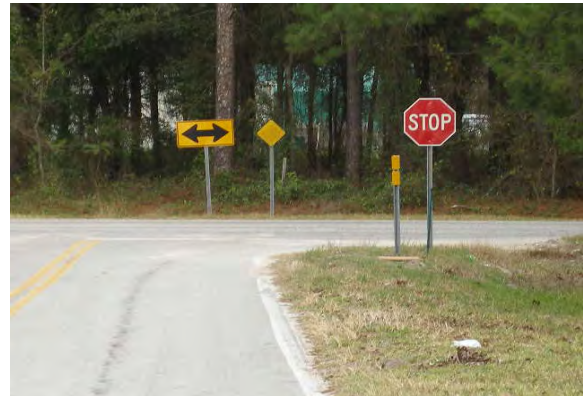
182 - Clay County, CR 226 approaching CR 209, new STOP location

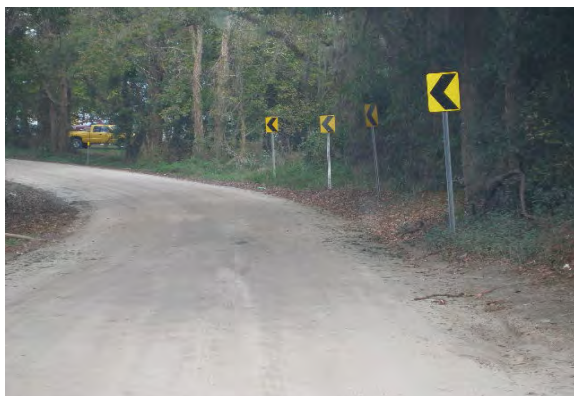
183 - Clay County, CR 15A, Chevrons in place looking east on North Road at second turn

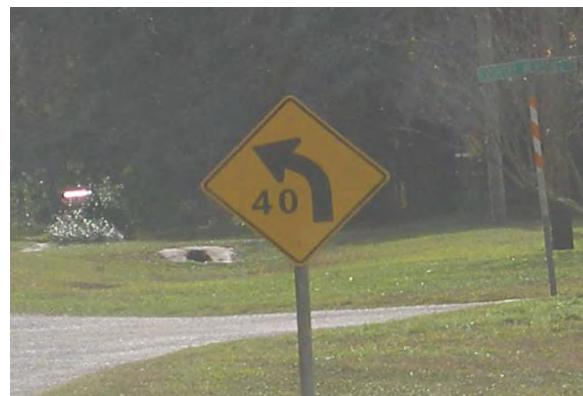
184 - Clay County, CR 220A (Long Bay Road), completed work

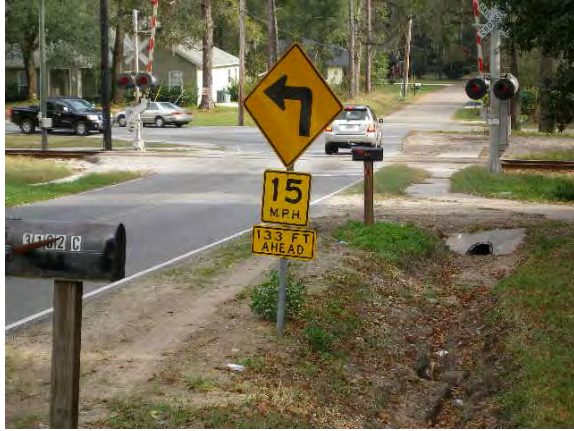
185 - Clay County, CR 224A (Peoria Road) at RXR, new turn sign with advisory and advisory speed

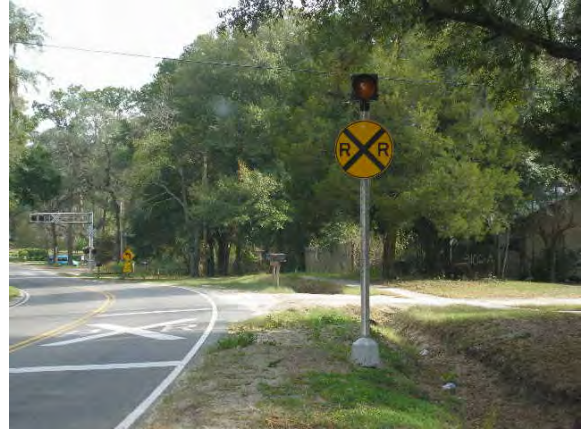
186 - Clay County, CR 224A (Peoria Road) at RXR, replaced RXR warning sign with new sign mounted with warning light

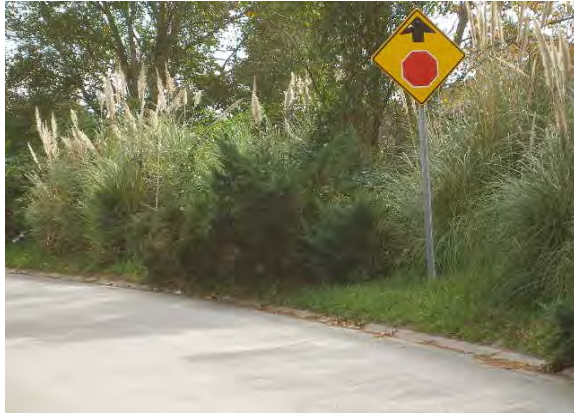
187 - Clay County, Heritage Farms Boulevard at Farm Way, placed new STOP Ahead sign

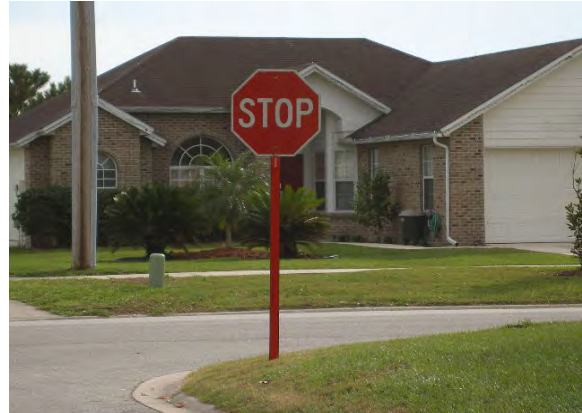
188 - Clay County, Heritage Farms Boulevard at Farm Way, placed reflective red strip on STOP sign post

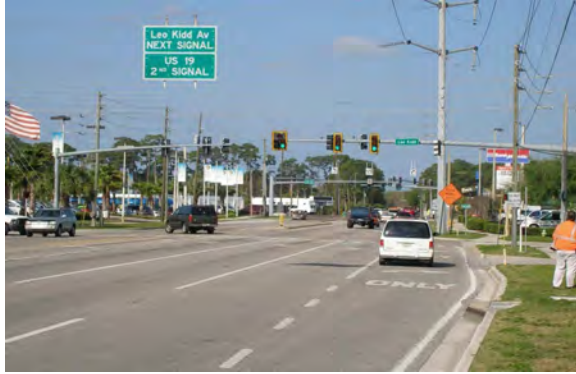
192 - Pasco County, Ridge Road at Leo Kid Avenue, overhead signs potentially take away driver attention from traffic signals, overhead street name signs reduce driver attention to traffic signal at Leo Kidd

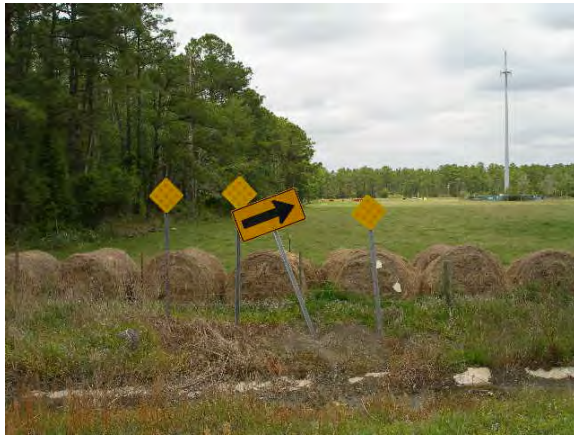
195 - Clay County, Mallard Road ½ mile south of CR 218, new sign following 2003 MUTCD standard

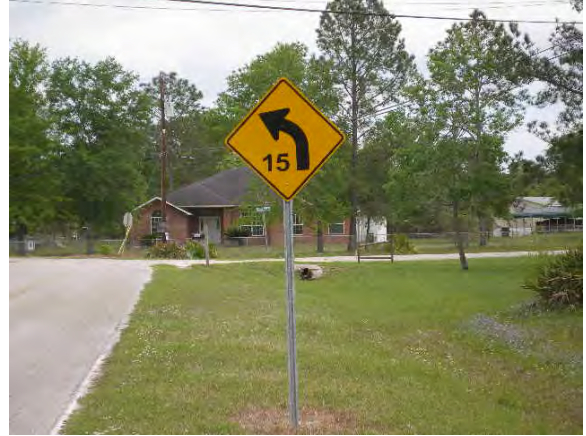
196 - Clay County, Mallard Road ½ mile south of CR 218, assembly following FDOT Design Standard #17349, arrow sign has been pushed and needs straightening

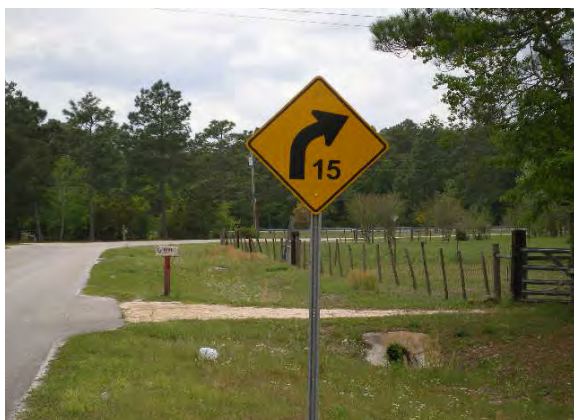
197- Clay County, Mallard Road ½ mile south of CR 218, new curve sign with advisory speed determined by using a ball bank indicator

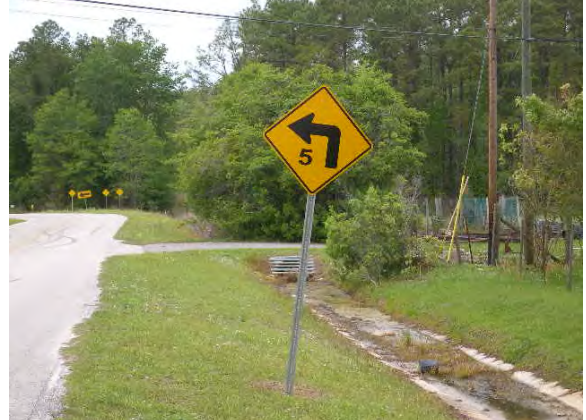
198 - Clay County, Mallard Road ½ mile south of CR 218, new sign southbound at curve (no sign before)

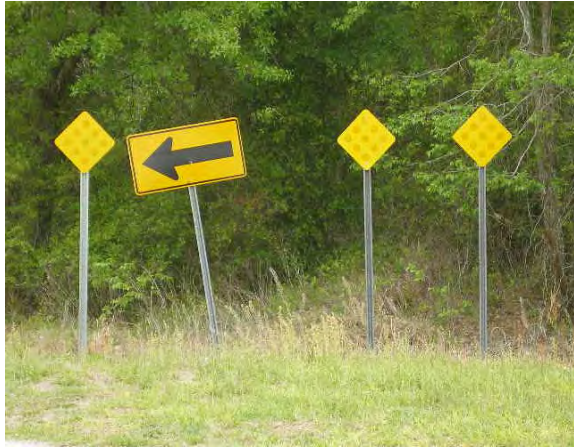
199 - Clay County, Mallard Road ½ mile south of CR 218, new sign at turn southbound

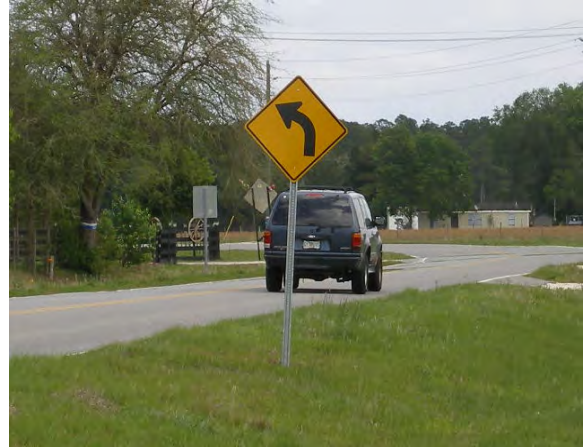
200 - Clay County, Mallard Road ½ mile south of CR 218, new assembly southbound

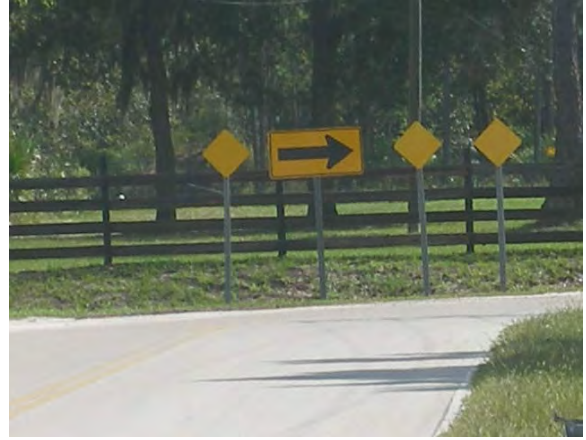
205 - Clay County, Thunder Road, turn assembly signage has not been brought to standard per Florida DOT Design Standard Index No. 17349, Case I

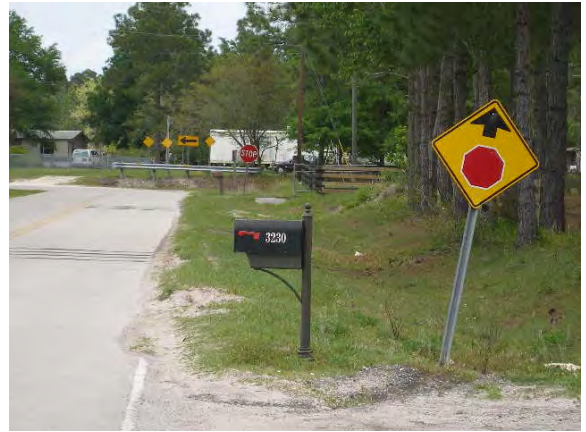
207 - Clay County, Thunder Road, northbound approach to the STOP condition at the first turn

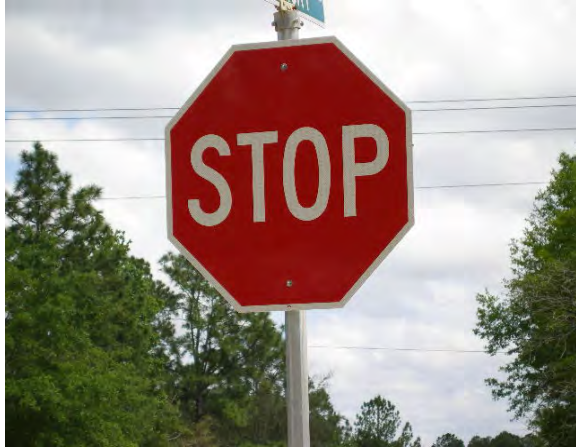
208 - Clay County, CR 215 intersection with Santa Clara Avenue, Camel Avenue, Juniper Avenue, Chicory Avenue, Deer Avenue, Primrose Avenue, example of upgraded STOP sign

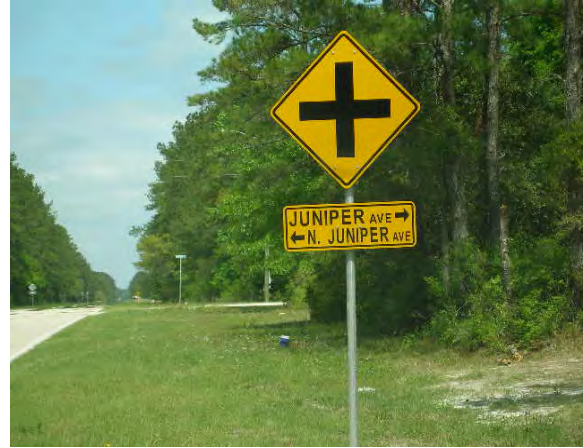
209 - Clay County, CR 215 intersection with Juniper Avenue, new high intensity grade warning sign

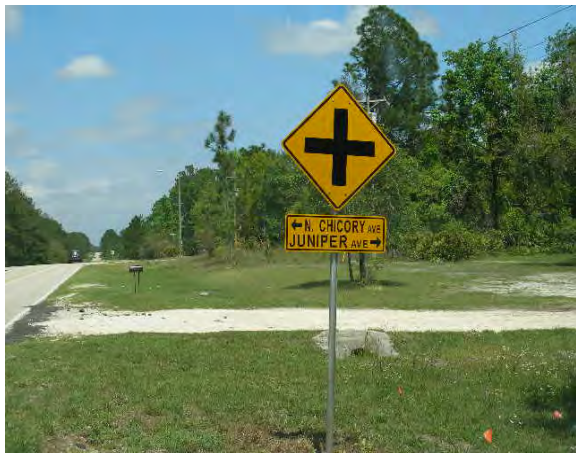
210 - Clay County, CR 215 intersection with Juniper Avenue and Chicory Avenue, new high intensity grade warning sign

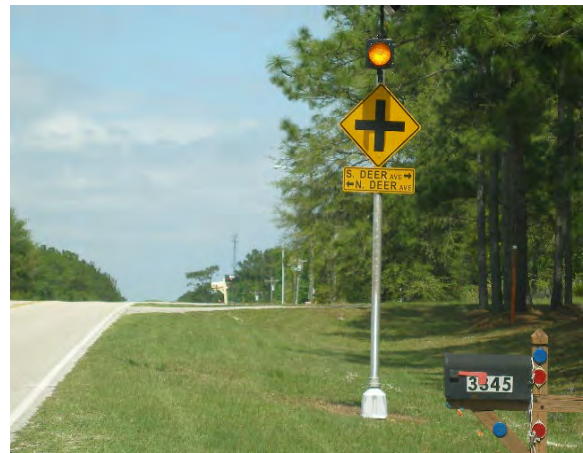
211 - Clay County, CR 215 intersection with Deer Avenue, new high intensity grade warning signs with amber flashing light located at intersections on the crest of a vertical curve where site distances can be a problem

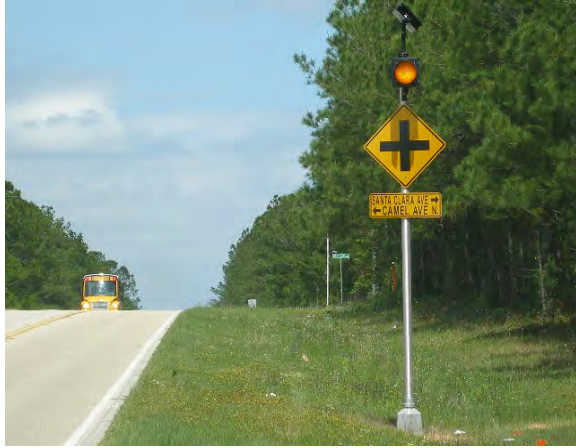
212 - Clay County, CR 215 and Santa Clara Avenue and Camel Avenue, new northbound signing

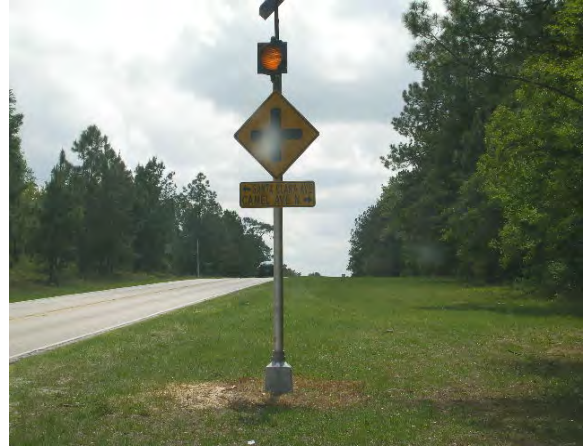
213 - Clay County, CR 215 and Santa Clara Avenue and Camel Avenue, new southbound signing

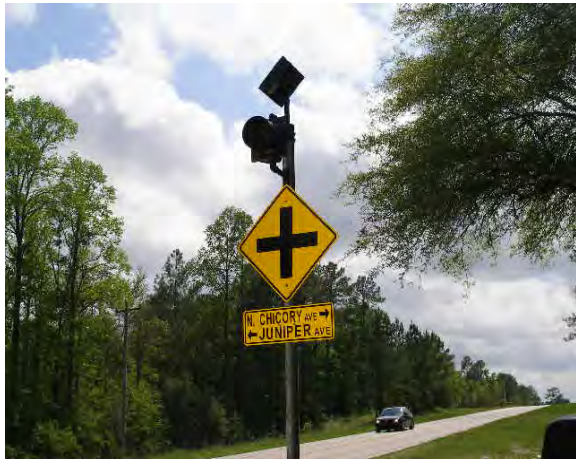
214 - Clay County, CR 215 and Chicory Avenue and Juniper Avenue, new southbound signing

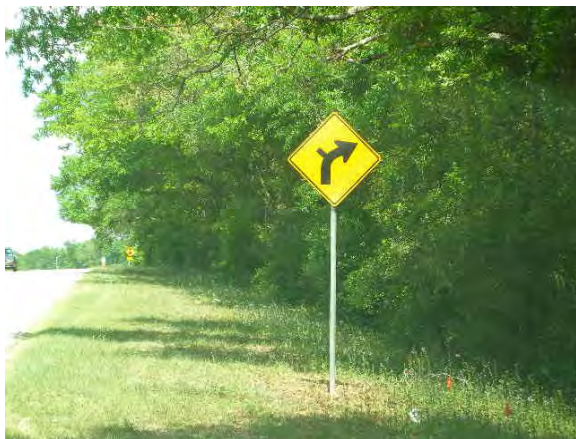
215 - Clay County, CR 215 and Primrose Avenue, new signing sequence #1

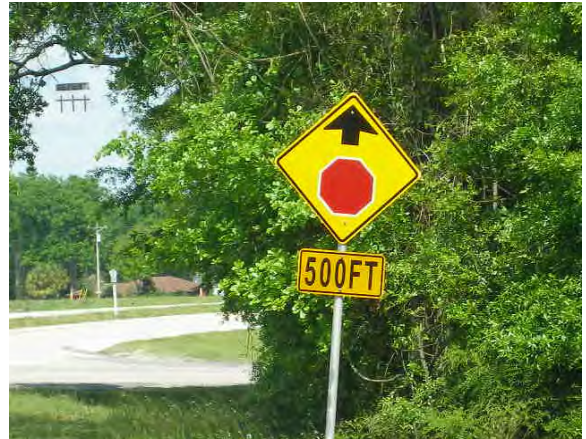
216 - Clay County, CR 215 and Primrose Avenue, new signing sequence #2

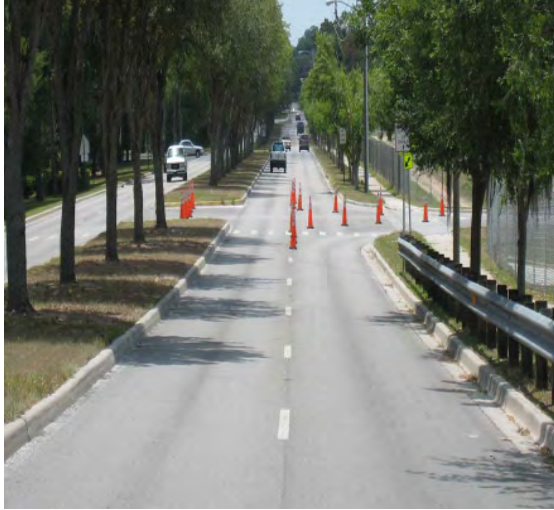
217 - Clay County, CR 215 and Primrose Avenue, new signing sequence #3

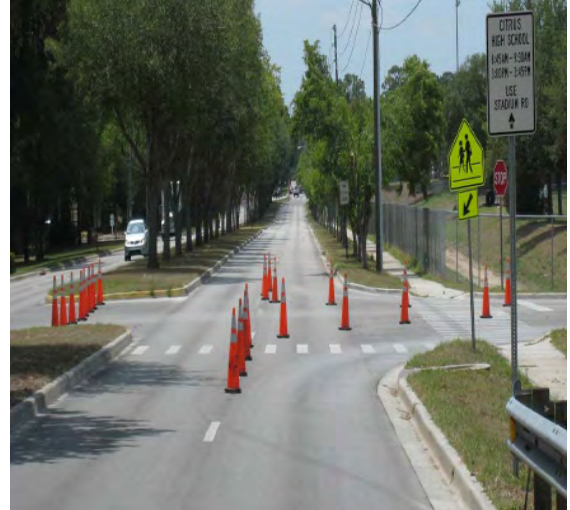
218 - Citrus County, Inverness Primary School, westbound approach to South Cherry Avenue

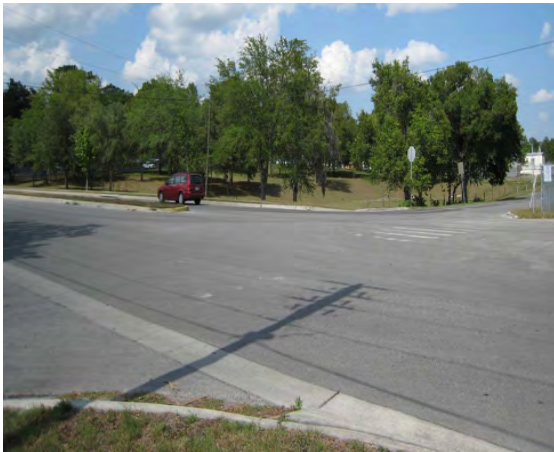
219 - Citrus County, Inverness Primary School, westbound approach to South Cherry Avenue closeup

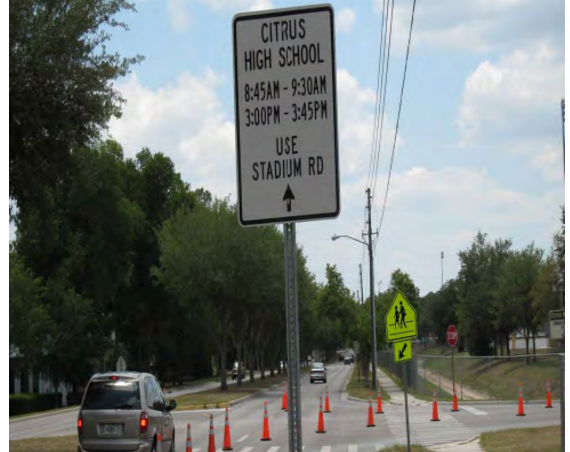
220 - Citrus County, Inverness Primary School, pedestrian crossing view from South Montgomery Avenue

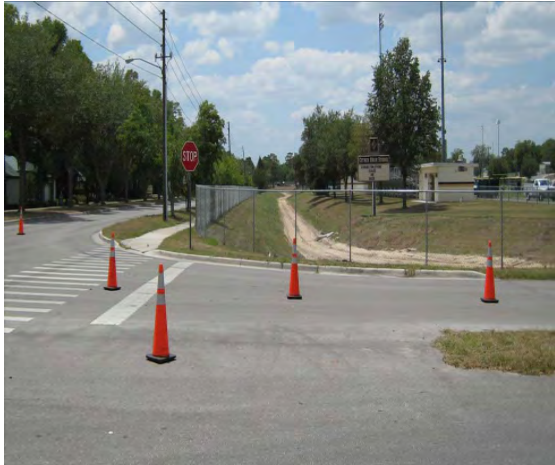
221 - Citrus County, Inverness Primary School, school driveway usage sign

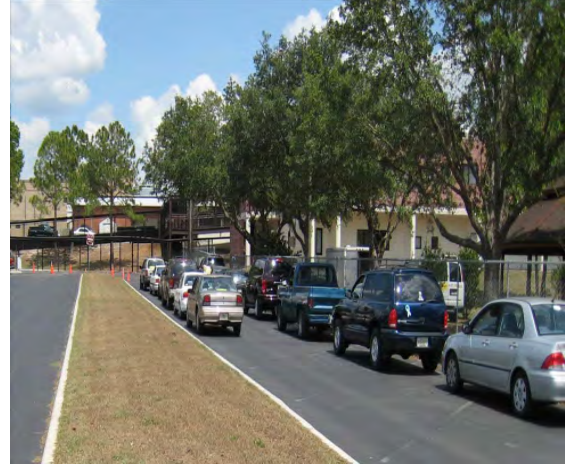
222 - Citrus County, Inverness Primary School, median on South Cherry Avenue

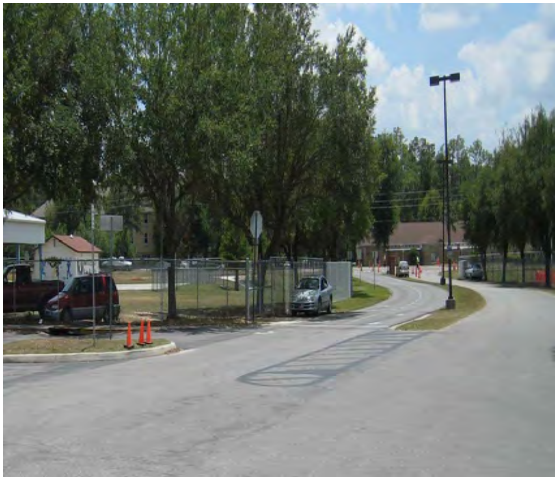
223 - Citrus County, Inverness Primary School, vehicle queue in parking lot

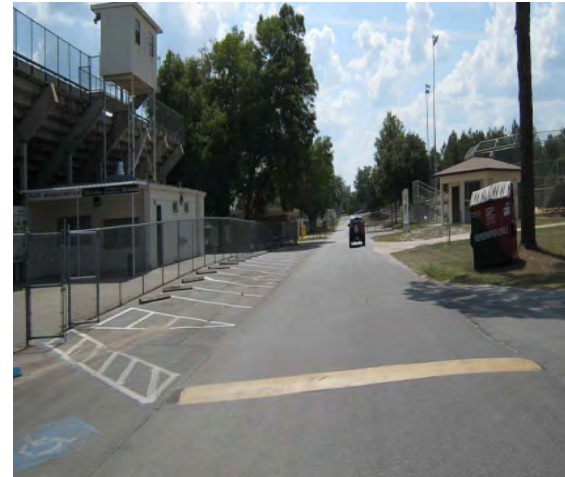
224 - Citrus County, Inverness Primary School, entrance on South Cherry Avenue

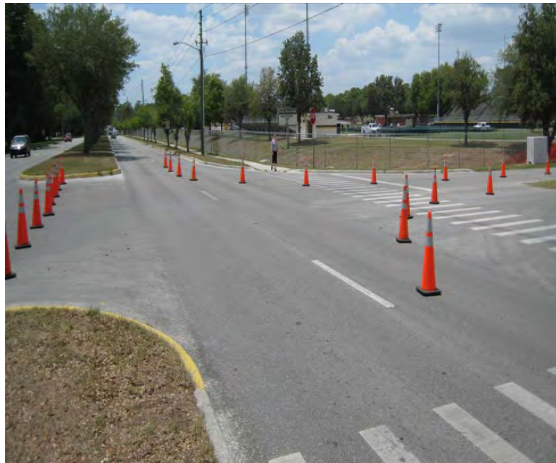
225 - Citrus County, Inverness Primary School, entrance on Frank Webb Way

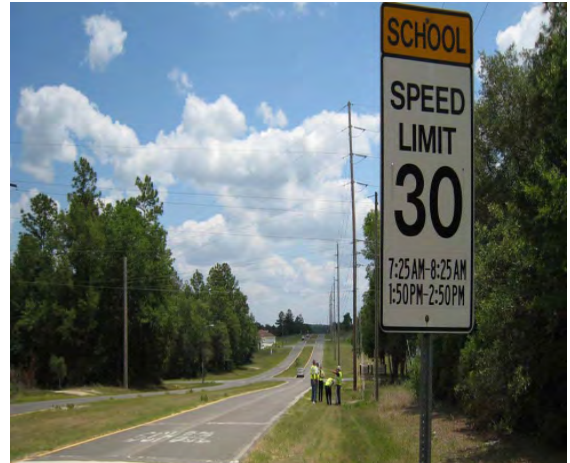
226 - Citrus County, Inverness Primary school, at West Highland Boulevard and South Cherry Avenue

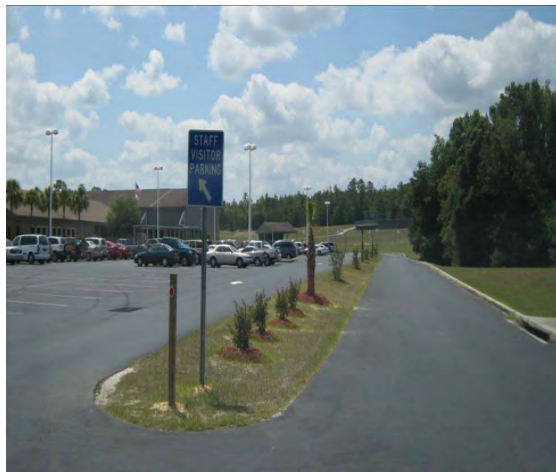
227 - Citrus County, Citrus Spring Middle School, on West Citrus Spring Boulevard

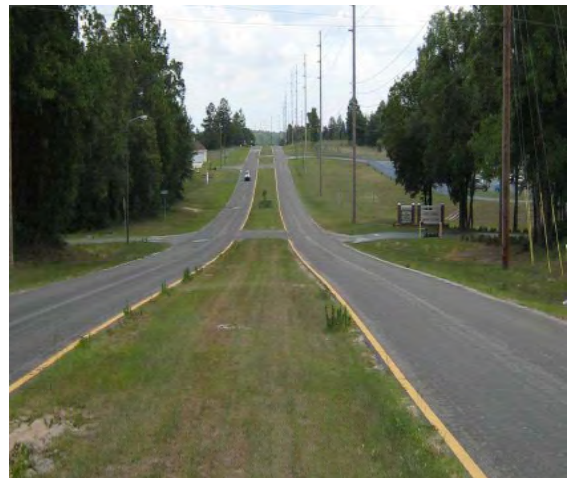
228 - Citrus County, Citrus Spring Middle School, along south perimeter of school

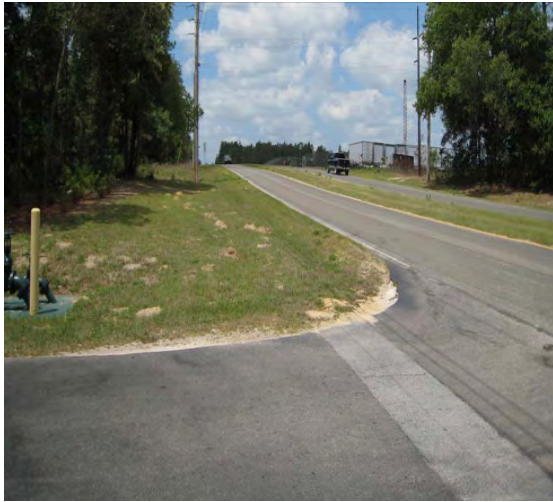
229 - Citrus County, Citrus Spring Middle School, West Citrus Spring Boulevard at North Greendale Drive, eastbound approach

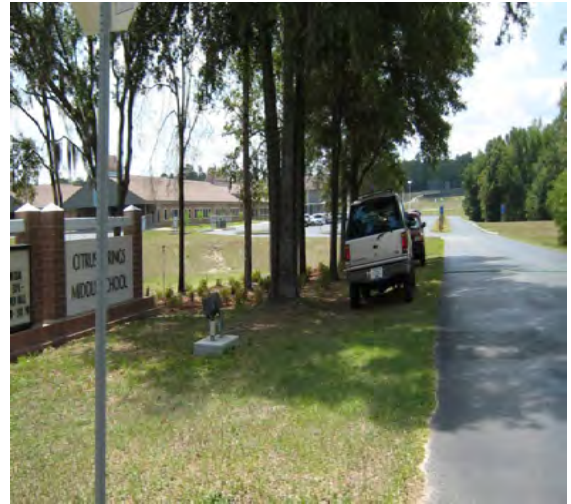
230 - Citrus County, Citrus Spring Middle School, West Citrus Spring Boulevard at North Greendale Drive, westbound view from driveway

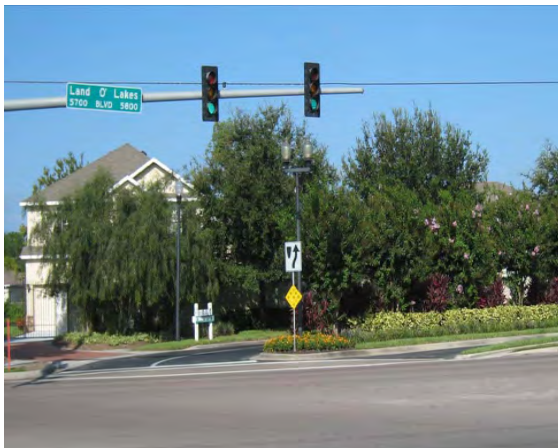
231 - Citrus County, Citrus Spring Middle School, southbound school driveway

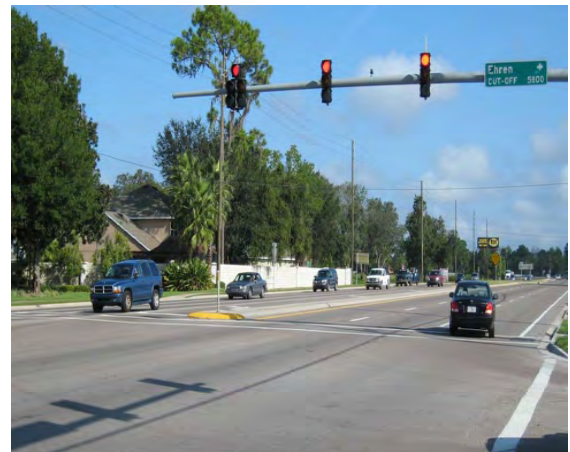
232 - Pasco County, Ehren cutoff at US 41 westbound

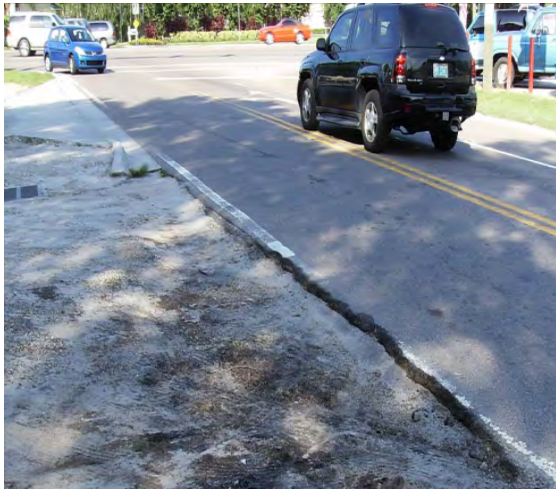
233 - Pasco County, Ehren cutoff at US 41 intersection

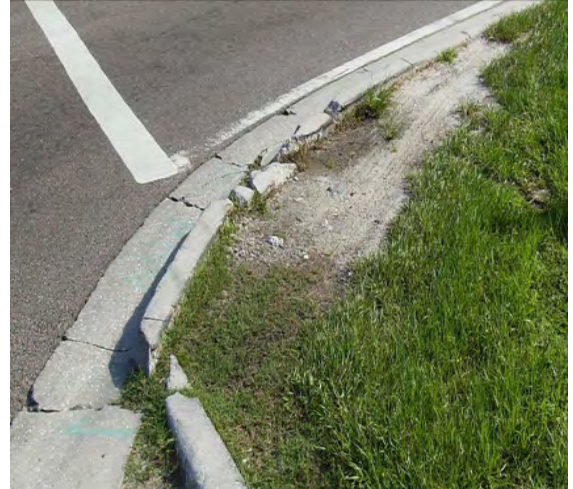
234 - Pasco County, Ehren cutoff and US 41, pavement edge

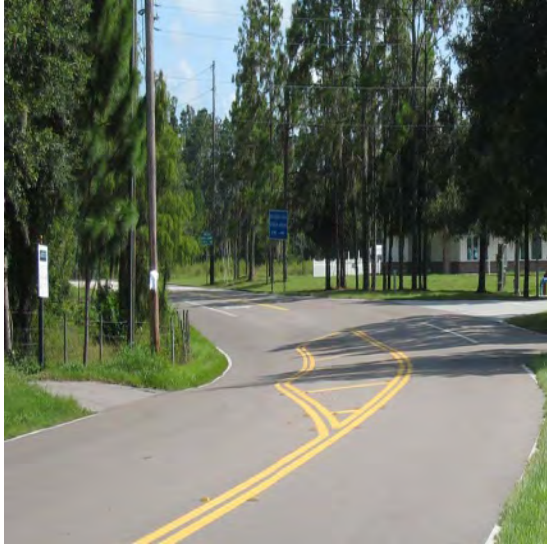
237 - Pasco County, Ehren cutoff southbound, about 250 feet west of Dupree Lakes

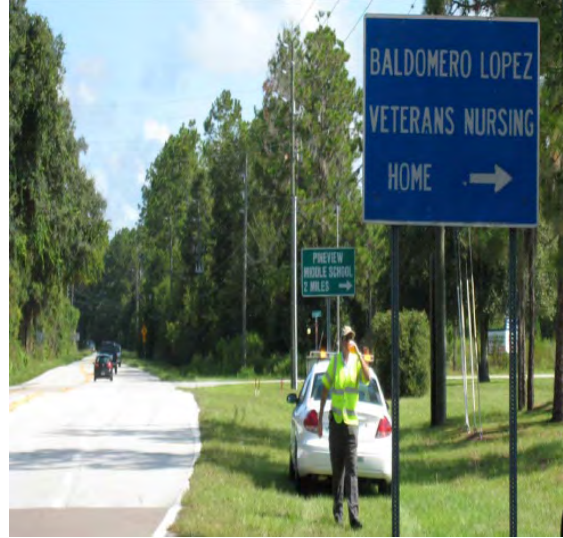
238 - Pasco County, Ehren cutoff, entrance to Veterans Nursing Home, pole on north side of road

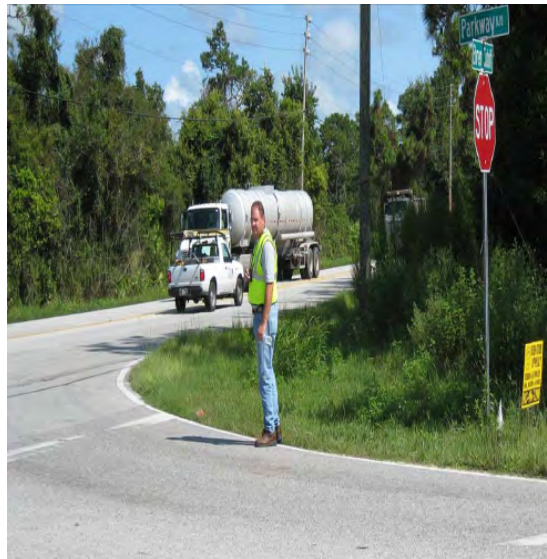
239 - Pasco County, Ehren cutoff west of Parkway Boulevard, destination signs

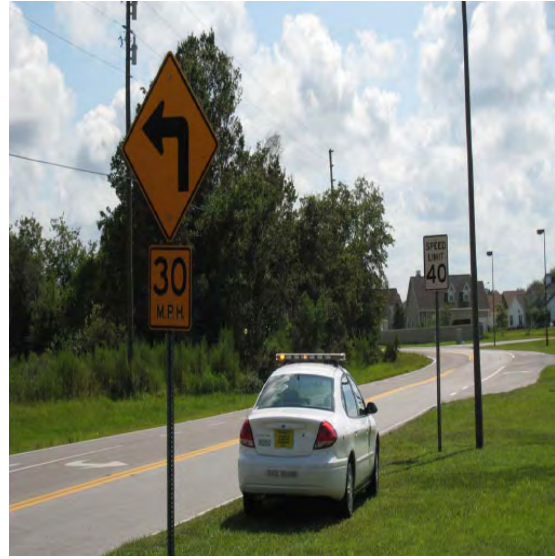
240 - Pasco County, Ehren cutoff at Parkway Boulevard

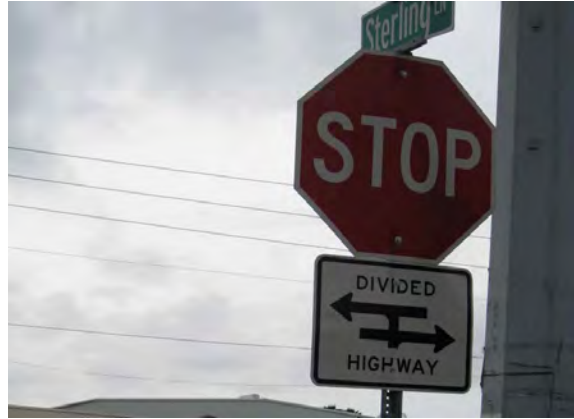
242 - Clay County, CR 315C at Blueberry Hill Road

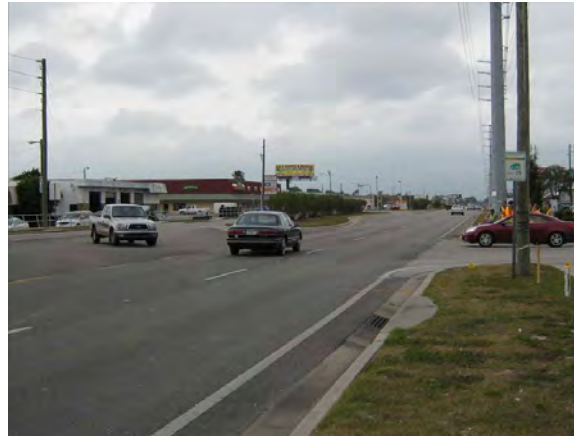
248 - Pasco County, Ridge Road (CR 587) at Sterling Lane, bushes planted in median limit sight distance for southbound turns

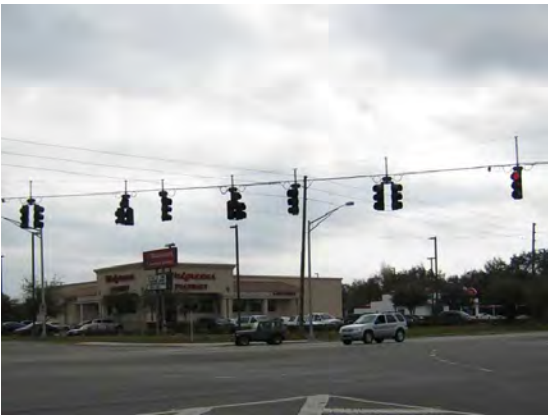
249 - Pasco County, Ridge Road (CR 587) at Sterling Lane, PCPT bus stop on the northeast corner of the intersection not accessible to disabled

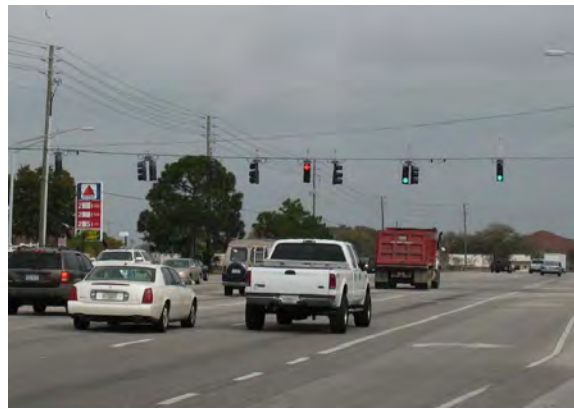
250 - Pasco County, Little Road (CR1) at Embassy Boulevard / Hilltop Drive, traffic signal heads do not have blackplates

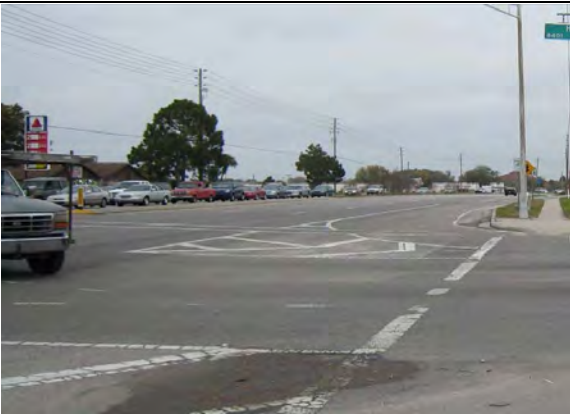
251 - Pasco County, Little Road (CR1) at Embassy Boulevard / Hilltop Drive, north and southbound approaches each have two signal heads serving the three thru lanes

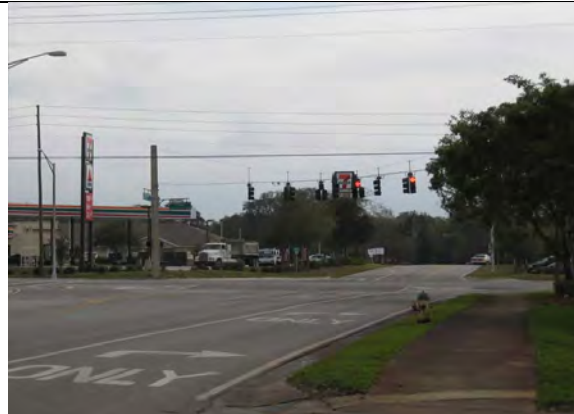
252 - Pasco County, Little Road (CR1) at Embassy Boulevard / Hilltop Drive, southbound vehicles can backup beyond horizontal curve north of intersection

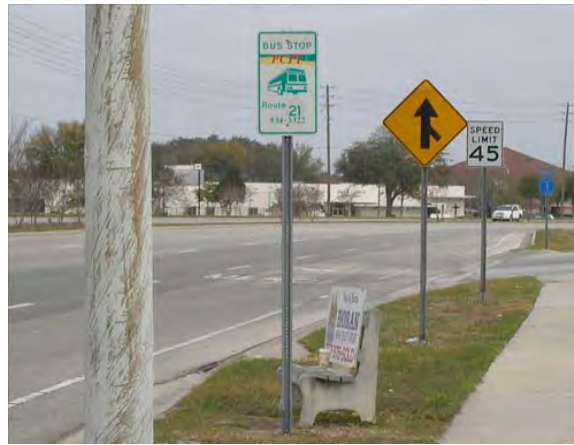
254 - Pasco County, Little Road (CR1) at Embassy Boulevard / Hilltop Drive, speed limit sign southbound on south side of intersection limits view of merge sign

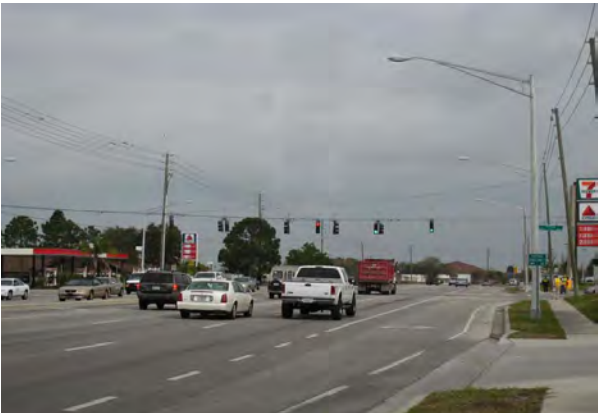
255 - Pasco County, Little Road (CR1) at Embassy Boulevard / Hilltop Drive, bus stop sign on north side limits view of merge sign for northbound vehicles

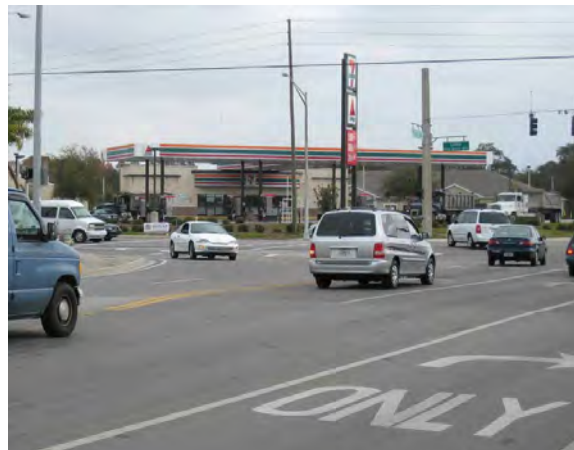
258 - Pasco County, Little Road (CR1) at Embassy Boulevard / Hilltop Drive, vehicles conflicting with each other at full median opening for driveway approximately 200 feet west of CR1 and Embassy Boulevard intersection

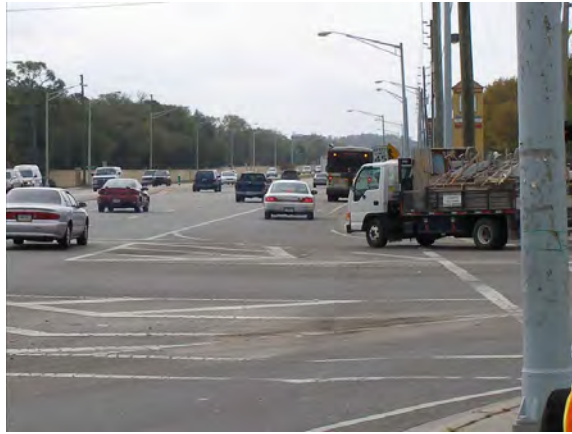
261 - Pasco County, Little Road (CR1) at Embassy Boulevard / Hilltop Drive, vehicle and bus conflict accentuated by driveways on the north and south side of intersection in merge lanes beyond the bus stops

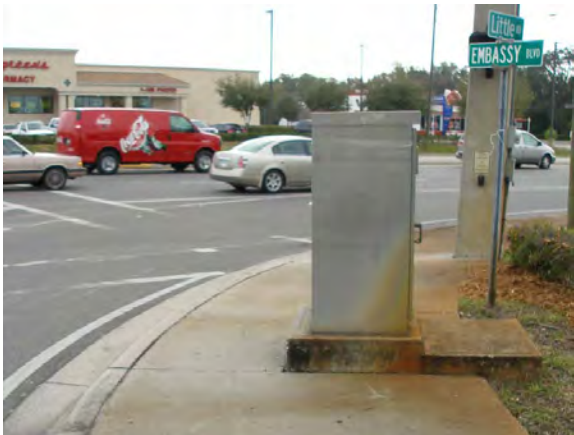
262 - Pasco County, Little Road (CR1) at Embassy Boulevard / Hilltop Drive, traffic signal controller cabinet located in sidewalk on southwest corner of intersection

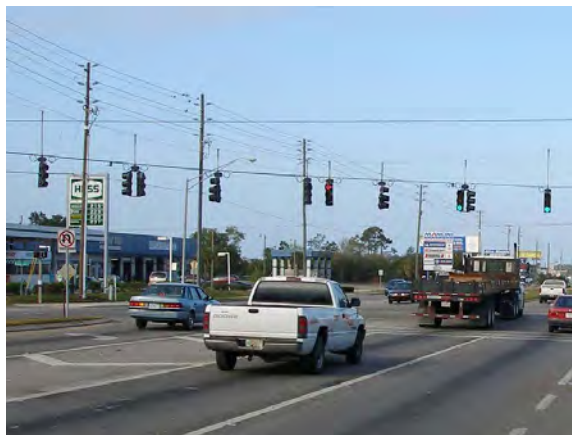
263 - Pasco County, Ridge Road (CR 587) at Regency Boulevard, traffic signal heads do not have blackplates

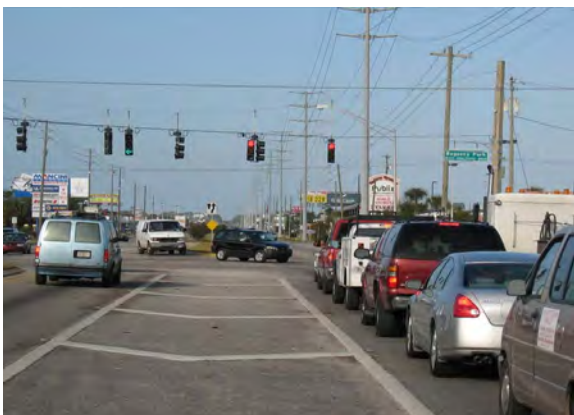
264 - Pasco County, Ridge Road (CR 587) at Regency Boulevard, signal heads for westbound thru vehicles appear to be aligned over painted gore for separated left turn lane

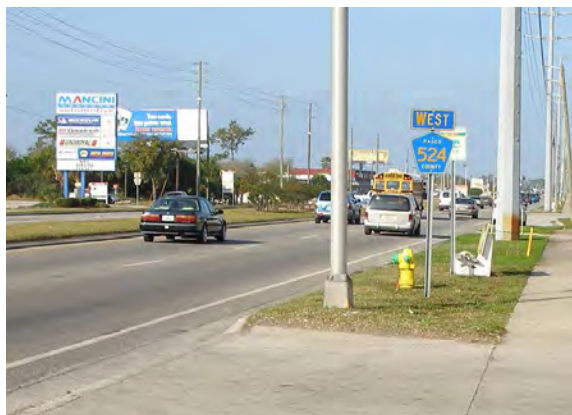
265 - Pasco County, Ridge Road (CR 587) at Regency Boulevard, no speed limit signs westbound

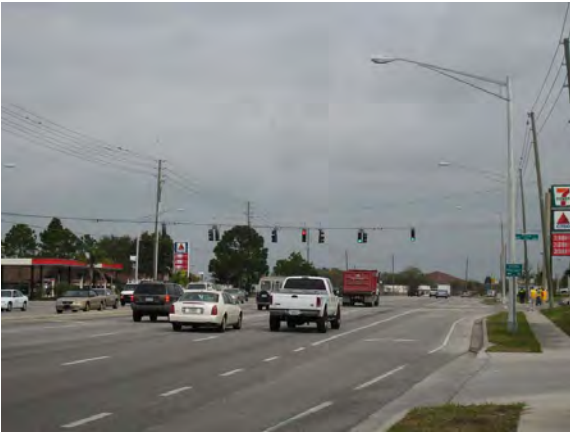
266 - Pasco County, Ridge Road (CR 587) at Regency Boulevard, no signs indicating name of next signalized intersections along corridor

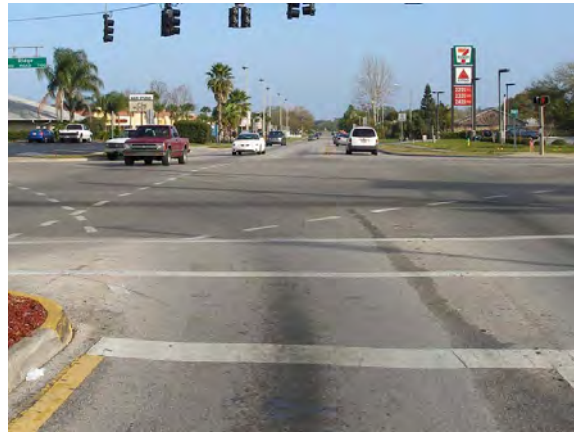
267 - Pasco County, Ridge Road (CR 587) at Regency Boulevard, skip guide lines provided at intersection for southbound thru movement, but no markings provided for northbound movement

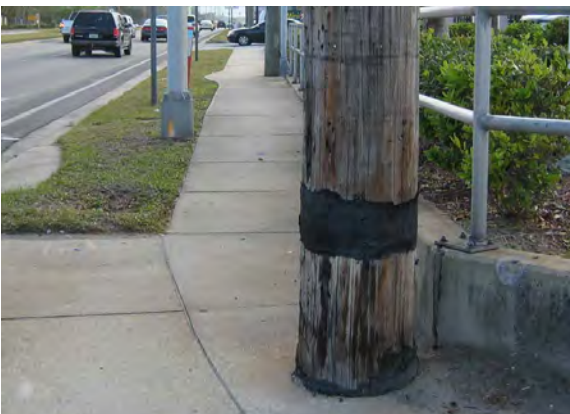
270 - Pasco County, Ridge Road (CR 587) at Regency Boulevard, wood utility poles in sidewalk on southeast intersection corner

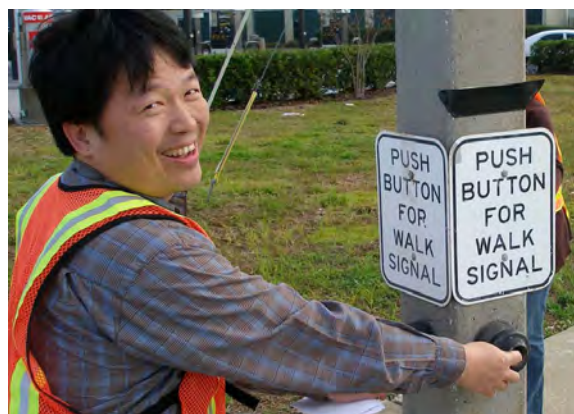
271 - Pasco County, Ridge Road (CR 587) at Regency Boulevard, pushbuttons not up to current standards making it difficult for pedestrians to tell which button controls which crossing

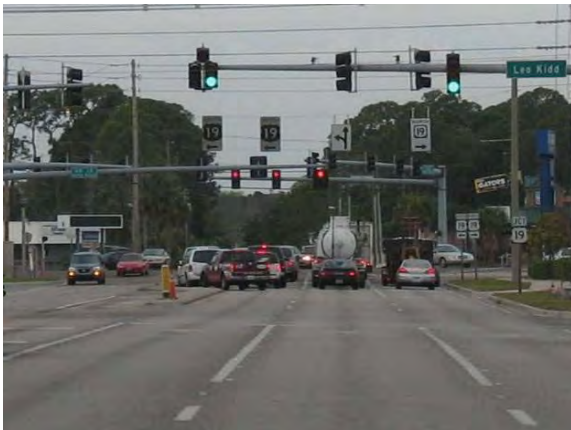
274 - Pasco County, Ridge Road (CR 587) at Leo Kidd Avenue , two signal heads for three thru lanes

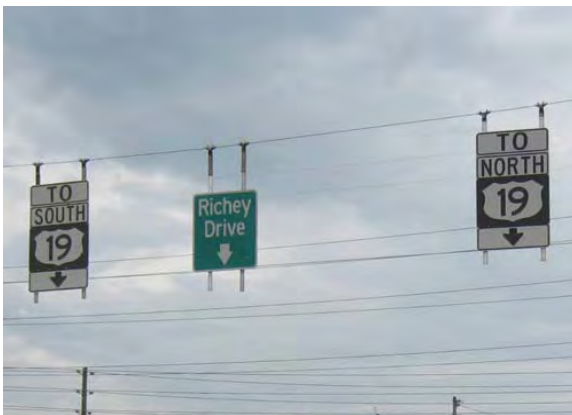
276 - Pasco County, Ridge Road (CR 587) at Leo Kidd Avenue, three styles of overhead US 19 markers used

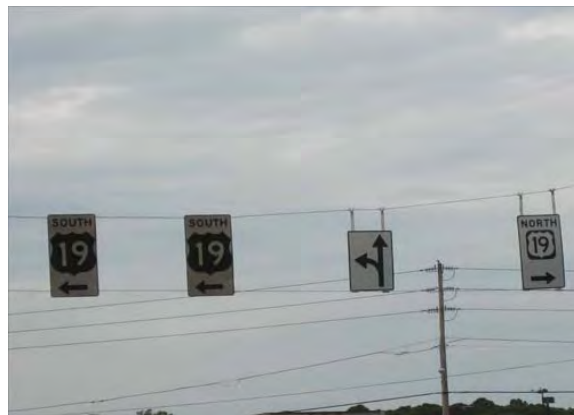
277 - Pasco County, Ridge Road (CR 587) at Leo Kidd Avenue , overhead markers for US 19

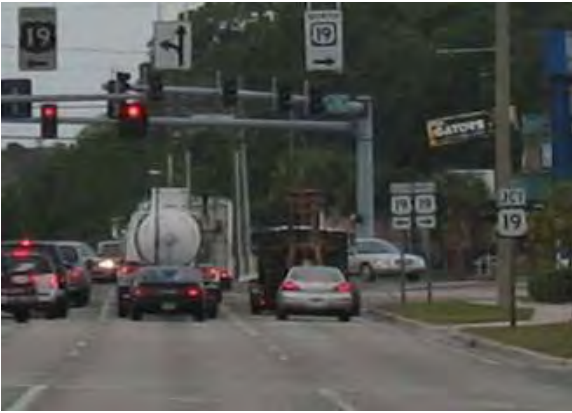
278 - Pasco County, Ridge Road (CR 587) at Leo Kidd Avenue, US 19 junction sign close to intersection not allowing drivers time to change to appropriate lane

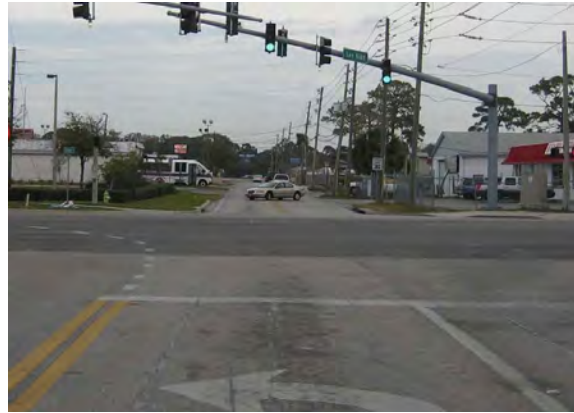
279 - Pasco County, Ridge Road (CR 587) at Leo Kidd Avenue, southbound thru lane lines up with northbound left turn lane

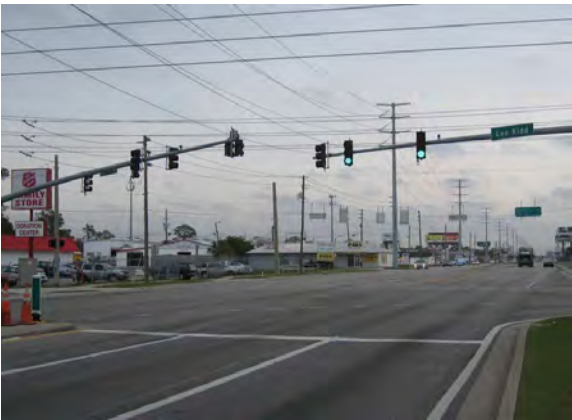
280 - Pasco County, Ridge Road (CR 587) at Leo Kidd Avenue, no overhead street lighting present at intersection

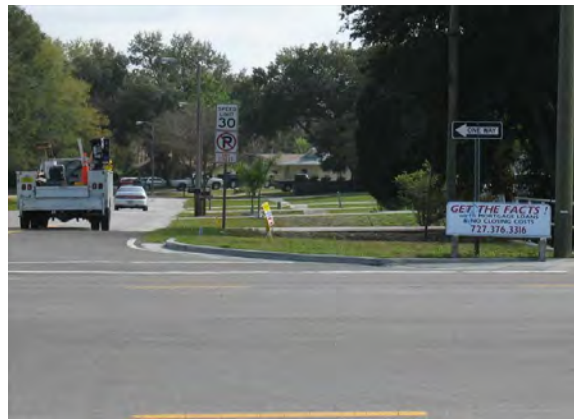
281 - Pasco County, Little Road (CR 1) at Saint Lawrence Drive, one way signs at intersection do not appear to meet MUTCD standards for median openings 30 feet wide or greater

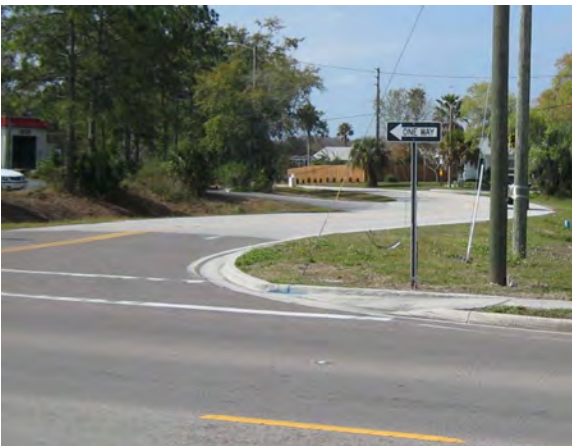
282 - Pasco County, Little Road (CR 1) at Saint Lawrence Drive, unmarked horizontal curves present at far side of intersection for eastbound and westbound approaches

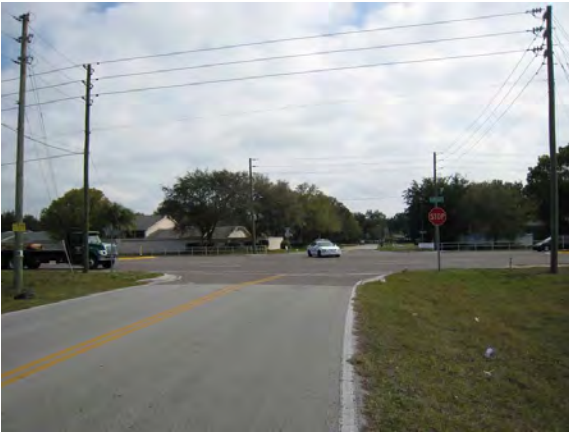
284 - Pasco County, Little Road (CR 1) at Saint Lawrence Drive, no street lighting present at intersection

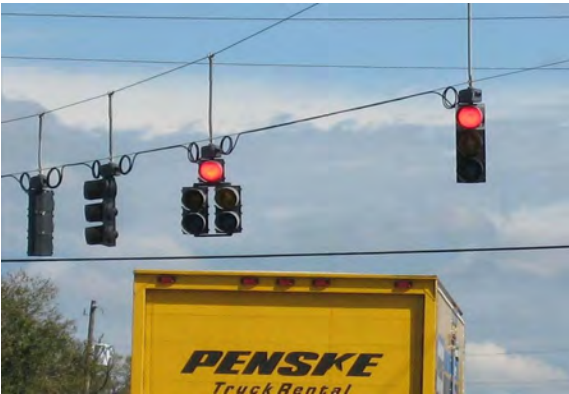
286 - Pasco County, SR 54 at Morris Bridge Road / Eiland Boulevard (CR 579), no backplates on traffic signal head

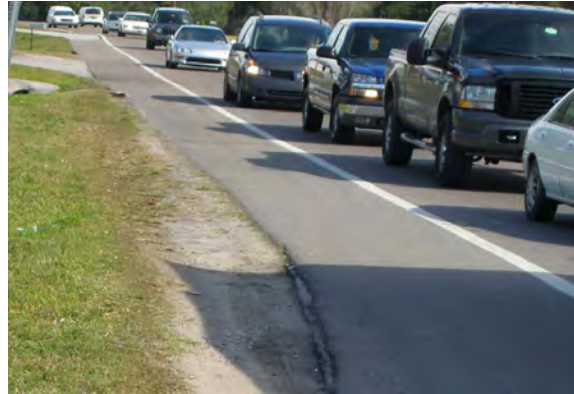
287 - Pasco County, SR 54 at Morris Bridge Road / Eiland Boulevard (CR 579), significant queuing beyond horizontal curve on SR 54 for vehicles approaching intersection from the westbound approach

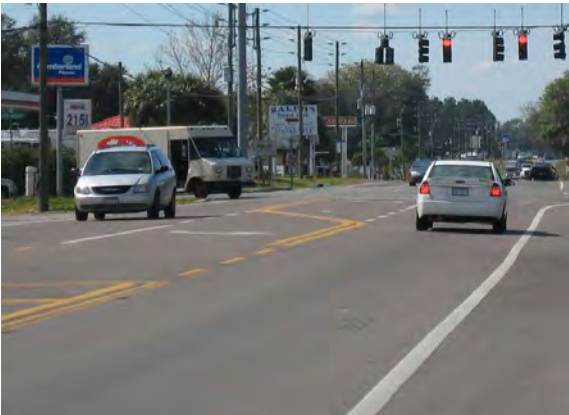
288 - Pasco County, SR 54 at Morris Bridge Road / Eiland Boulevard (CR 579), left turn queues stack past marked left turn storage west/northbound, turn lane storage westbound limited by business turn lanes

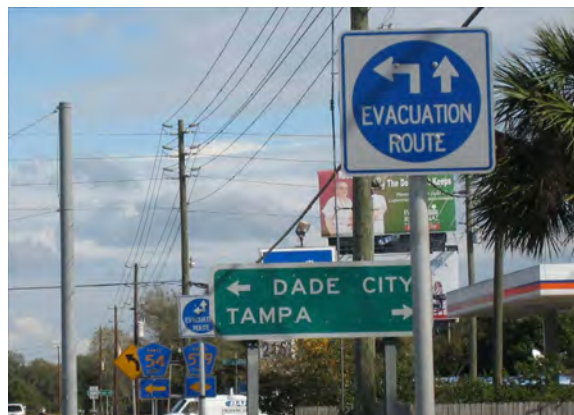
289 - Pasco County, SR 54 at Morris Bridge Road / Eiland Boulevard (CR 579), two different consecutive evacuation signs on eastbound approach, second sign impeding view of county road designation signs

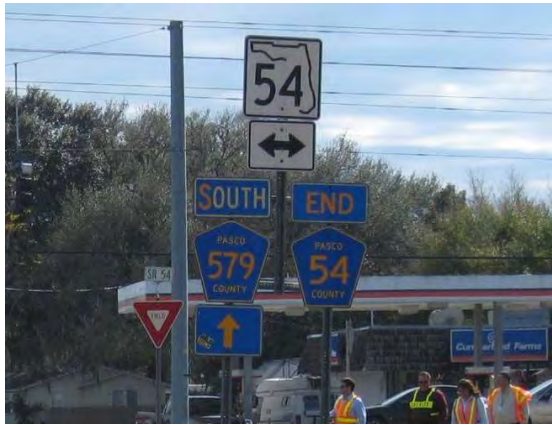
290 - Pasco County, SR 54 at Morris Bridge Road / Eiland Boulevard (CR 579), faded signs
