Florida LTAP Safety Circuit Rider Program

Final Report

FDOT Project BD545-52
UF52349

September 2009

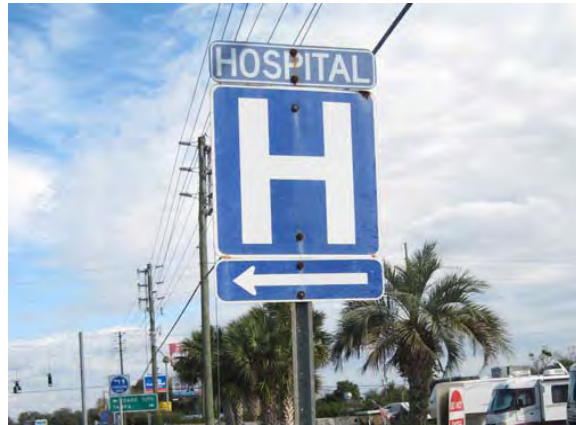
291 - Pasco County, SR 54 at Morris Bridge Road / Eiland Boulevard (CR 579), faded sign

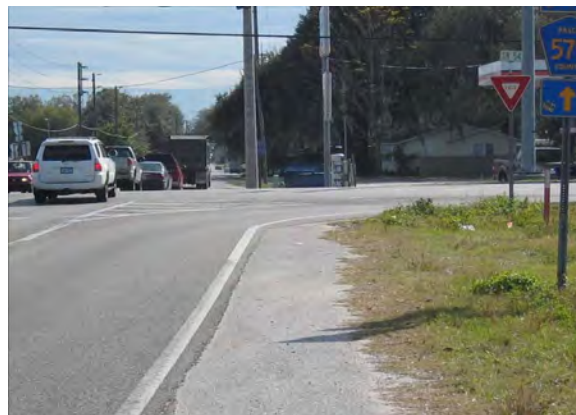
294 - Pasco County, SR 54 at Morris Bridge Road / Eiland Boulevard (CR 579), advance warning sign for horizontal curve on east side of intersection located prior to intersection

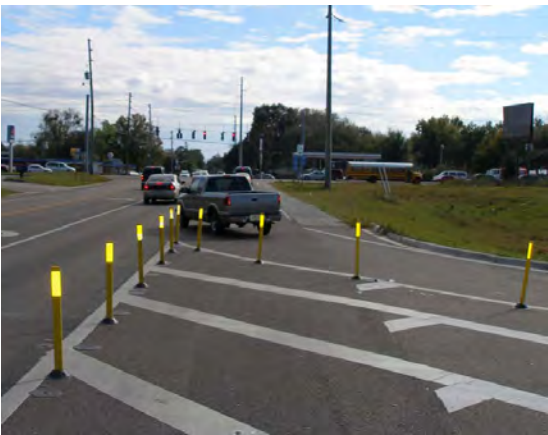
297 - Pasco County, SR 54 at Morris Bridge Road / Eiland Boulevard (CR 579), dedicated southbound right turn lane has only one right turn arrow on pavement

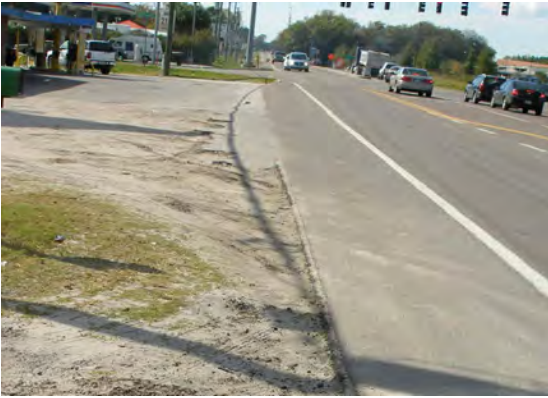
300 - Pasco County, SR 54 at Morris Bridge Road / Eiland Boulevard (CR 579), southeast quadrant of intersection appears to be one continuous unrestricted driveway

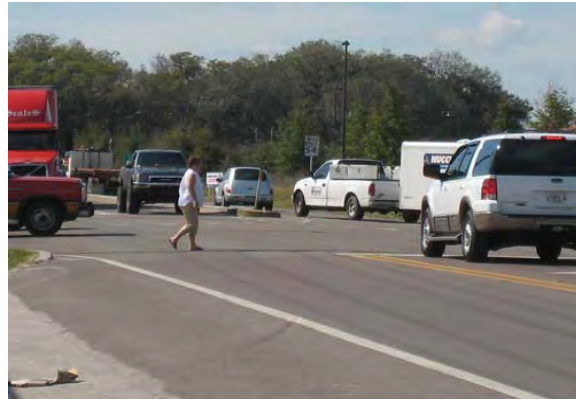
301 - Pasco County, SR 54 at Morris Bridge Road / Eiland Boulevard (CR 579), pedestrians crossing intersection where no pedestrian facilities are available

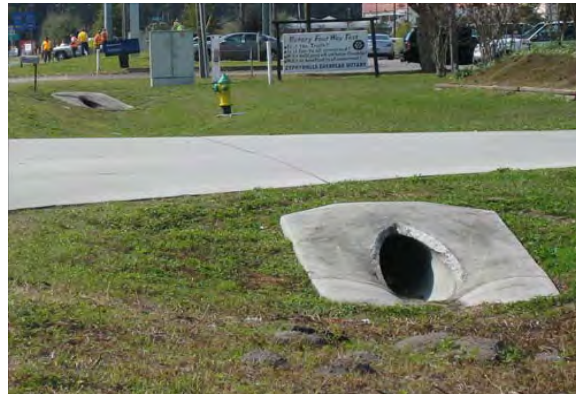
303 - Pasco County, SR 54 at Morris Bridge Road / Eiland Boulevard (CR 579), uncovered drains

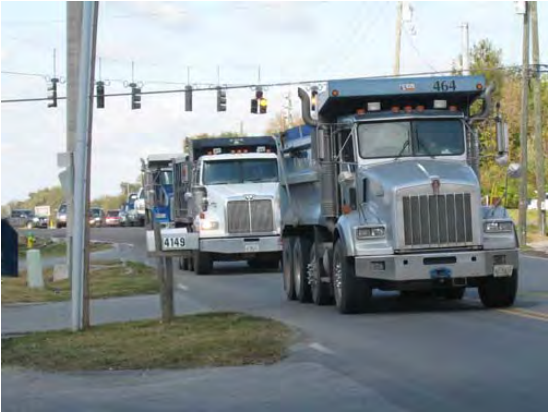
306 - Pasco County, SR 54 at Morris Bridge Road / Eiland Boulevard (CR 579), mailbox appears to be in clear zone

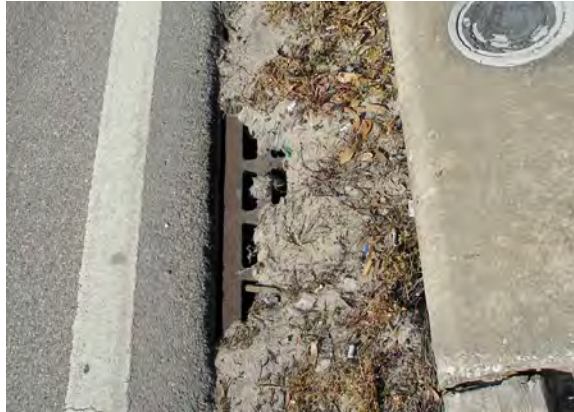
307 - Pasco County, SR 54 at Morris Bridge Road / Eiland Boulevard (CR 579, blocked drain around intersection

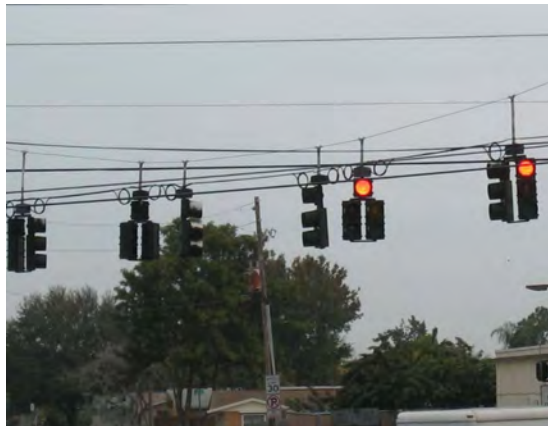
308 - Pasco County, SR 54 at Morris Bridge Road / Eiland Boulevard (CR 579), no approaches have white lights installed to aid red light running enforcement

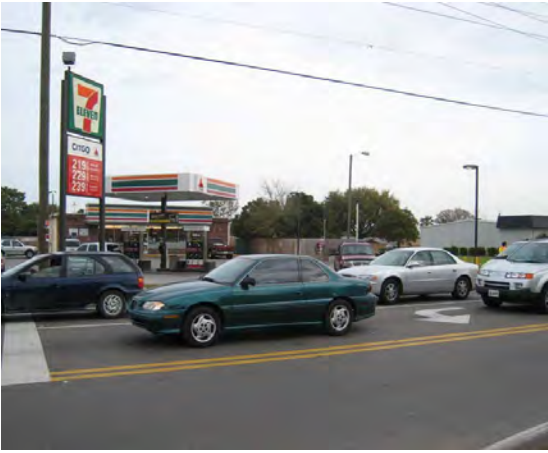
309 - Pasco County, Trouble Creek Road (CR 518) at Madison Street, no backplates for traffic signal heads and overhead cables impede signal indication view for northbound approach

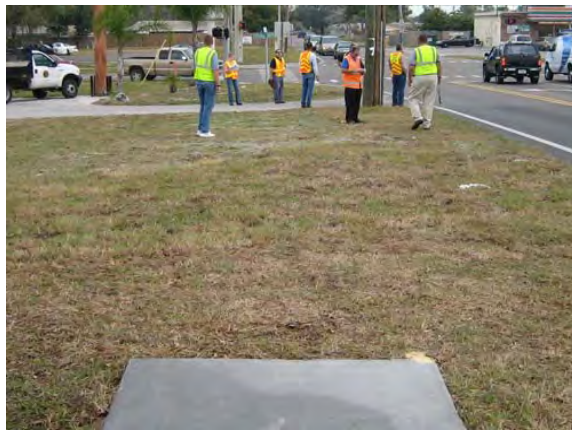
312 - Pasco County, Trouble Creek Road (CR 518) at Madison Street, pavement drop-off on westbound approach to business driveway where no shoulder is present on Trouble Creek Road

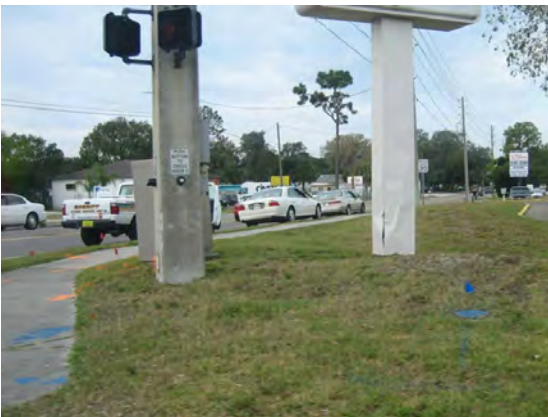
313 - Pasco County, Trouble Creek Road (CR 518) at Madison Street, sidewalk not continuous on southwest corner of intersection

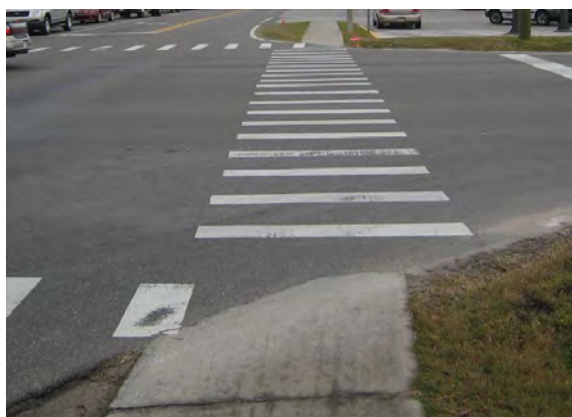
314 - Pasco County, Trouble Creek Road (CR 518) at Madison Street, pushbuttons in northwest corner of intersection cannot readily be accessed by persons with disabilities

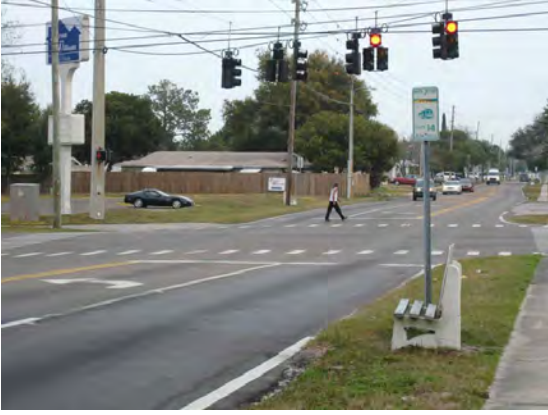
315 - Pasco County, Trouble Creek Road (CR 518) at Madison Street, ramps leading to pedestrian crossings on all four corners of intersection do not have truncated domes installed

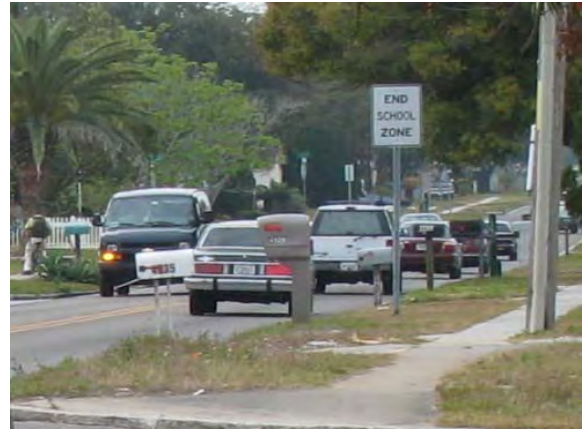
317 - Pasco County, Madison Street at Cecilia Drive, older standard pedestrian crossing signs used on eastbound approach

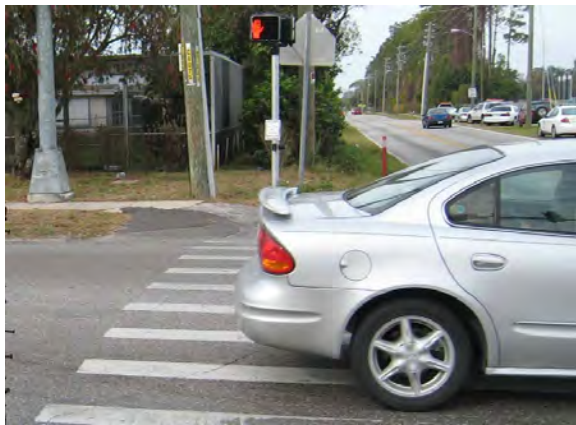
318 - Pasco County, Madison Street at Cecilia Drive, northbound approach into school zone does not seem to be designated by pavement markings

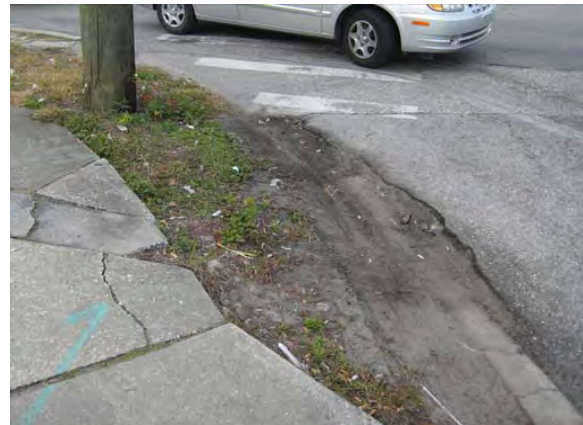
319 - Pasco County, Madison Street at Cecilia Drive, sight distance for southbound vehicles is restricted to the east

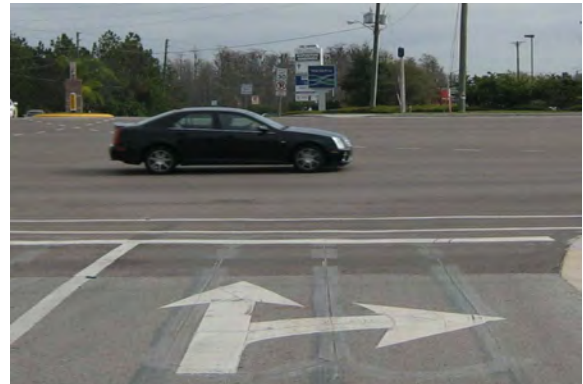
321 - Pasco County, Little Road (CR 1) at Rancho del Rio Drive, no backplates for traffic signal heads

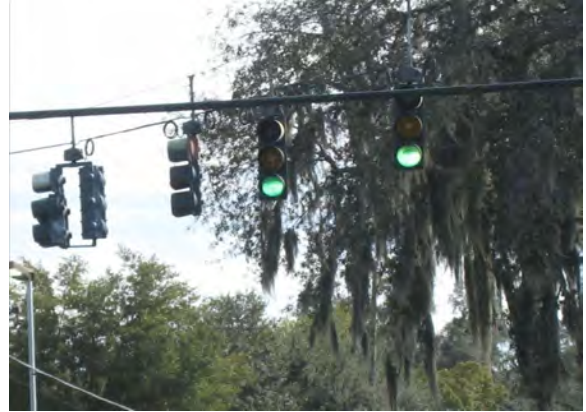
327 - Pasco County, Little Road (CR 1) at Rancho del Rio Drive, no signs indicating name of next signalized intersections along corridor and no street lighting present at intersection

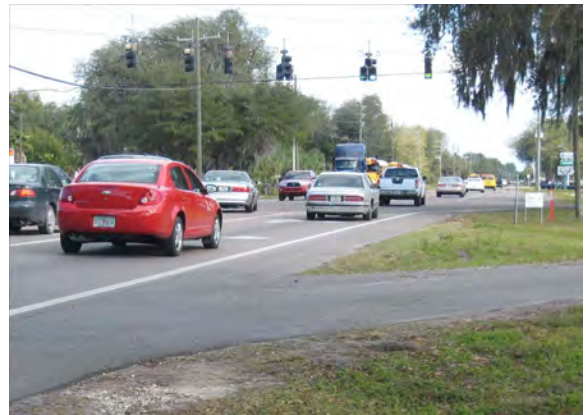
329 - Pasco County, SR 54 at Dean Dairy / Coats Road, vehicles queuing on SR 54 beyond business driveways near intersection

Site ID #	Date	County	Location	Pre-Review Statistics	Comments	Suggestions from SCR	Photo Reference	Actions taken by Agency	Follow-Up Statistics
Pasco-10	Feb-Mar 2007	Pasco	SR 54 at Dean Dairy / Coats Road	The Pasco County CDMS indicates that an average of 6.6 rear end crashes per year, 4.8 angle crashes per year, and 1 left turn crash per year occur at the intersection.	The northwest corner of the intersection is occupied by a Sunoco gas station, the northeast corner is vacant but a sign was noted indicated that a Walgreens drug store will be constructed there, the southwest corner by a shopping plaza with a Winn-Dixie supermarket, and the southeast corner by a Hardy's restaurant store.	(1) At intersection: install backplates, use reflective border backplates where background behind signals is dark, upgrade to LED signal displays, install overhead street lighting, provide pedestrian facilities. (2) Replace burnt out bulb and replace missing blue RPM on northbound approach. (3) Review timing on eastbound approach to provide more mainline green time, review driveways near intersection, provide more through capacity. (4) Trim trees on eastbound and westbound approaches, install advance street name signs. (5) Refurbish pavement markings and RPMs at intersection approaches. (6) Northbound and southbound direction: modify driveway to become a right in / right out. (7) Take corrective measures at northeast and southeast corners to eliminate the drop-off condition, install a paved shoulder on Morris Bridge Road. (8) Eastbound and westbound approaches: revise left turn lanes on intersection's approaches to reduce vehicle conflict points.	328, 329, 330, 331, 332, 333, 334, 335

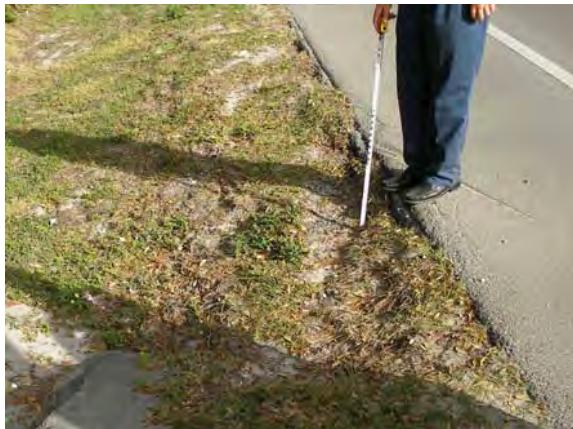
332 - Pasco County, SR 54 at Dean Dairy / Coats Road, intersection has only one overhead street light

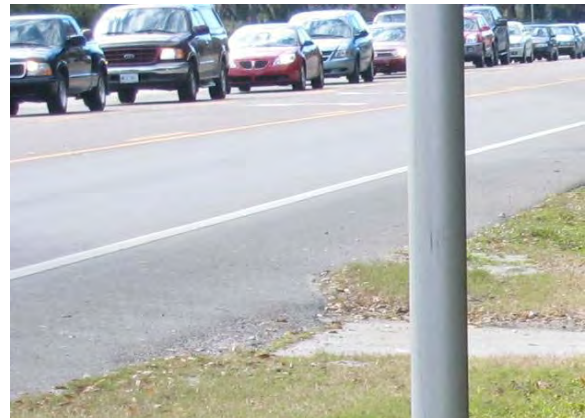
333 - Pasco County, SR 54 at Dean Dairy / Coats Road, pavement drop off on southeast and northeast intersection corners

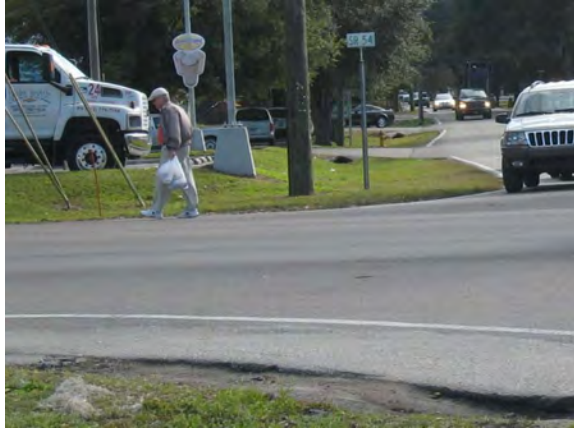
334 - Pasco County, SR 54 at Dean Dairy / Coats Road, vehicle conflict surrounding driveways around two-way left turn lane on eastbound and westbound intersection approaches

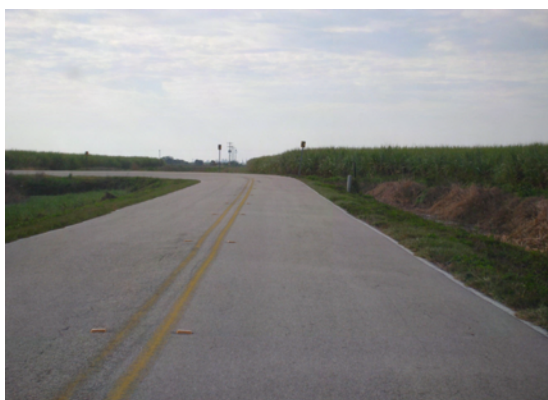
338 – Glades County, CR 720, looking east from just west of first curve, (note skid marks on pavement and lack of shoulders and presence of deep, shallow side ditches)

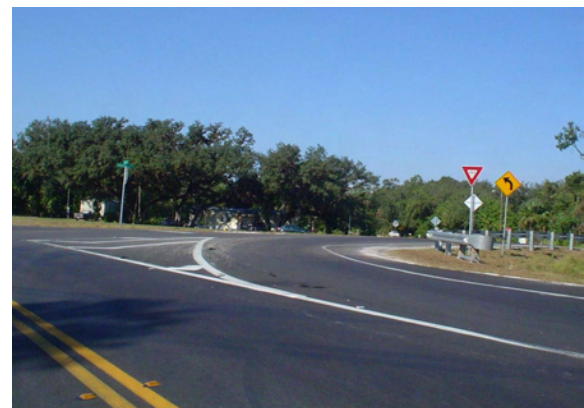
339 – Glades County, CR 720, note spacing of Chevrons and condition

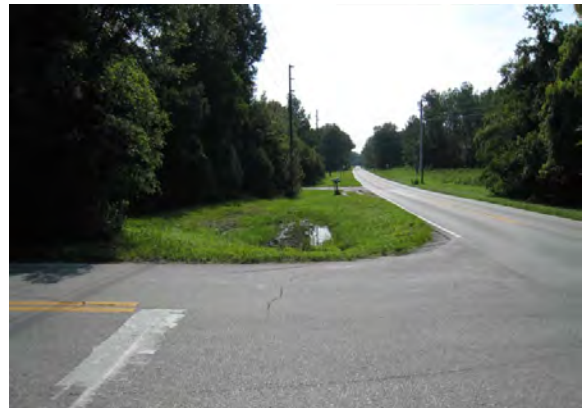
344 – Hernando County, Mondon Hill Road and McIntyre Road, no overhead street lighting

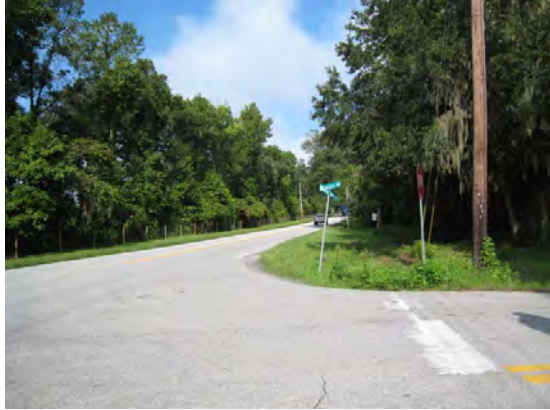
347 – Hernando County, Mondon Hill Road and McIntyre Road, vegetation limiting approach visibility to Mondon Hill Road

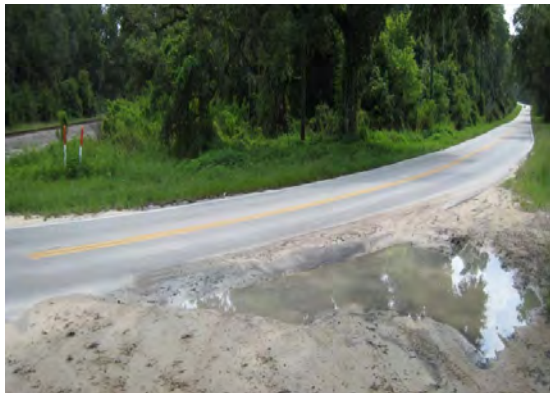
355 – Hernando County, Citrus Way at Fort Dade Avenue (CR 484), edge lines

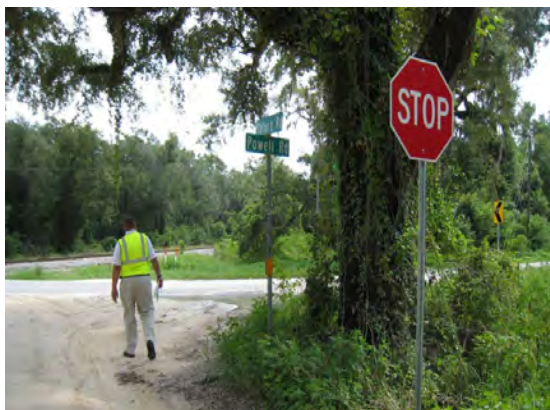
358 – Hernando County, Powell Road at Saturn Road, eastbound approach

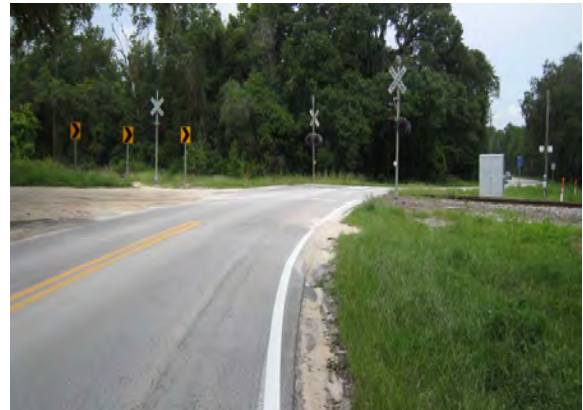
359 – Hernando County, Powell Road at Saturn Road, northbound approach signs

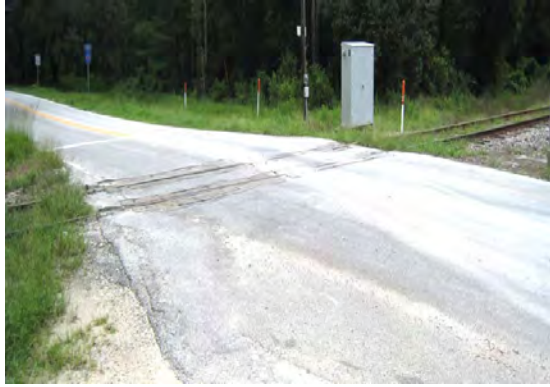
360 – Hernando County, Powell Road at Saturn Road, centerline on westbound approach

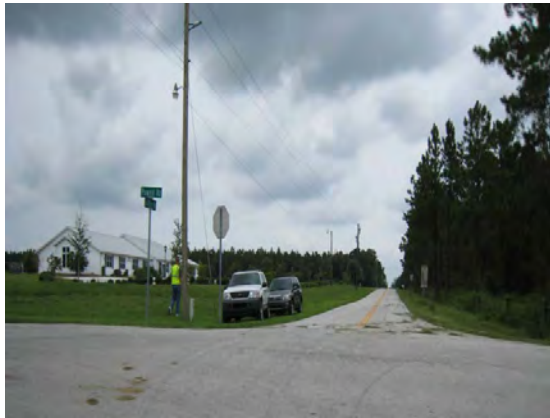
362 – Hernando County, Powell Road at Saturn Road, paved shoulders currently absent for both intersection approaches

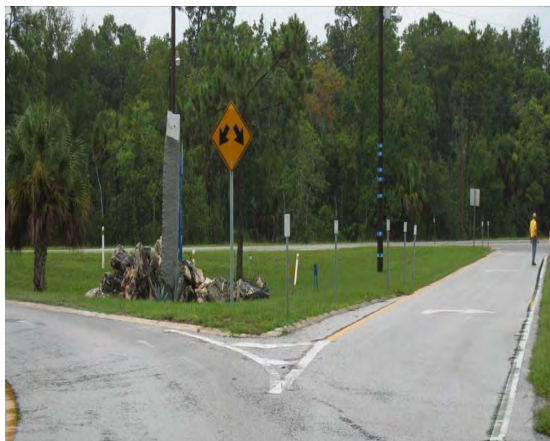
364 – Hernando County, Powell Road at Griffin Road, curve warning sign

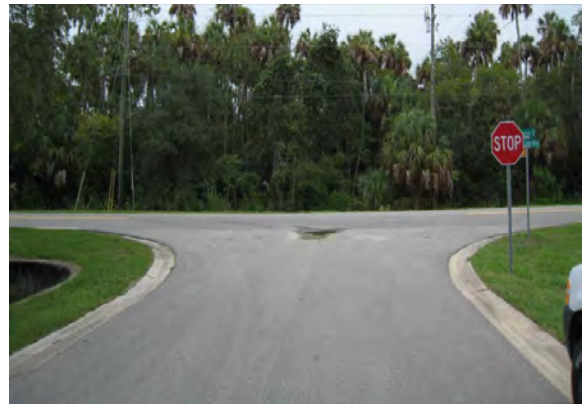
369 – Hernando County, Shoal Line Boulevard at Porpoise Street, drainage structure

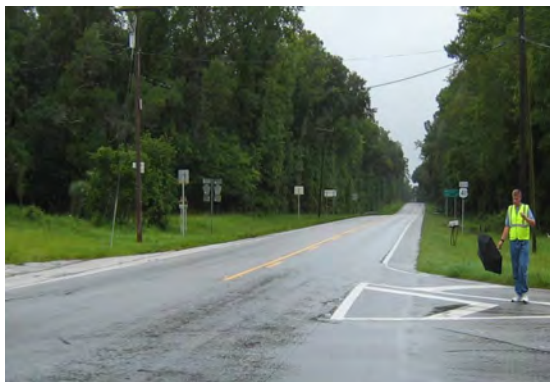
374 – Hernando County, Lake Lindsey Road at Broad Street, STOP bar placement

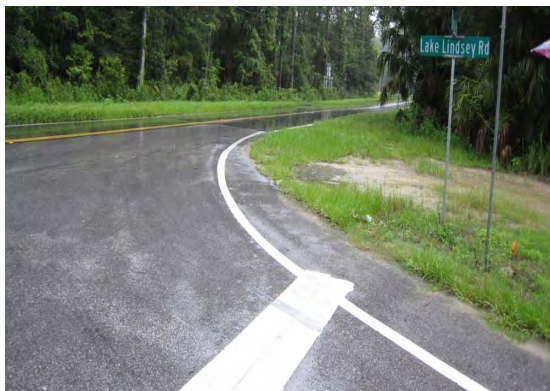
382 – Hernando County, Lake Lindsey Road at Citrus Way, no street lighting

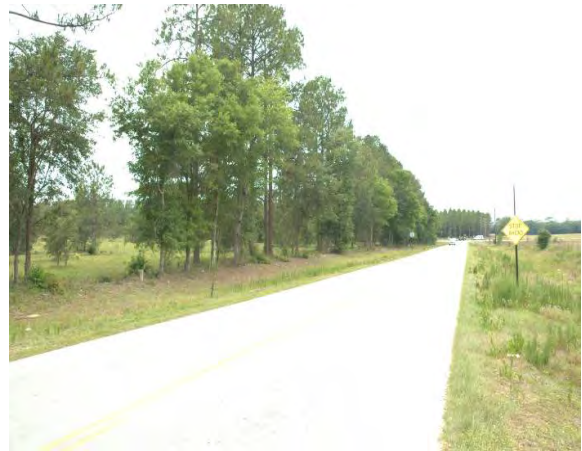
386 - Levy County, CR 241 and CR 335, 30"x30" STOP sign dirty
