Final Report

July 2018

Use of Small Unmanned Aerial Vehicles (sUAV) for Structural Inspection

Florida Department of Transportation (FDOT)
Office of Maintenance
Richard I. Kerr, P.E. – Project Manager

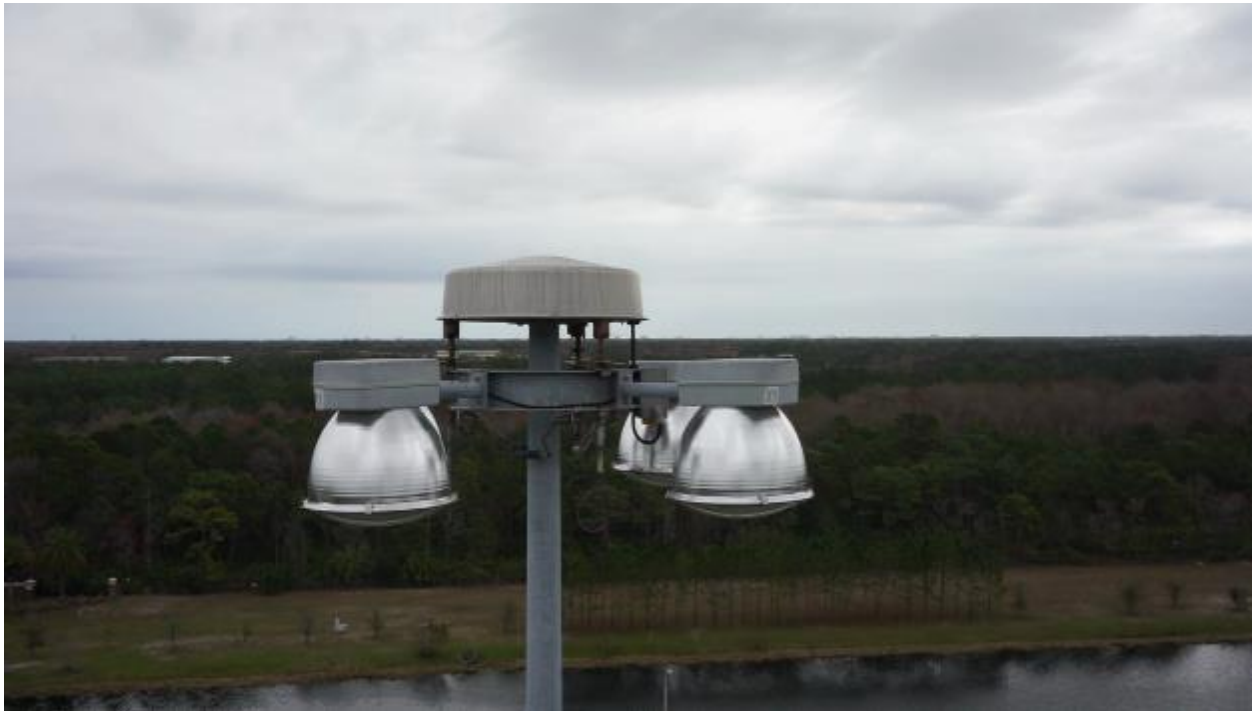
Figure A2-29. 72P740 - View of Lights from West

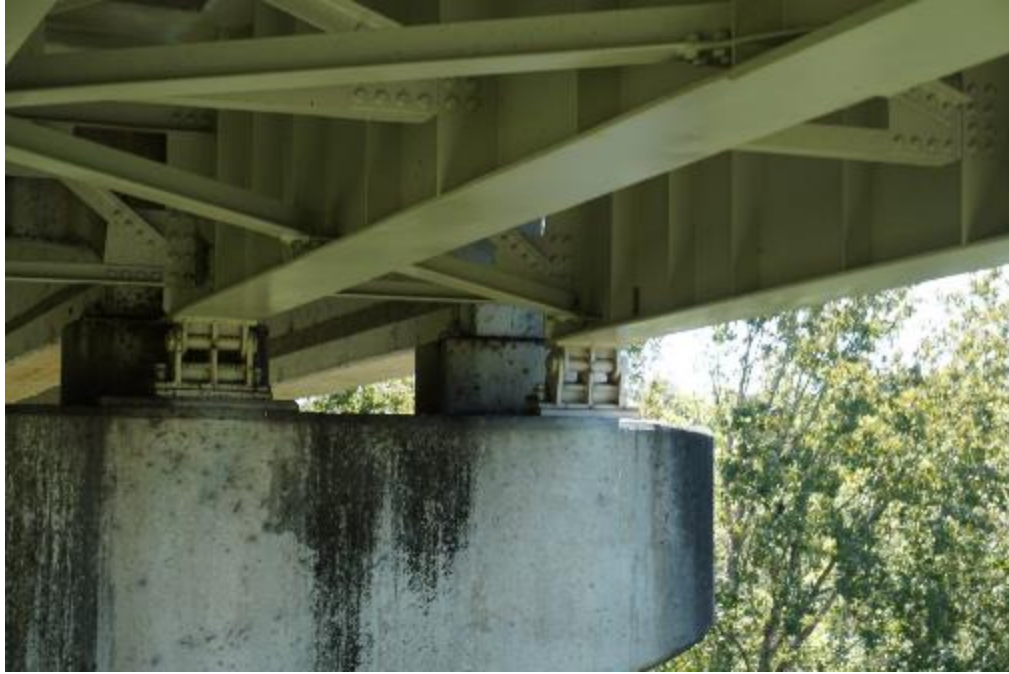
Figure A2-92. 360055 – View of rocker bearing near maximum range of movement
